## **Streambank erosion baseline establishment project**

Burnett & Kolan Rivers 2015

# **Appendix F**

Site report cards summarising  
streambank condition transects

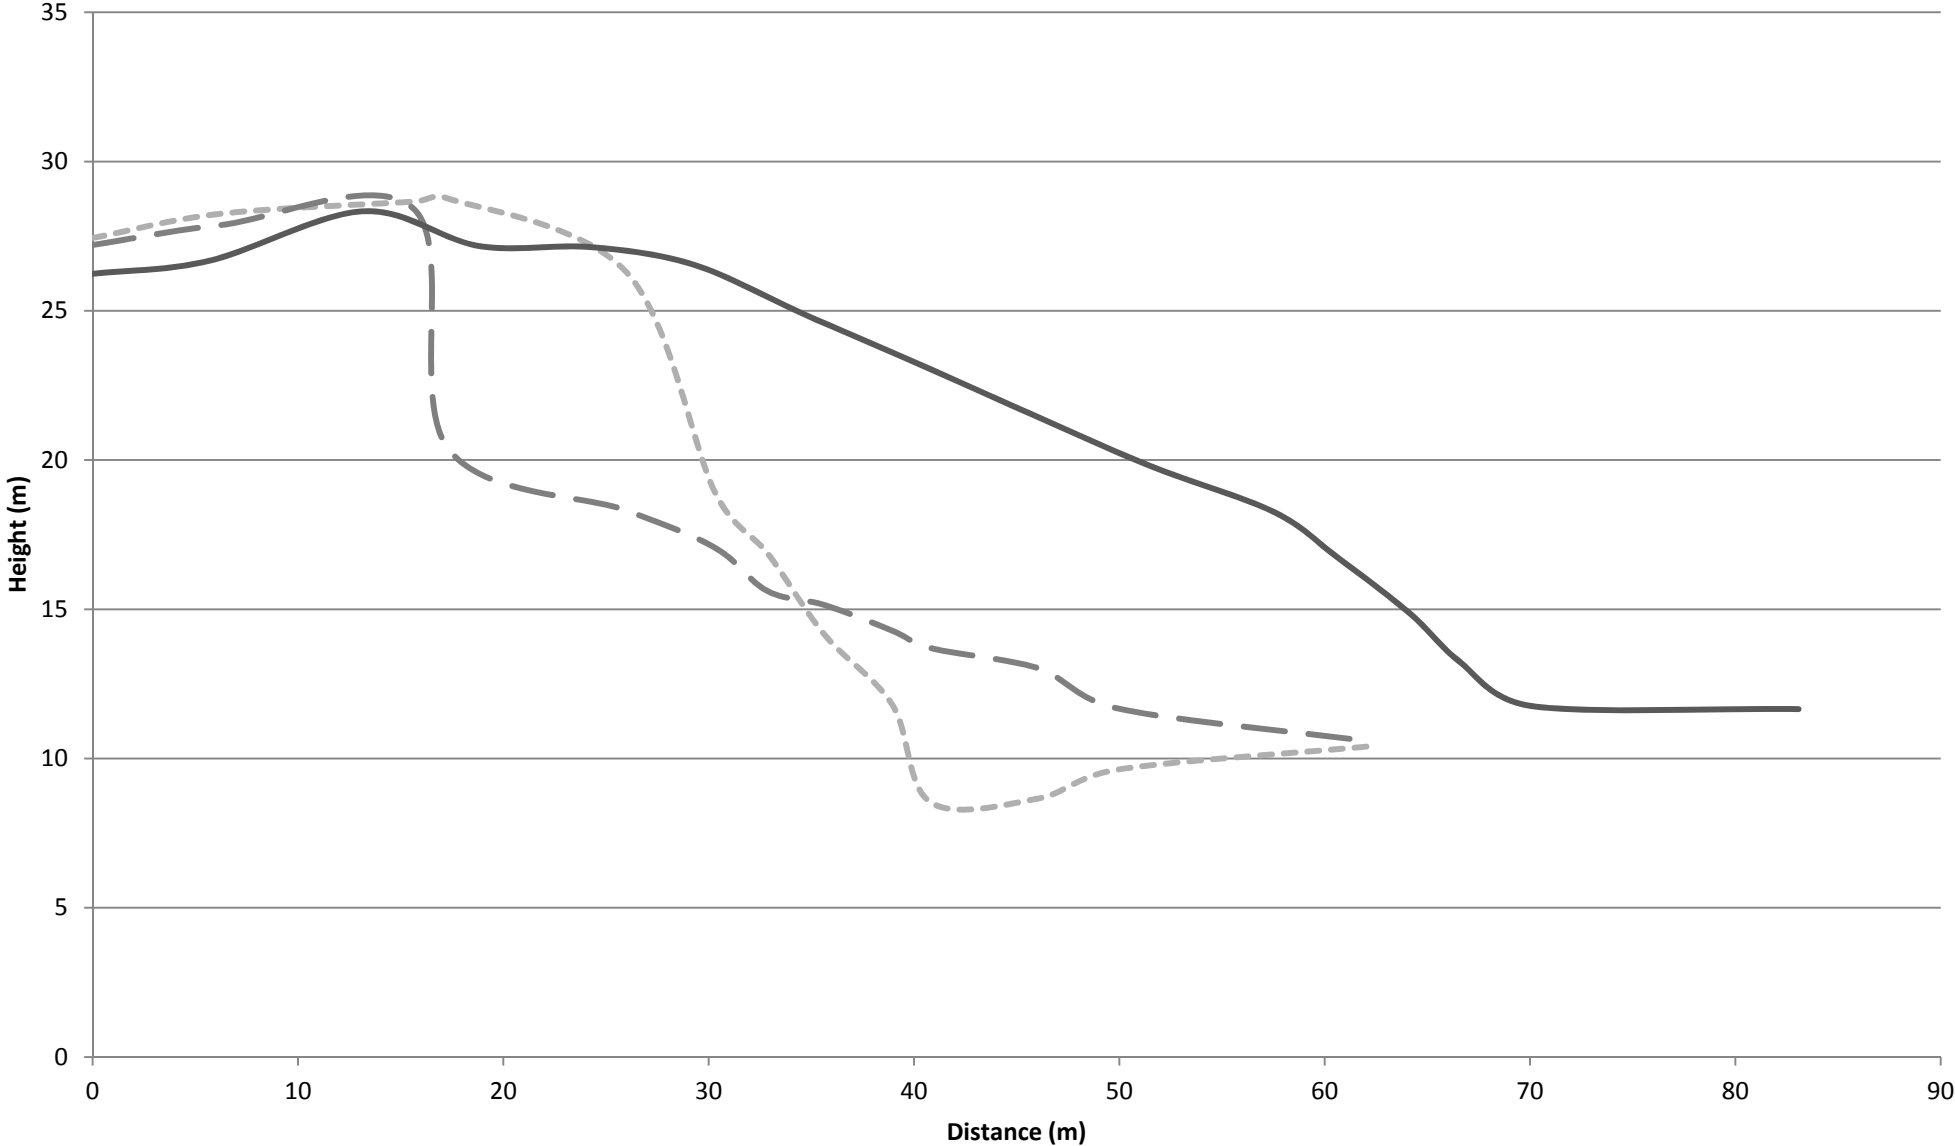
# Site 9 - Transect 1

--- Pre-Flood    -.- Post-flood    — Post-earthworks

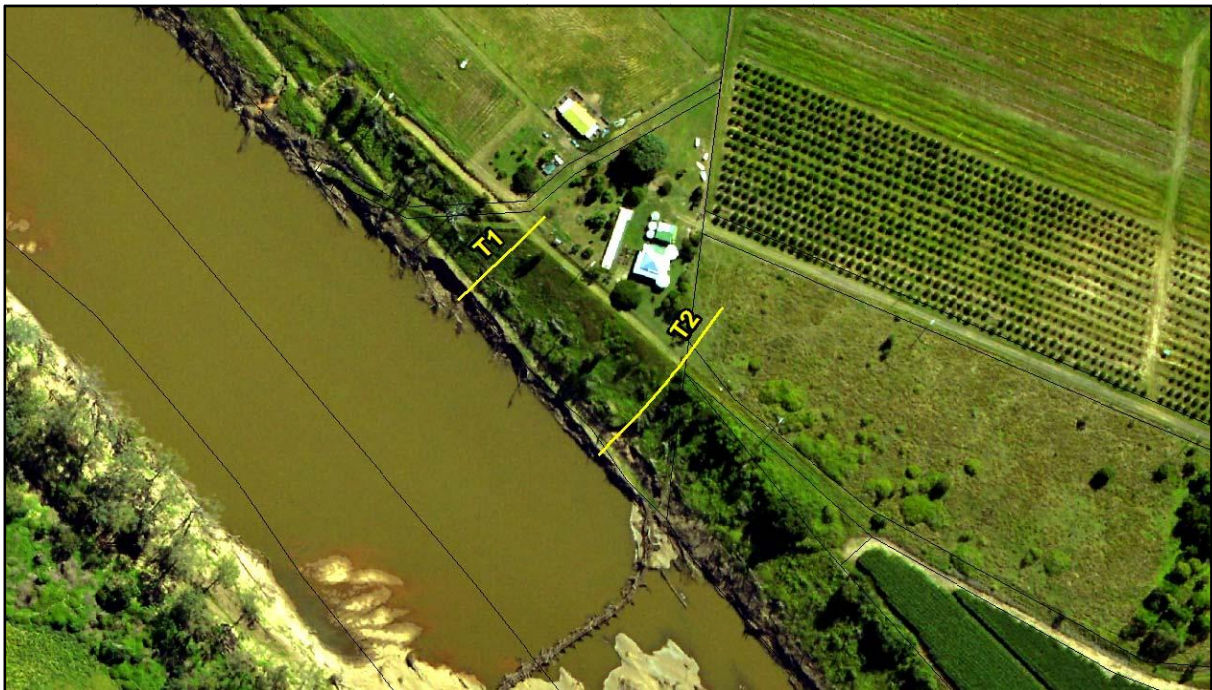
Flood waters covered almost all of the property and rose well above the revegetation sites. Infrastructure (including fences) and equipment were damaged. Scouring occurred along the whole bank, with moderate slumping along the lower section below the railway, causing approximately 3m of land to be lost.

No earthworks undertaken, revegetation only. Manual removal and spraying of weeds, with some irrigation. Riparian area fenced to exclude stock. Stock (horses and goats) will occasionally be permitted to enter the site for purposes of weed control.

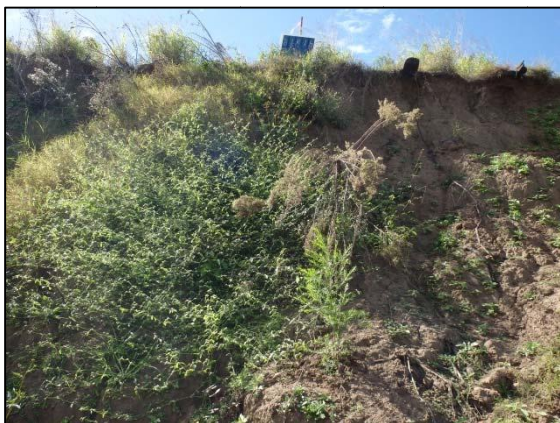
**PHOTO:** LB1R14(iii)

View of segment 4 from end of transect (at water's edge), looking upslope.

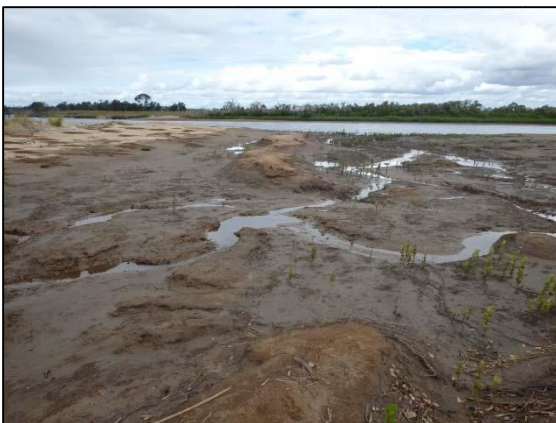
**PHOTO:** K2R23a(iv)

Photo taken halfway between Segment 3 and 4 of Transect 2 (approx. 70m from start), looking south towards river.

Area representative of Transect 1 is seen in left of photo.

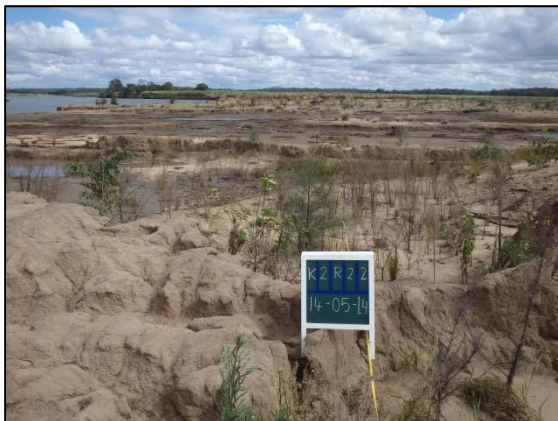
**PHOTO:** K2R22(i)

Photo taken at Segment 2 of Transect 2, looking west along the Transect, across the eroded channel.

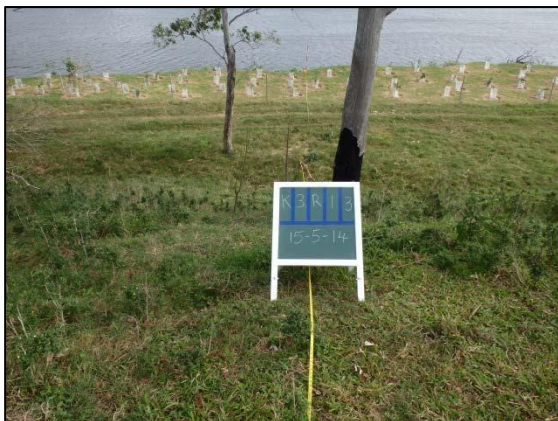
**PHOTO:** K3R13(i)

Photo taken at Segment 3 of Transect 1, looking along transect (downslope) towards the river.

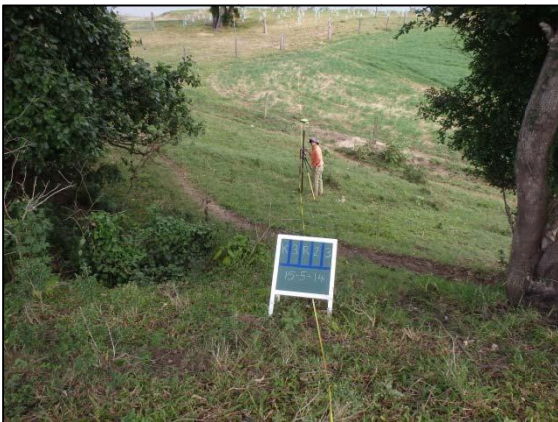
**PHOTO:** K3R23(i)

Photo taken at Segment 3 of Transect 2, looking along transect (downslope) towards the river.

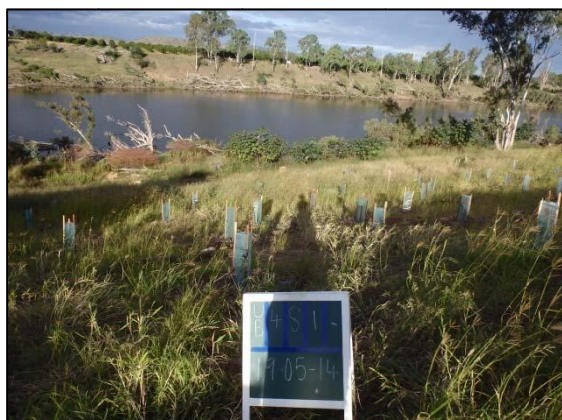
**PHOTO:** UB4S1B

Photo taken looking south across revegetation area at Transect 1.

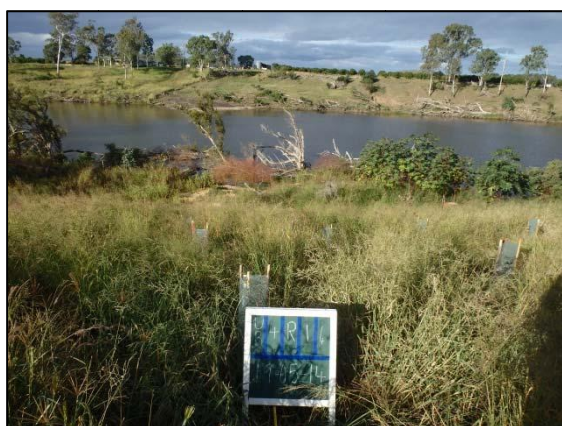
**PHOTO:** UB4R14(i)

Photo taken at Segment 4 of Transect 1 looking (downslope) towards river, across revegetated area.

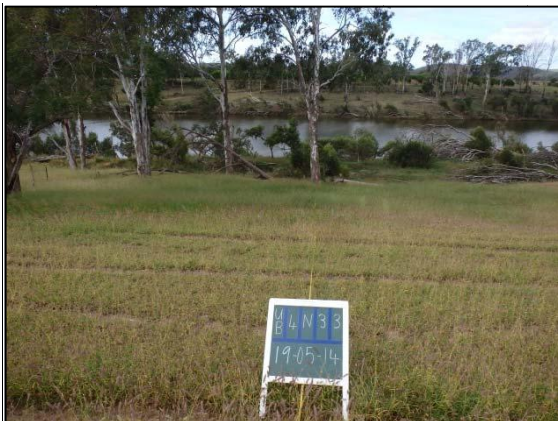
**PHOTO:** UB4N33(i)

Photo taken at Segment 3 of Transect 3 looking (downslope) towards river.

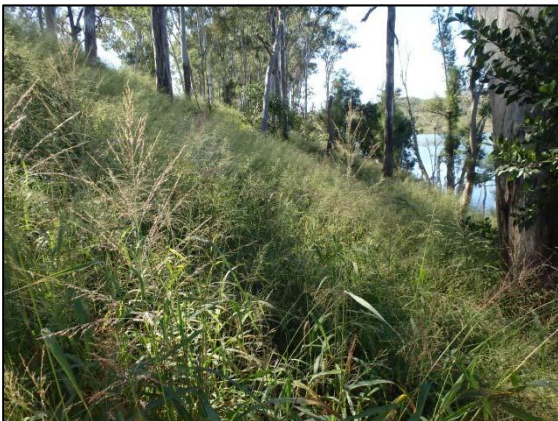
**PHOTO:** UB5N14(iv)

Photo taken at Segment 4 of Transect 1 looking east (across slope).

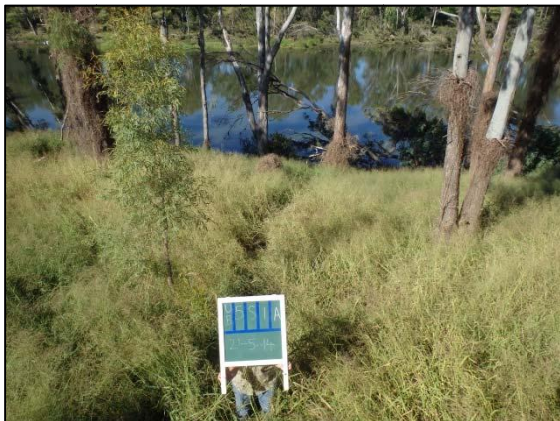
**PHOTO:** UB5S1A

Photo taken from edge of riparian area (also break of slope) in Segment 2 of Transect 1, looking (downslope) towards river.

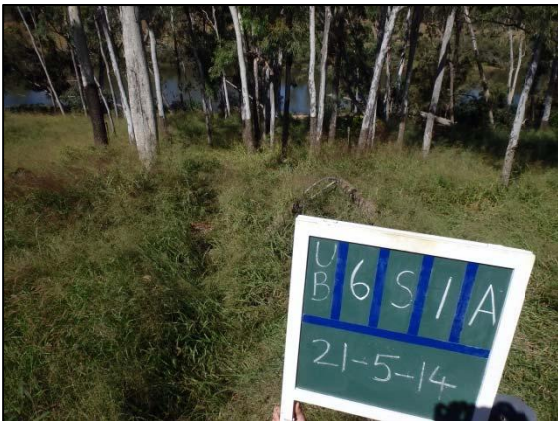
**PHOTO:** UB6S1A

Photo taken at edge of riparian area (also break of slope) at Segment 2 of Transect 1, looking (downslope) towards river.

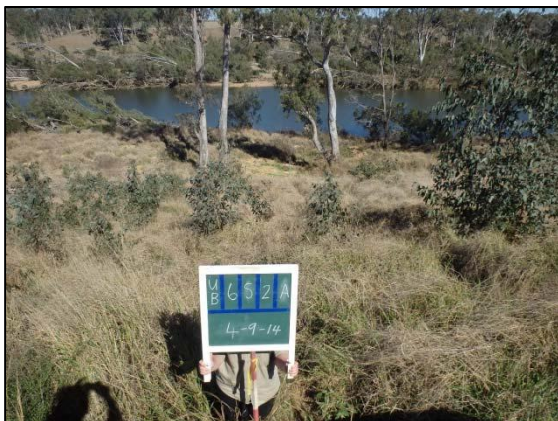
**PHOTO:** UB6S2A

Photo taken from edge of riparian area (also break of slope) at Segment 2 of Transect 2, looking (downslope) towards river.

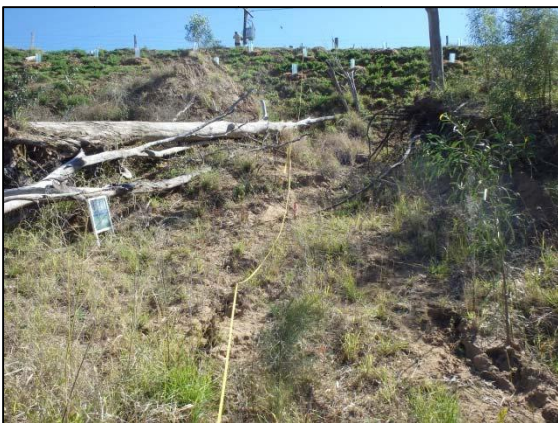
**PHOTO:** UB8R24

Photo taken from Segment 4 of Transect 2, at the water's edge, looking north (upslope) along transect.

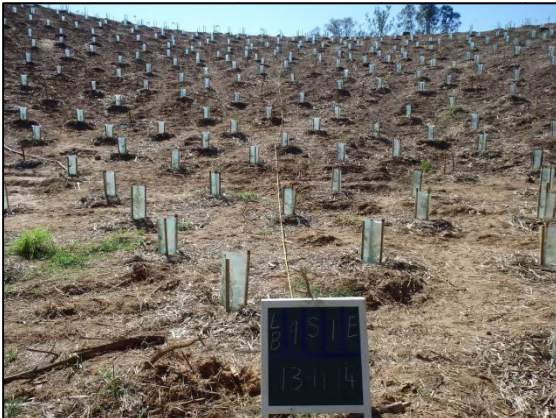
**PHOTO:** UB9S1E

Photo taken from the end of Transect 1, looking (upslope) to the top of the repaired slump.
