16.1 Pilot Transfer Arrangements – Marine Notice 04/2023

MARINE NOTICE

Marine Notice 2023/04
Supersedes 2022/03

Pilot transfer arrangements

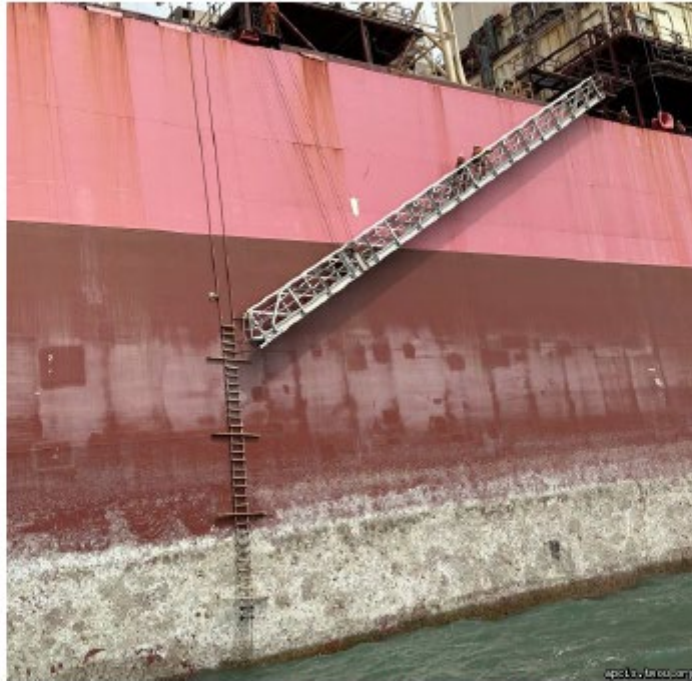
One common issue found is that the pilot ladder does not extend the required 2.0 m past the accommodation platform when a combination arrangement is used. Photo 2 illustrates an example of a pilot ladder not extending the required height past the platform.

Photo 2: Example of non-compliant combination pilot ladder arrangements.

As shown in photos 2 and 3 persons cannot climb the pilot ladder to a level where they can move safely onto the accommodation ladder.

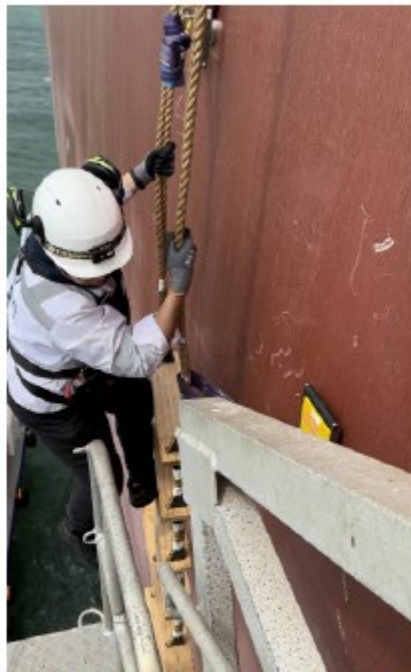
Photo 3: Person unable to safely access accommodation ladder platform from pilot ladder.

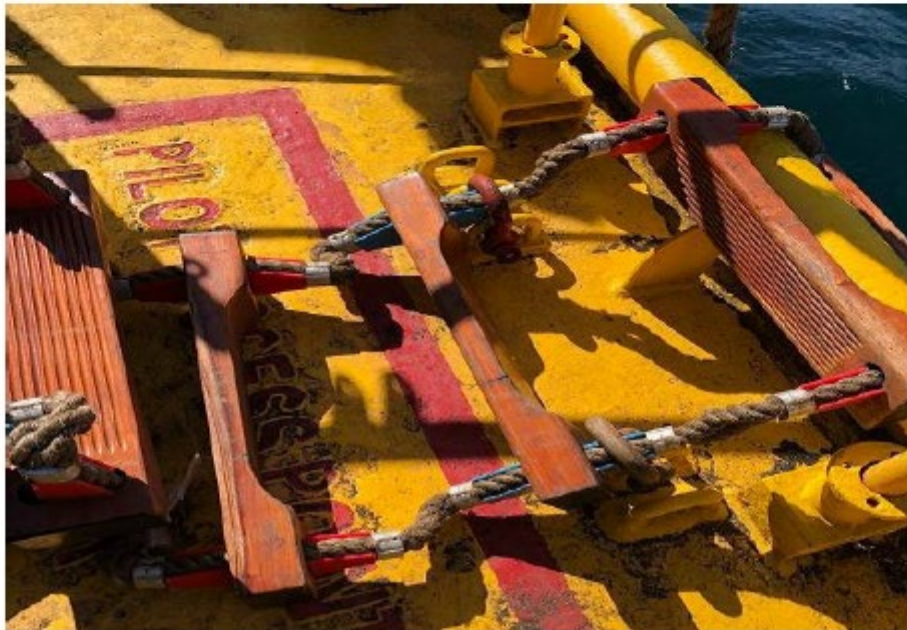
The ladder's steps, spreaders or chocks should not be used to carry the weight of the ladder as they are not designed for this and do not have sufficient strength. For this reason, shackles, bars and tongues should not be used to secure the ladder to the deck. They will damage the ladder and put weight on the parts which are not designed to carry the weight.

Photo 4 shows an example of an unsafe use of shackles to secure pilot ladders.

Photo 4: Unsafe pilot ladder securing arrangements (Reproduced with permission from Fremantle Ports).

It is common industry practice to use a rope stopper usually in the form of a rolling hitch knot between the pilot ladder sides ropes and the approved strong point on the main deck. This will transfer the weight of the ladder arrangement directly onto the designated strong point and will not damage the ladder.

It is suggested that two strong (at least 2 x 24 kN) manila ropes be used to secure the pilot ladder. Photo 6 illustrates a method of tying a rolling hitch knot.

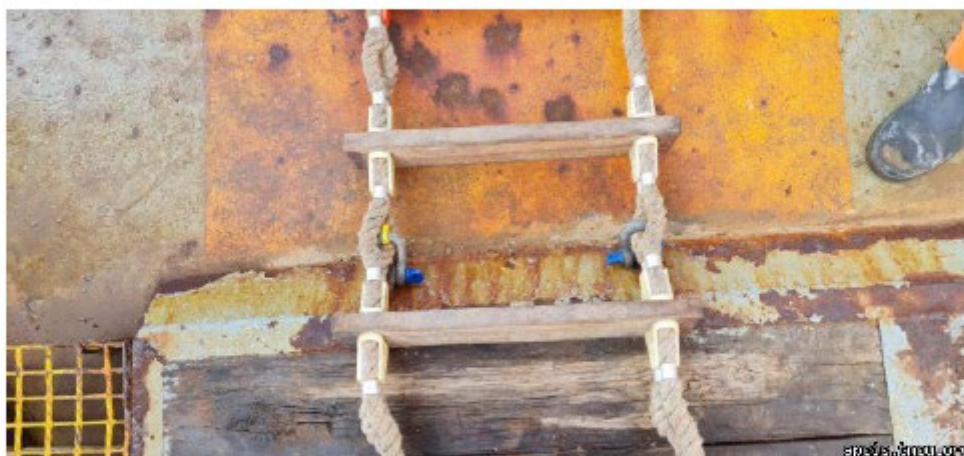
Photo 5: Unsafe pilot ladder securing arrangements.

Photos 5 shows the pilot ladder being secured to the strong point by using a shackle passed through the pilot ladder side ropes. This puts increased load on the single part of the side rope and the chock securing arrangements.

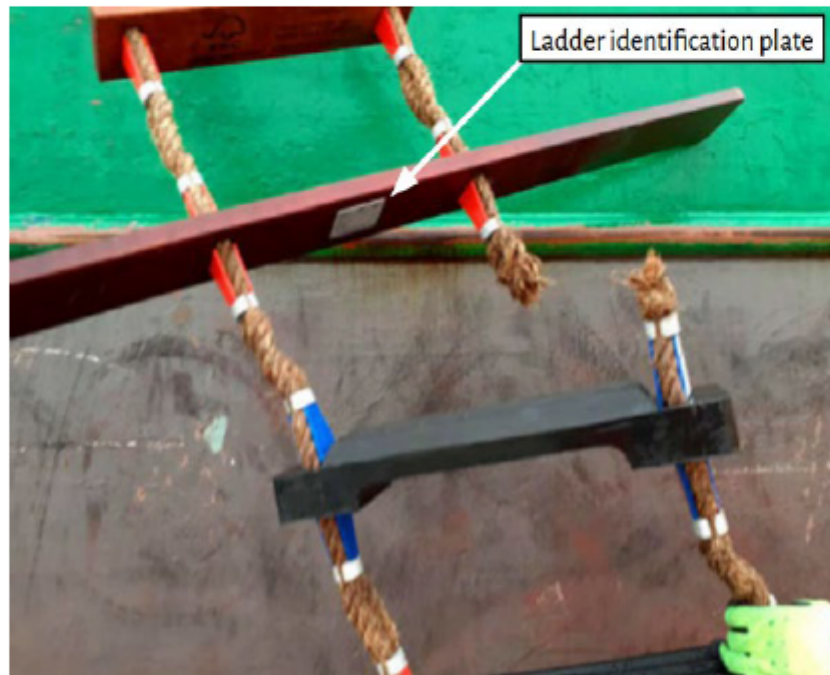
Photo 8: Pilot ladder where side ropes parted when in use (Reproduced with permission of the MAIB).

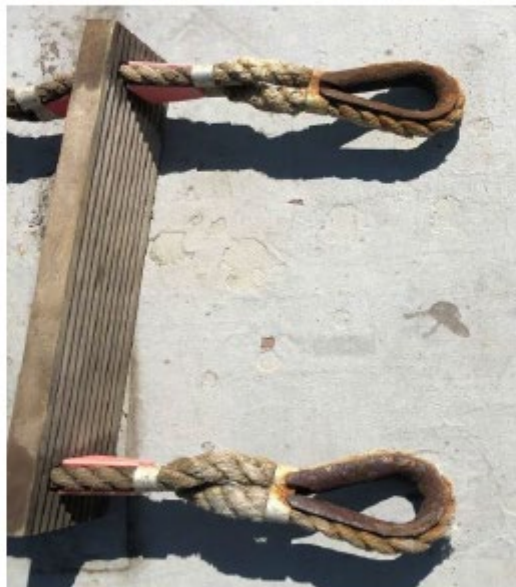
Common areas of defects can be the thimble ends of the pilot ladder. Corroded end point thimbles as illustrated in photo 9, can damage the side ropes leading to failure.

Photo 9: Example of corroded end point thimbles (Reproduced with permission from Fremantle Ports).

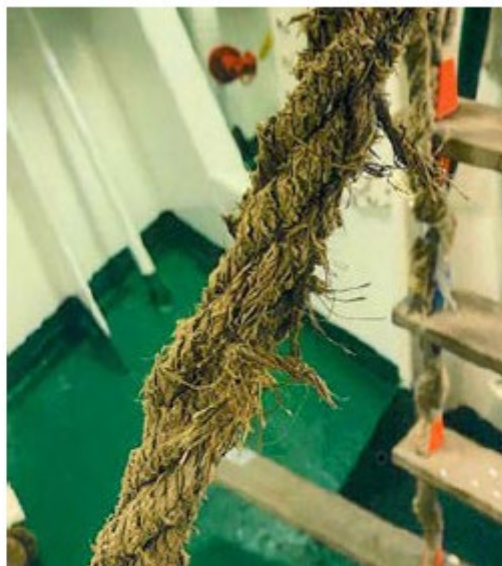
Another common area is the frayed or damaged side ropes as illustrated in photo 10. These should be detected during routine visual inspections.

Photo 10: Frayed side rope.

If side ropes are frayed, or in any way degraded the ladder should not be used.

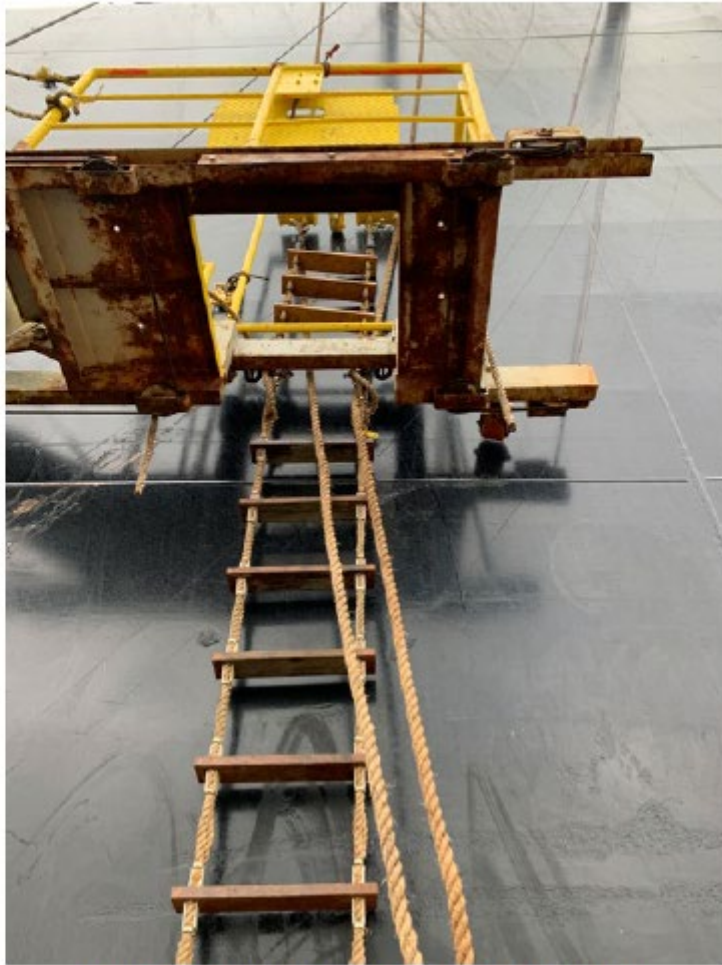
If the pilot ladder and man ropes are not rigged through the trapdoor this creates an unsafe arrangement for persons as illustrated in photo 11

Photo 11: Unsafe trapdoor pilot transfer arrangement.

There has been an increase in ships fitted with trapdoor arrangements. The additional requirement for their use is "the pilot ladder and man ropes shall be rigged through the trapdoor extending above the platform to the height of the handrail".

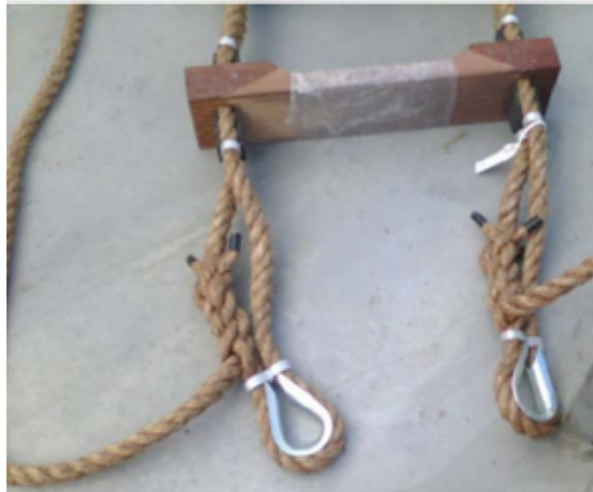
During recent PSC inspections AMSA surveyors have noted pilot ladders which have been constructed with splices in the side ropes.

Photo 12: Example of non-compliant pilot ladder with splices in side ropes.

Pilot ladders constructed like this are considered non-compliant by AMSA. Ship operators and masters are recommended to check their pilot ladders for splices in the side ropes. It should be noted by operators coming to Australian ports that the availability of compliant pilot ladders is limited in Australia. To prevent avoidable delays operators are recommended to have spare compliant pilot transfer arrangements onboard.
