Resources Safety & Health  
Queensland

# 2020 Level 1 exercise

Held at Moranbah North coal mine

Monday 6 December 2020

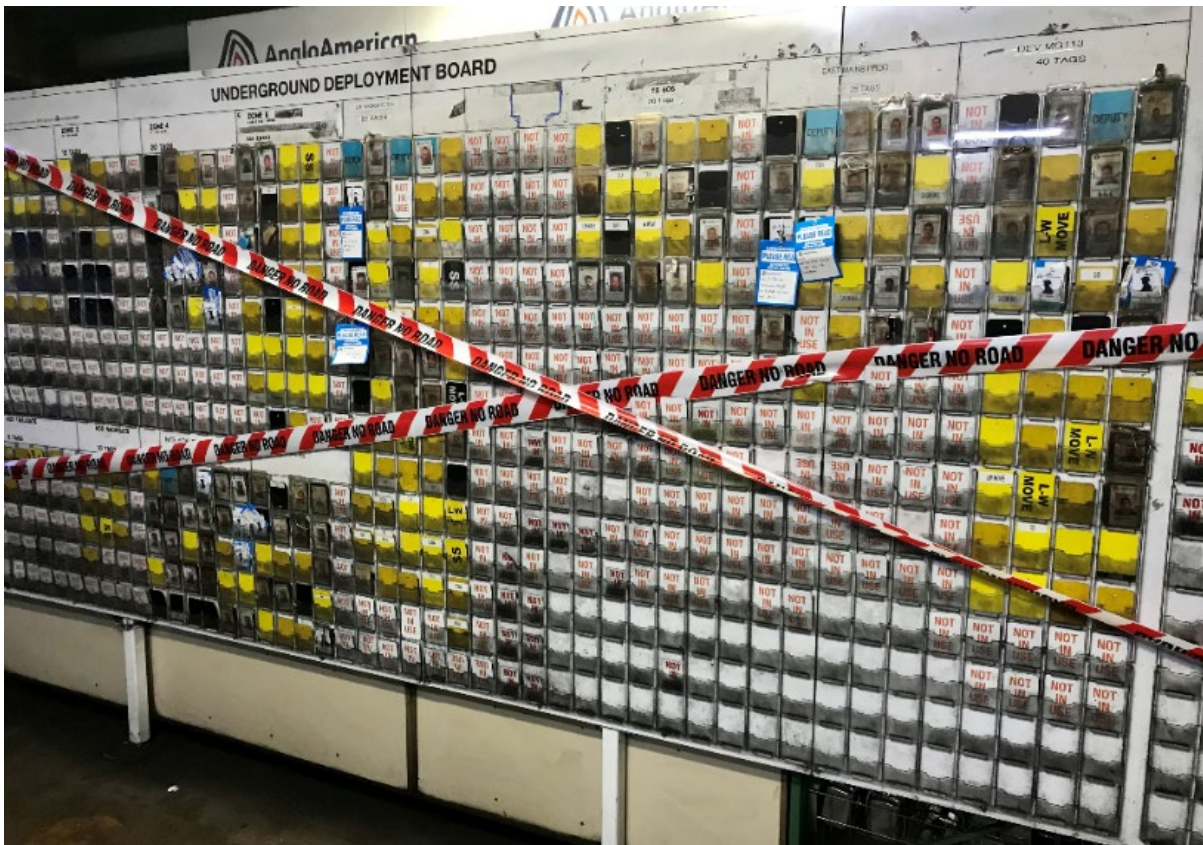
When the tag board was covered with no-road tape in a cross to prevent access to the board (see Figure 7), it was observed that the tape covered the tag of the missing CMW.

The surface tag board was checked at 04:05, and the CMW (who had not moved on MineDash since 22:30) was identified at 04:22. The CMW’s tag was actually behind the tape and not easy to spot (see Figure 7).

Figure 7 Surface tag board (note the danger tape covers some of the tags)
