# Level One Emergency Exercise Report

5 November 2013

Ensham Coal Mine

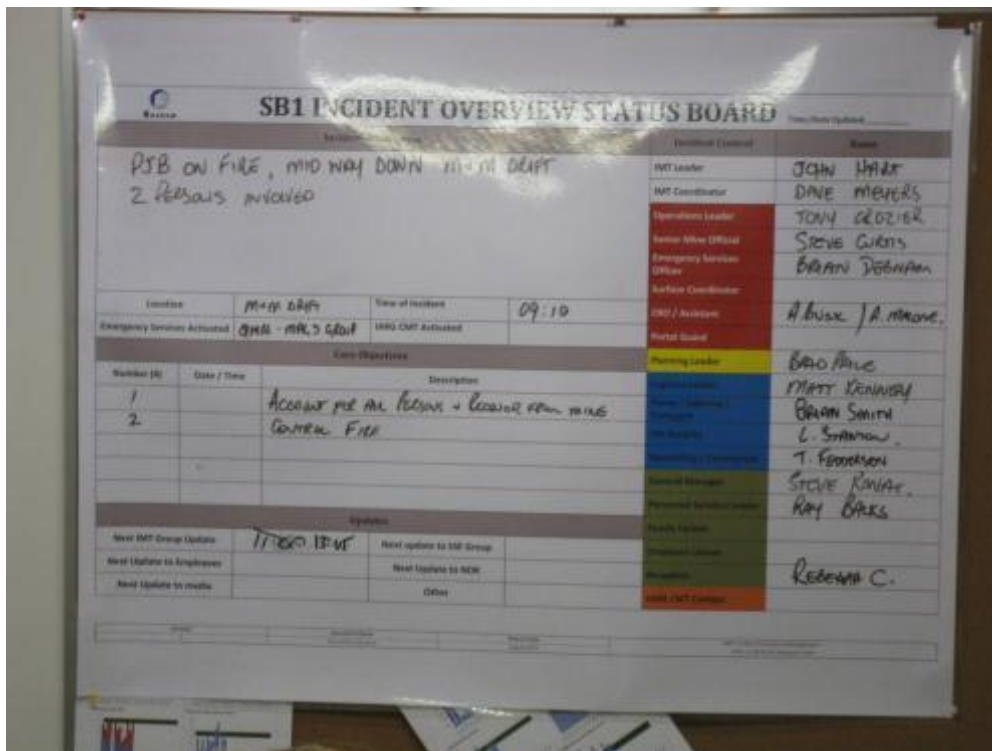
Image 6: Incident overview status board at 12.00 pm

- Despite the use of boards to set and monitor objectives there was inadequate focus on the number and location of persons underground. For example the IMT were not aware that the crew in 201 had to walk out due to the failure of the PJB in the panel to start. It was also some time before the IMT recognised that there was a missing CMW identified in the control room at 9.54 am formally noted in IMT at 11.07 am.

There was a status board (SB2) that would serve this function though it was deployed in IARG Crisis Management Team. It is noted that creation and maintenance of an SB2 in the IMT room is listed as a task of the incident management team coordinator on his duty card. There was an electronic system for monitoring the location of persons underground which proved to be not operating properly. This fault was not detected until several hours into the incident.
