# Report: 2021 Level 1 emergency exercise

Exercise date: Tuesday 26 October 2021

Exercise location: Oaky North Coal Mine

Report author: Geoff Nugent, Inspector of Coal Mines &

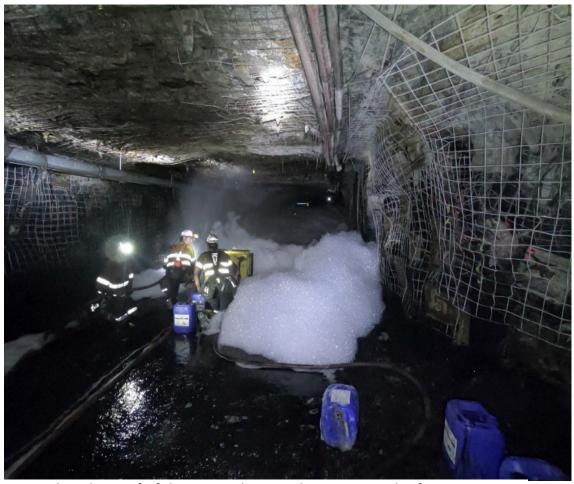
Figure 5 Photo shown to firefighting responders at incident site using Turbex foam generator

Assessor Note: Fire fighters are using blue high expansion drums of foam which do not seem to be very effective. The fire had burnt through the pipe work inbye but this was not identified for some time

- Ensure basic firefighting training includes the use of firefighting equipment for all classes of fire and the best medium to fight them
- Ensure the potential ramifications of using high expansion foam without modelling the outcome is understood
- Ensure limitations of firefighting equipment is understood e.g. Running 350m of hose lines
  can cause excessive pressure drop and consider using 64mm hoses to allow for maximum
  flow of water over a longer distance
- Conduct basic fire training as part of ongoing skills maintenance
- Conduct smaller scenarios on regular basis on each crew.

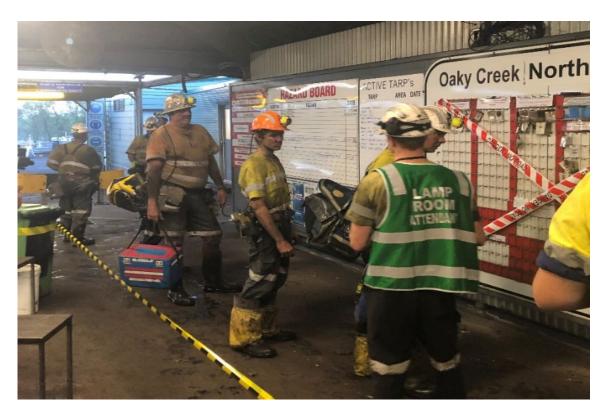
Figure 10 Surface Tag Board control

- Mine communication systems reported that the mine had limited cap lamps capable of communication and nodes underground. Mobile Phones were relied on, which on numerous occasions failed part way through communications between CRO, underground CMWs and Deputies leading to frustrations and delays in information transfer. Assessor was informed that the PED system doesn't work, and multiple Delay messages observed prior to exercise activation and not used as no confidence in the system. Did not witness DAC system being used to communicate emergency to outbye workers and Drillers and an Outbye Electrician were not identified as missing DAC may have assisted.

- Holders, key stakeholders, and those off site to facilitate active and informed emergency management.
- Need to utilise real time coal mine worker tracking solution that provides capability to identify location of people underground and on surface.
- Consider risk and the erosion factors to environmental monitoring system and does the
  mine capture TARP actions to be implemented if gas sensors have reached maximum
  capacity (as in this exercise all flat lined) to ensure accurate data is gathered to inform
  decision making and assurance it is safe for CMWs to remain underground or fighting a fire
  underground.
- What are the limitations or erosion factors of your mines communication system, can you communicate an emergency event to all CMWs in all areas of work on your mine site?

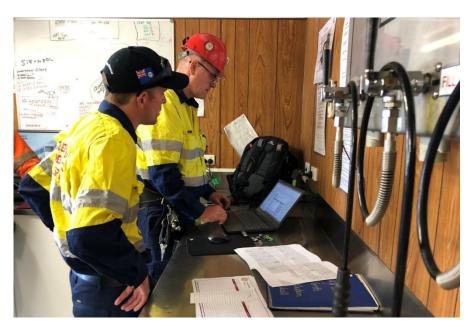
Figure 12 QMRS Staff preparing team deployment documents in OCN sub station

However, an authority to enter and captain's task sheet was developed by a QMRS training officer stationed at the sites rescue substation. These documents were collected by the Operations Manager and presented to the site SSE/UMM for review and signing. On review of documentation, it was found that whilst the authority to enter was signed by QMRS and Incident controller the captains task sheet was signed by the QMRS official only and not signed by the Incident controller.

- QMRS should review the effectiveness of deployment procedures for Operations Managers
  when notified of an emergency at a mine which may require the response of mines rescue
  team members.
- QMRS should review the resourcing requirements required during an emergency at a mine

- to effectively apply the defined risk management process for mines rescue teams to deploy and remain underground.
- Further, QMRS should review the resourcing requirements to efficiently deliver team deployment procedures and relevant information during an emergency response at a mine e.g., Captains Task Sheets, Gas monitoring data and TARP status, Authority to enter.
- QMRS should conduct a review or audit for each underground coal mine to determine if
  the operational procedures developed by QMRS can be effectively applied to carry out
  mines rescue services at the mine.
