Great Barrier Reef Catchment Loads Monitoring Program

Condition Report 2021-2022

Story Map text-only version

Prepared by: Water Quality and Investigations, Department of Environment, Science and Innovation

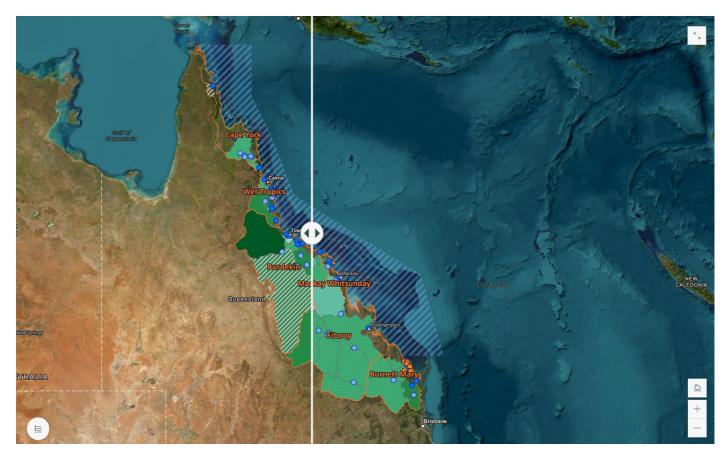
Swipe to compare: Particulate phosphorus loads on the left-hand side, and particulate phosphorus yields on the right-hand side for the 2021-2022 monitoring year. Click on the menu in the bottom left corner of the map to view the legend.

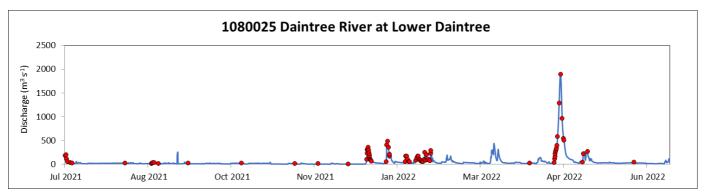
Figure 19 Hydrograph showing measured and modelled discharge (blue line) and sample coverage for total suspended solids, total nutrients, dissolved and particulate nutrients (red circles) in the Daintree River at Lower Daintree between 1 July 2021 and 30 June 2022. Representivity rating was excellent for all analytes.
