Severe Tropical Cyclone Oma

Storm Tide and Wave Monitoring Data

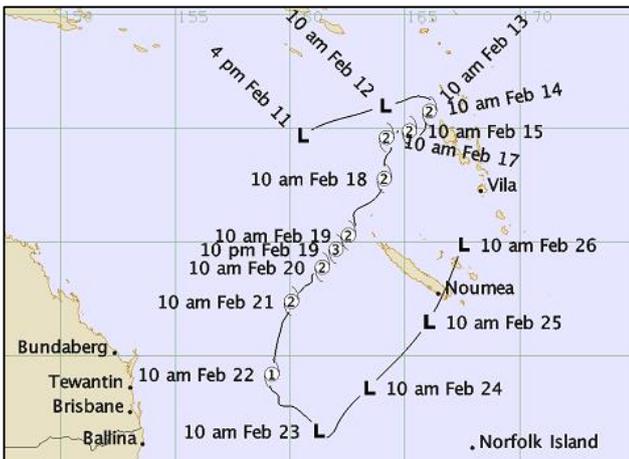
Figure 1 TC Oma Track Map (courtesy of BOM).

On Friday 11 February 2019 a tropical low in the Coral Sea off the coast of Cairns, Queensland tracked eastwards before developing into Tropical Cyclone (TC) Oma on 12 February. TC Oma gradually moved southwest, briefly intensifying to a category 3 severe tropical cyclone before moving into the southern Coral Sea as a category 2, and eventually being downgraded to a tropical low on 23 February.

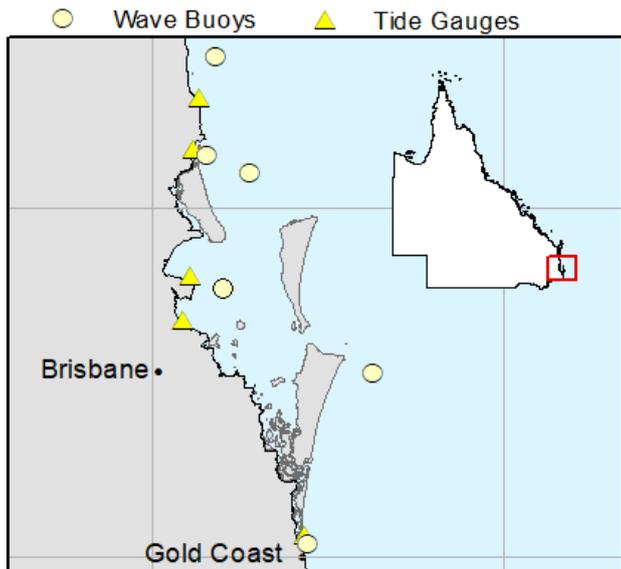
Figure 2 South East Qld wave buoy and tide gauge locations

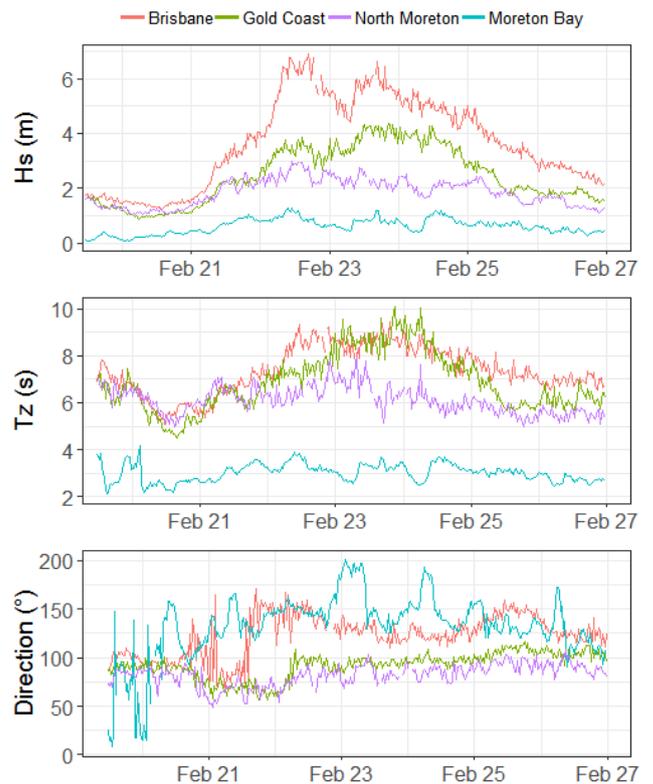
Figure 3 Significant wave height (Hs), Average period (Tz) and Direction for South East Qld wave monitoring sites

Significant wave height (Hs), average period (Tz) and direction were measured during TC Oma (Figure 3) demonstrating the impact along the SE Qld Coastline. Wave monitoring sites adjacent to the cyclone track showed increased wave heights and wave period from 21 February as TC Oma drew closer to the coast, before decreasing on 23 February when TC Oma was downgraded to a tropical low. The largest wave to be recorded by the DES wave monitoring network during the passage of TC Oma, was 13.1 m, recorded by the Brisbane wave buoy (Figure 4). On 22 February waves were travelling in a south-easterly direction as a result of the steep gradient of TC Oma coupled with a high pressure system in the Southern Ocean.

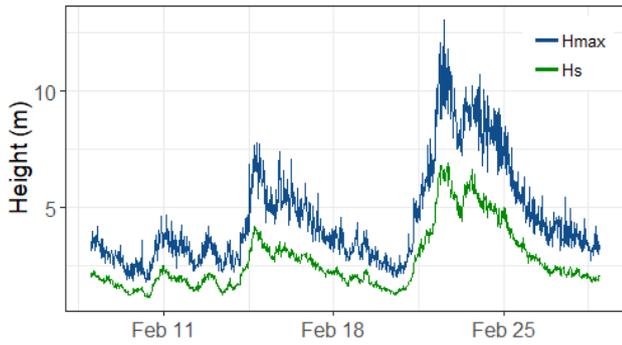
Figure 4 Brisbane maximum wave height (Hmax) and significant wave height (Hs) during the passage of TC Oma

Wave conditions recorded at a number of DES wave-monitoring stations were identified as record top ten wave heights (Table 1).

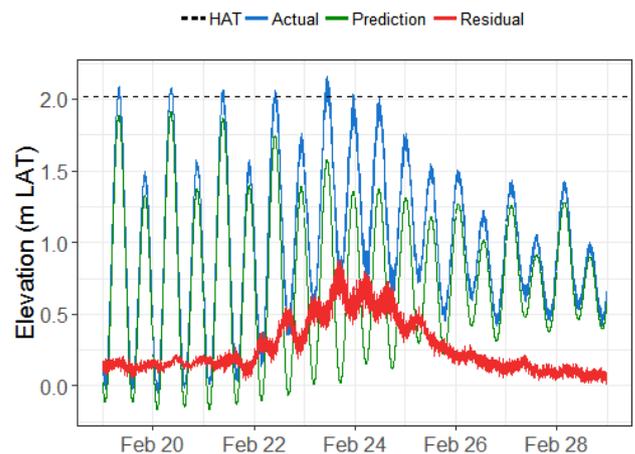
Figure 5 Gold Coast storm tide

Table 2 lists the highest recorded storm surge (residual) as a result of TC Oma at a number of the SE Queensland storm tide gauges. The table shows the largest maximum storm surge, which was at the Gold Coast (Figure 5), while other monitoring stations along the coastline recorded maximum storm surge levels between 0.29 and 0.45 metres.

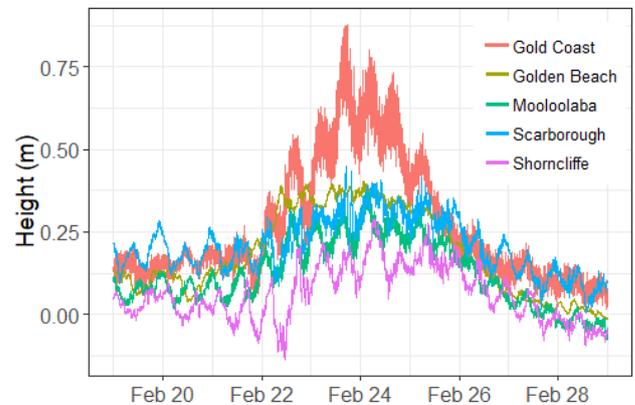
Figure 6 Storm Surge at SE Queensland tide gauges during TC Oma

Residuals for the SE Queensland tide gauges is displayed in Figure 6 and clearly demonstrates the impact of TC Oma at the Gold Coast.

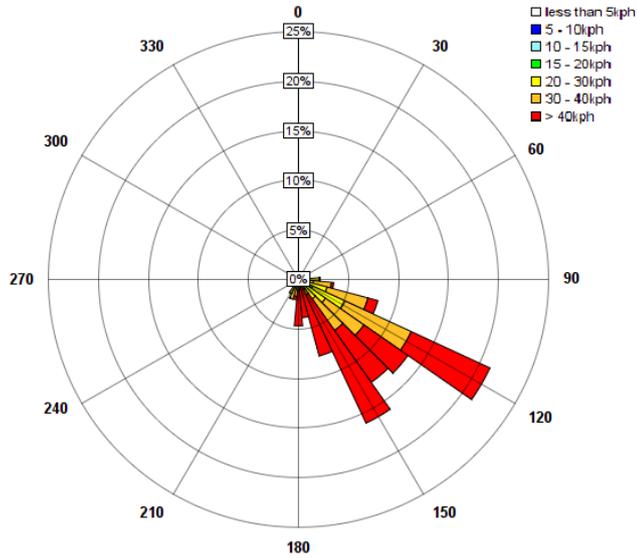
Figure 7 Wind Speed and Direction at Cape Moreton for the period 17/2/2019 to 28/2/2019

The Bureau of Meteorology observed damaging sustained wind gusts of up to 130 km/h and significant beach erosion occurred along SE Qld due to the wave energy produced by TC Oma. At Cape Moreton wind gusts greater than 40 km/h were recorded, predominantly coming from a south-easterly direction (Figure 7) and reached speeds up to 90 km/h (kph).

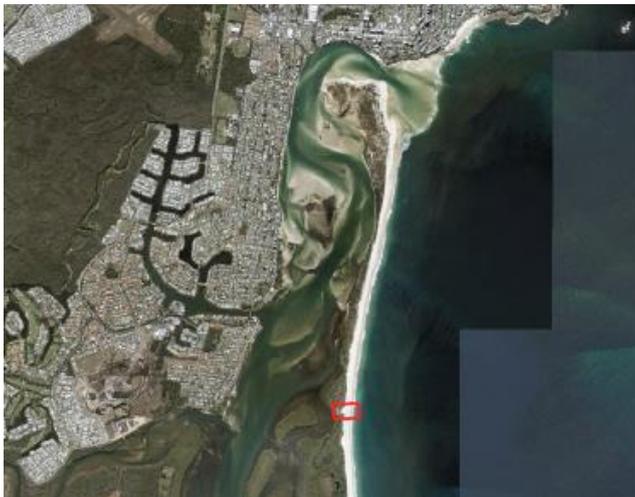
Figure 8 Survey site on Bribie Island

A beach profile survey was conducted on Bribie Island prior to TC Oma on 11 December 2018 and after TC Oma on 03 March 2019, allowing the erosion caused by TC Oma to be measured. Two beach profiles were mapped (Figure 8 and Figure 9) showing the level of erosion resulting from TC Oma. Photos taken at the survey site on Bribie Island before (Figure 10) and after (Figure 11) show the extent of beach erosion, with clearly evident erosion scarps.

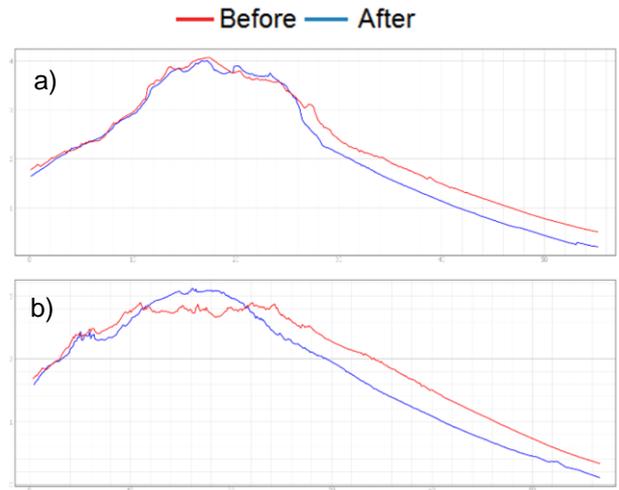
Figure 9 a) Profile 1 and b) Profile 2 conducted at Bribie Island

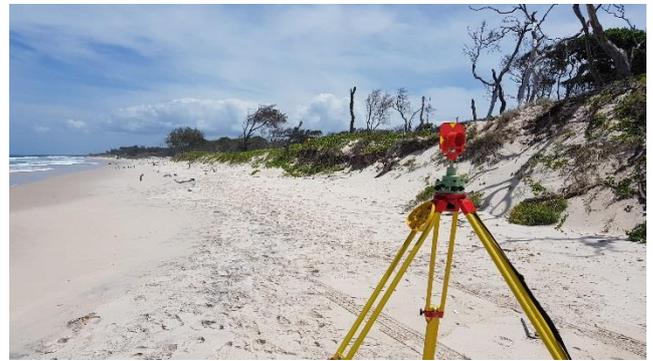
Figure 10 Bribie Island on 11 December 2018 before TC Oma

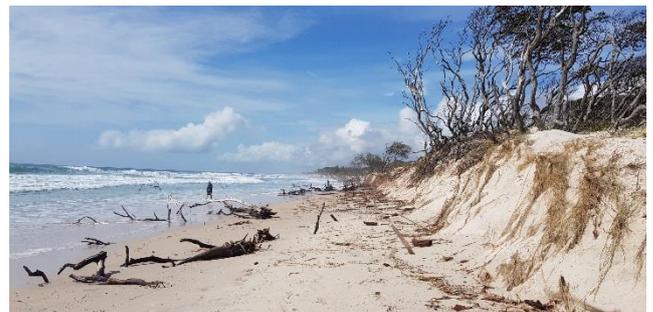
Figure 11 Bribie Island on 03 March 2019 after TC Oma
