PRELIMINARY GEOTECHNICAL INVESTIGATION

**PROPOSED GATTON CORRECTIONAL PRECINCT
KRUGERS ROAD, SPRING CREEK**

**prepared for
PROJECT SERVICES
(Project Services No 48370)**

**DP Project 47276
9 August 2007**

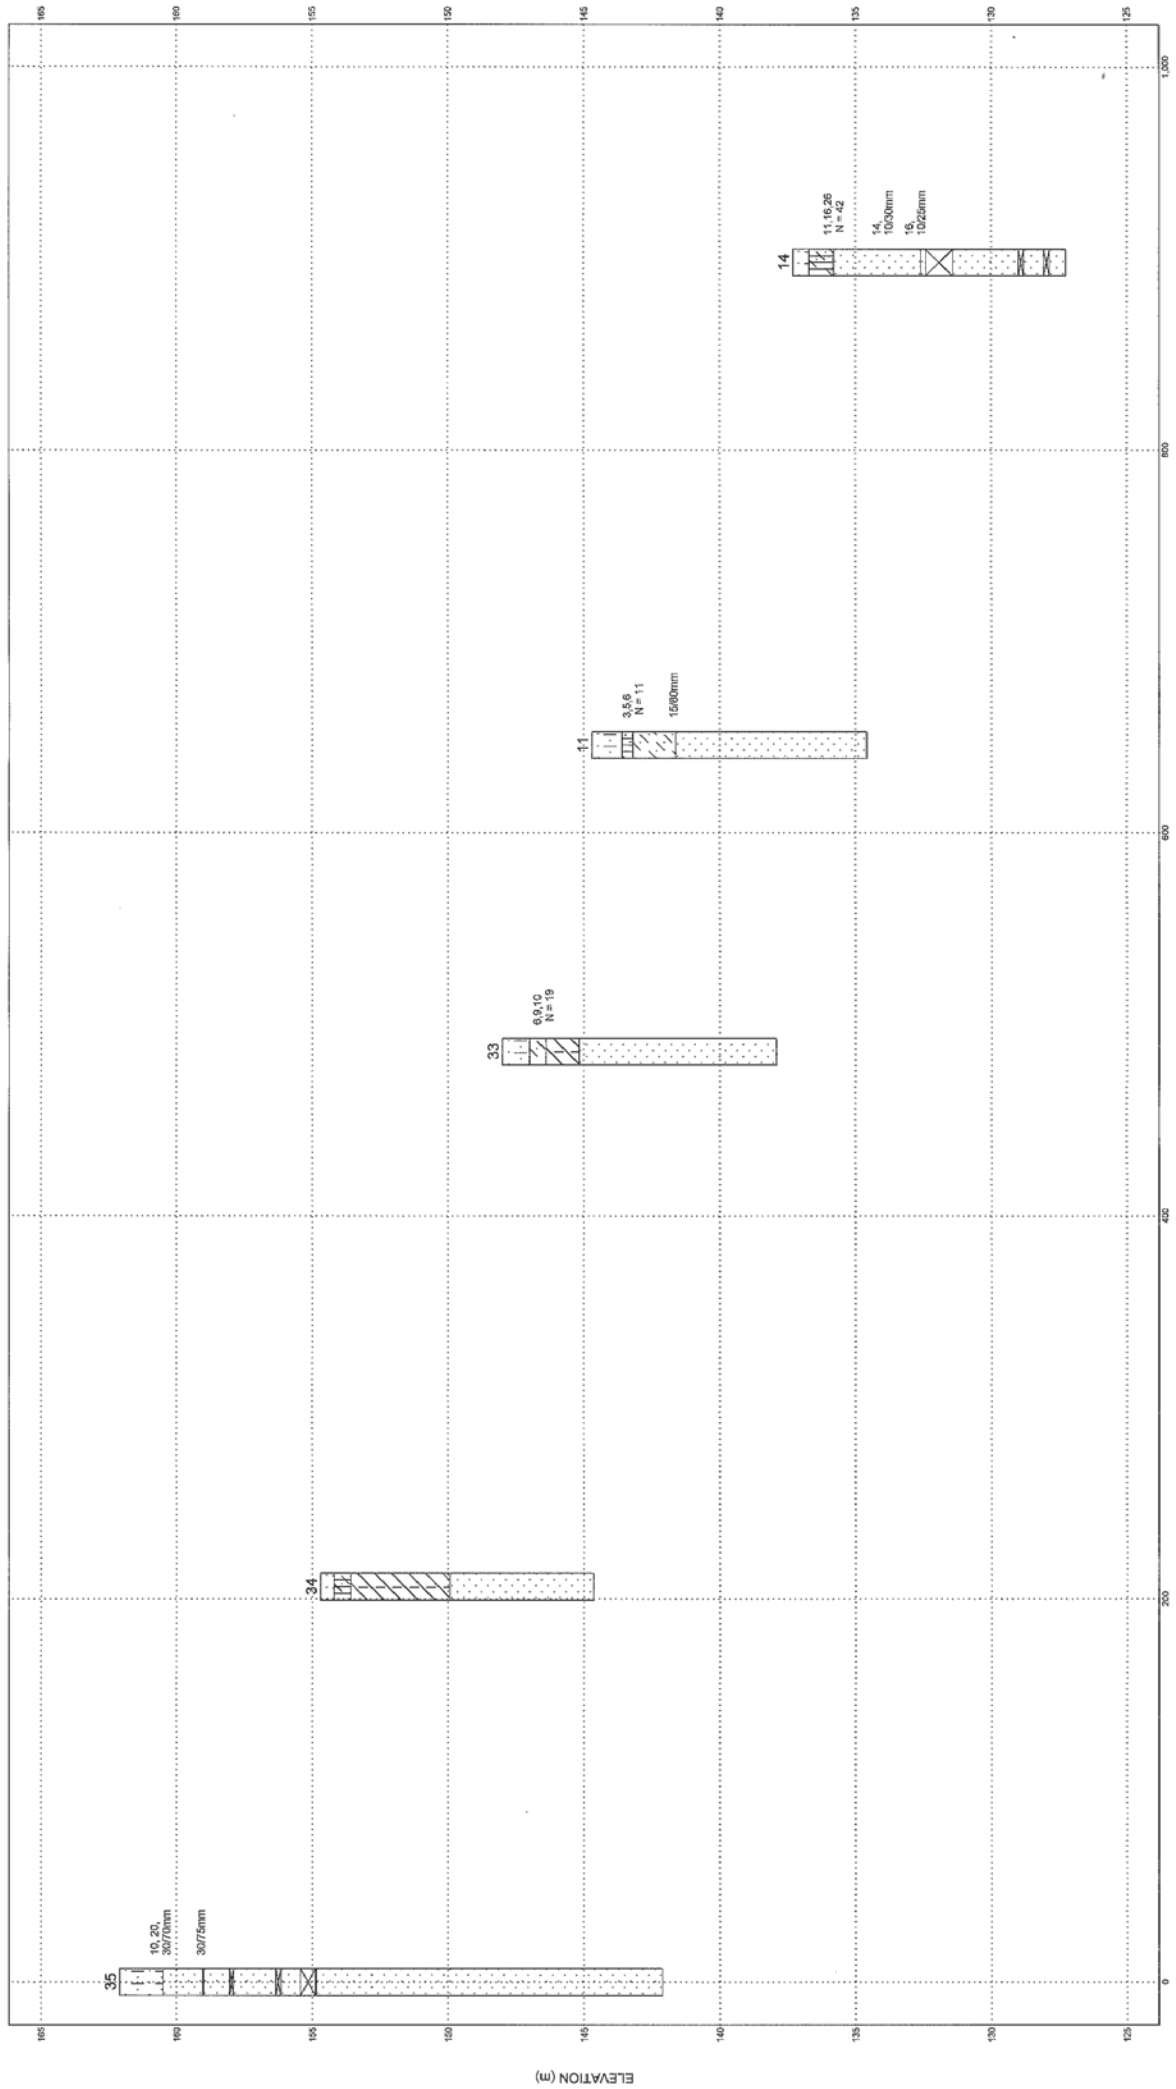
⊕ TEST BORE LOCATION AND NUMBER

- NOTES:-**
- ADAPTED FROM DRAWING 07-1010-SK-C003 PROVIDED BY KEN WHITE CONSULTING ENGINEERS PTY LTD.
 - TEST LOCATIONS ARE APPROXIMATE ONLY AND ARE SHOWN WITH REFERENCE TO EXISTING SITE FEATURES.

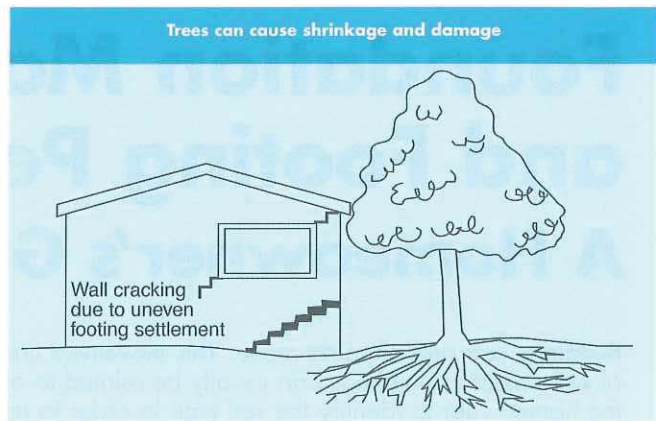
As the moisture absorption process completes its journey to the innermost areas of the building, the internal footings will rise. If the spread of moisture is roughly even, it may be that the symptoms will temporarily disappear, but it is more likely that swelling will be uneven, creating a difference rather than a disappearance in symptoms. In buildings with timber flooring supported by bearers and joists, the isolated piers will rise more easily than the strip footings or piers under walls, creating noticeable doming of flooring.

As the weather pattern changes and the soil begins to dry out, the external footings will be first affected, beginning with the locations where the sun's effect is strongest. This has the effect of lowering the external footings. The doming is accentuated and cracking reduces or disappears where it occurred because of dishing, but other cracks open up. The roof lines may become convex.
