# Damage Assessment Criteria for the Classification of Light Vehicle Statutory Write-Offs

Austroads is the peak organisation of Australasian road transport and traffic agencies.

The NMVTRC is an initiative of all Australian Governments and the Insurance Industry.

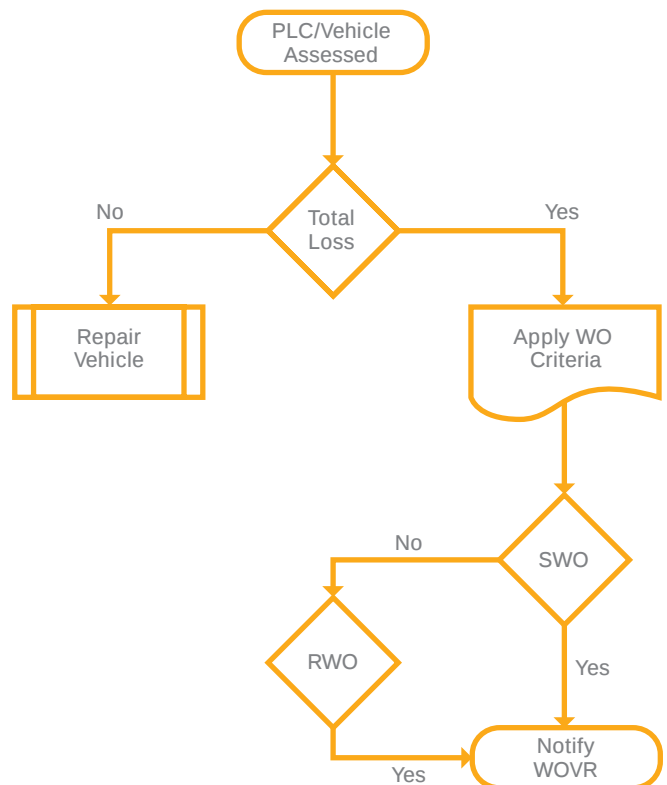
**Figure 1**

This guide is intended to be used by insurance personnel and other *notifiers* who are required to classify WOVs for regulatory purposes. It has been prepared on the basis that it provides sufficient technical precision to be able to be expressly referenced as an incorporated instrument under State and Territory law should a jurisdiction wish to do so. See Figure 1 for an overview of the end to end *assessment* process.

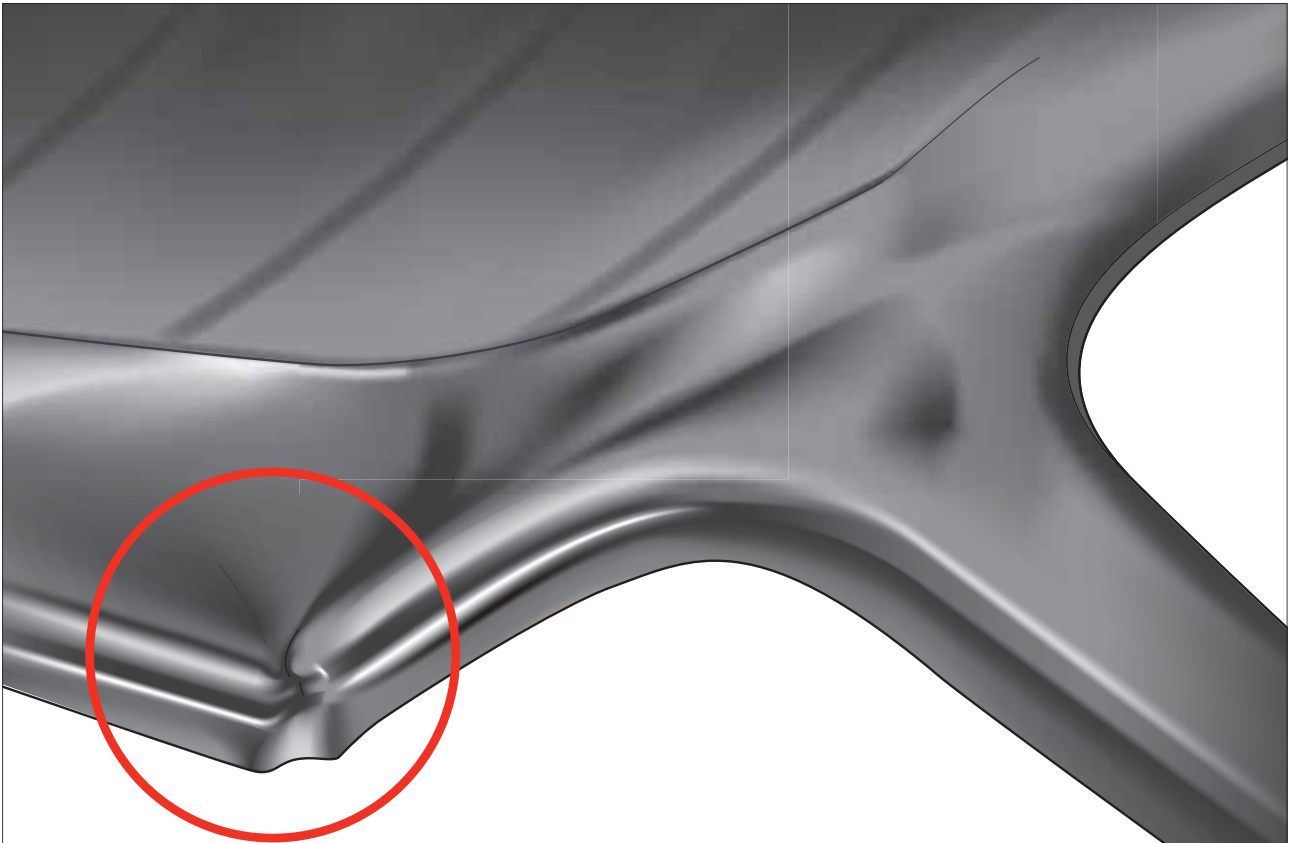
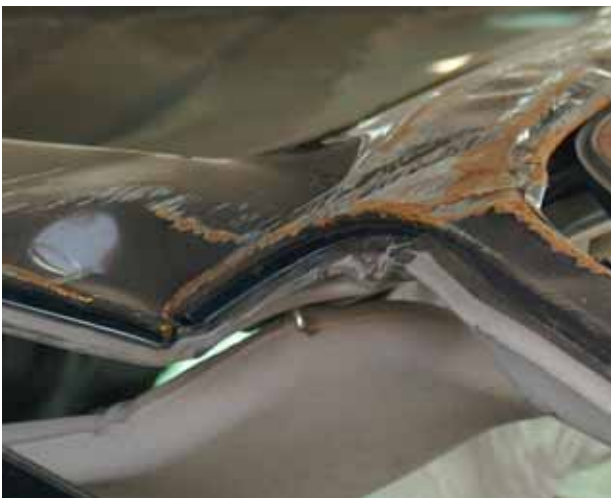
## 1.1 Roof – buckled

View of the roof, windscreen header, front left door header and 'A' pillar. The roof has been structurally loaded such that the windscreen header has buckled.

The criteria to be used for the vehicle's roof is that if the roof has been loaded such that individual structural element(s)/member(s) have been structurally: fractured, cut, cracked, buckled and/or is folded over onto itself, then the roof has an area of structural damage.

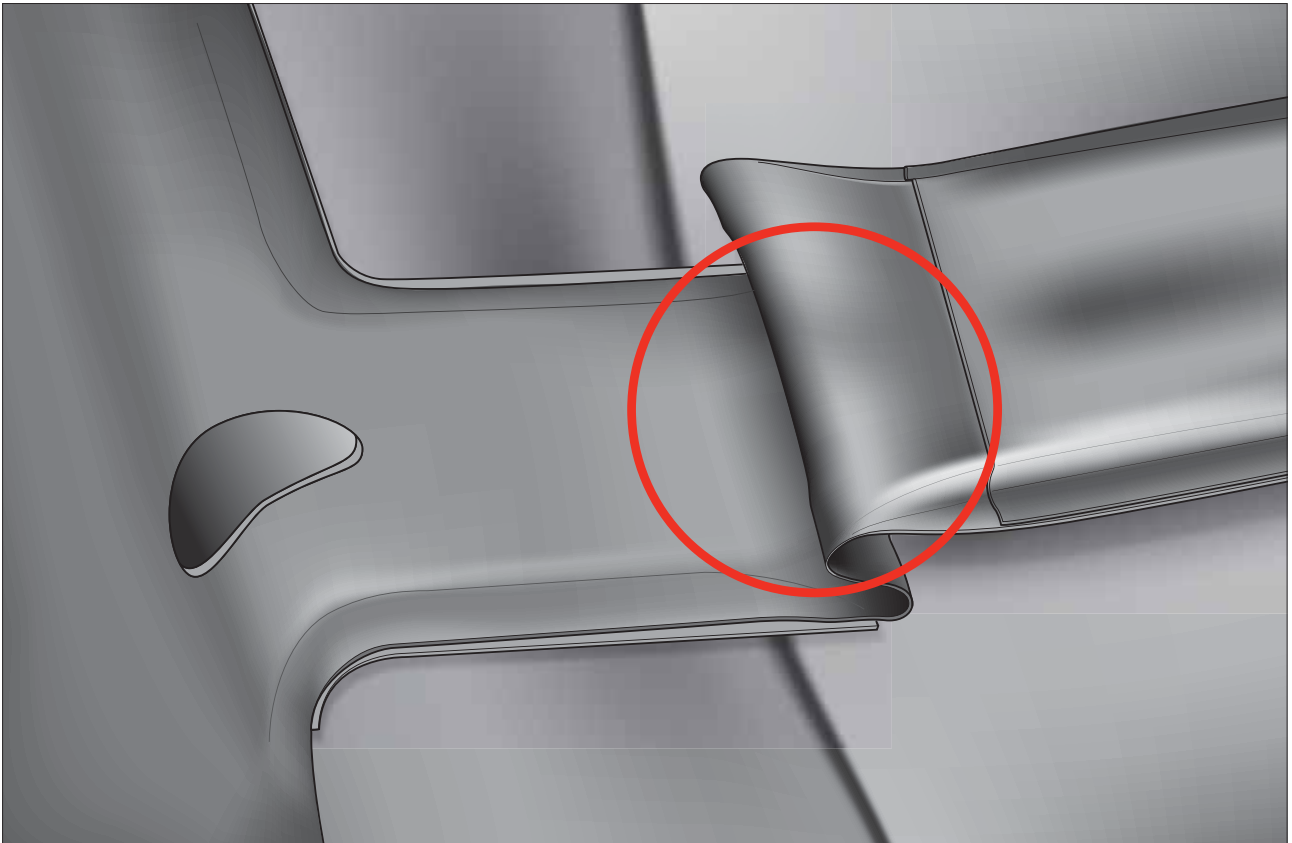
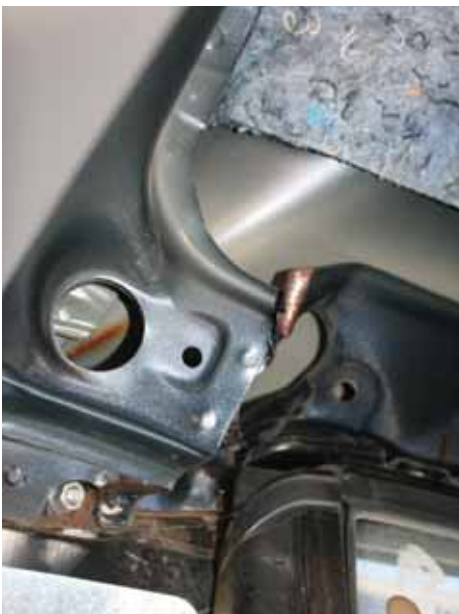
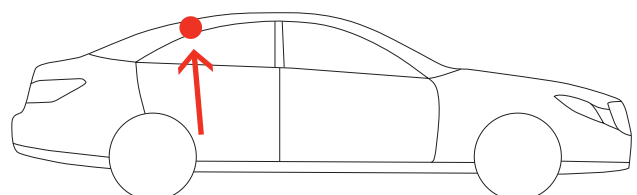
### 1.2 Roof support rail – folded

Internal view of lateral roof rail which due to structural loading has folded over onto itself.

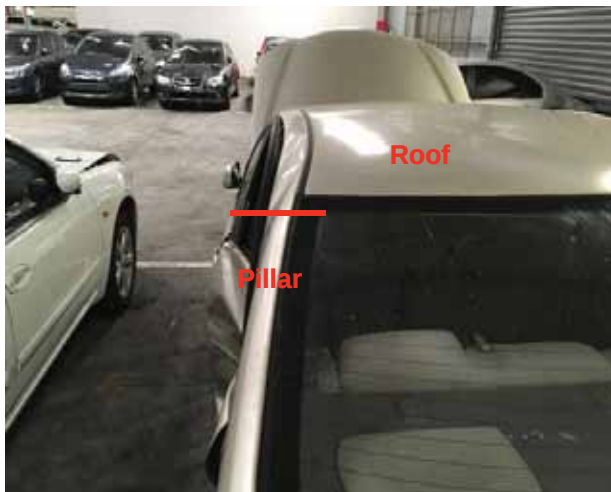
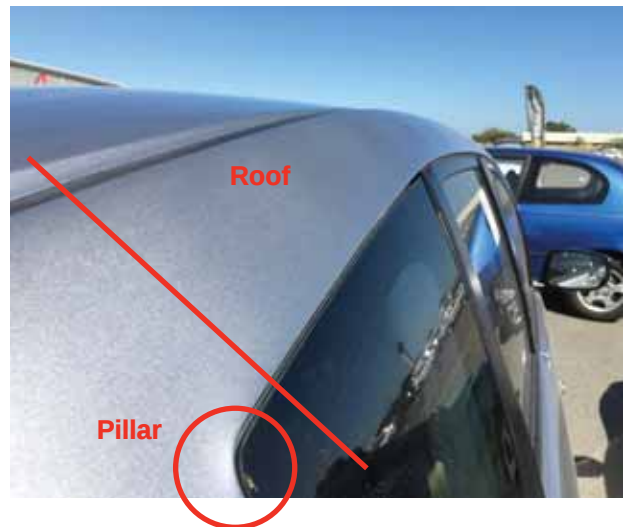
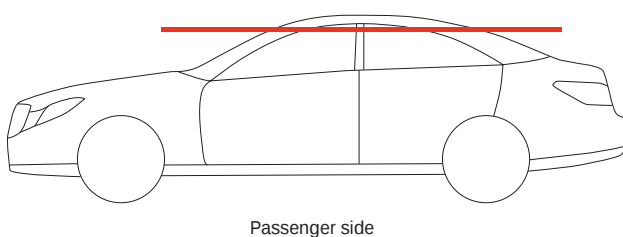
## Roof v Delineation

It is therefore recommended that Assessors apply a virtual halo to the side elevation of a subject vehicle, with those parts of the structure within the halo to be classified as forming part of the roof.

Above the horizontal line equals roof.

A 2017 audit of assessed total losses found a small number of cases where load damage reaching into the roof area was assessed to be contained to the adjoining pillar only. The problem is exacerbated in vehicles featuring sweeping, complex roof lines.

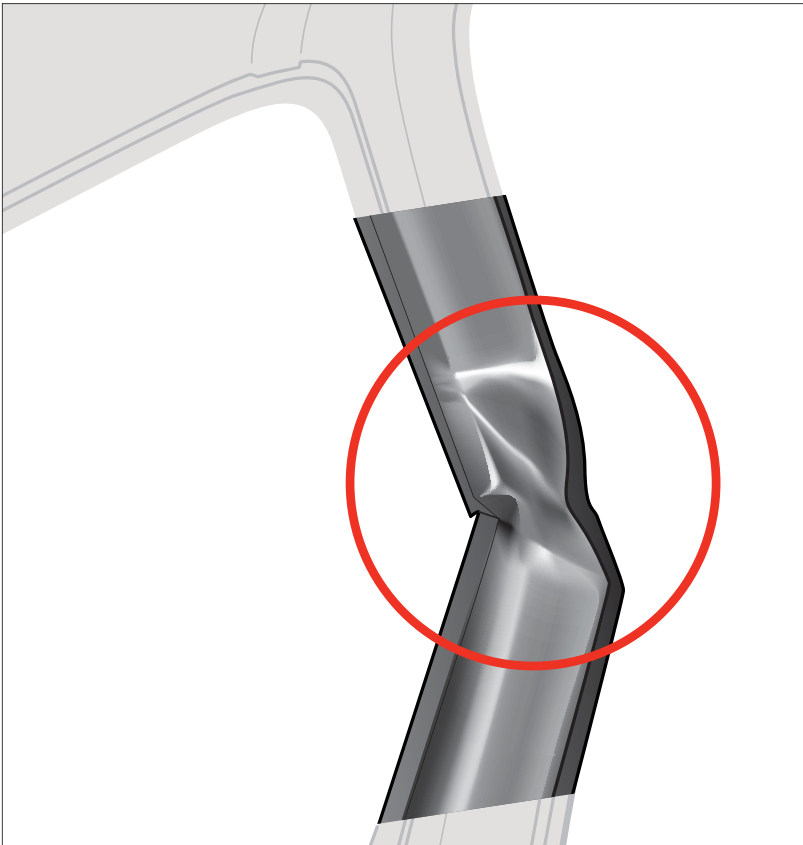
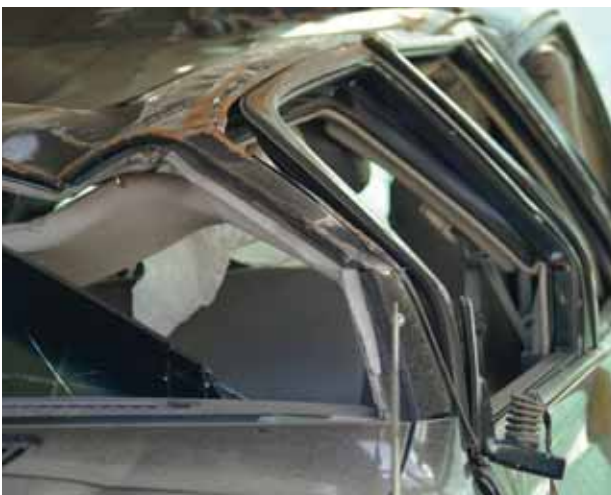
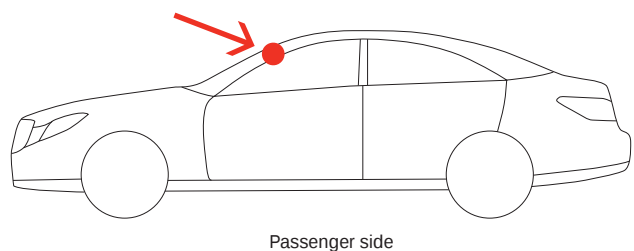
### 2.1 'A' pillar – buckled

A vehicle 'A' pillar which has failed by buckling due to structural loads to the roof.

Each pillar counts separately i.e., if three pillars are structurally damaged then based on the pillar damage alone the vehicle would have three areas of structural damage. Hence, the vehicle with three damaged pillars would be classified as a SWO.

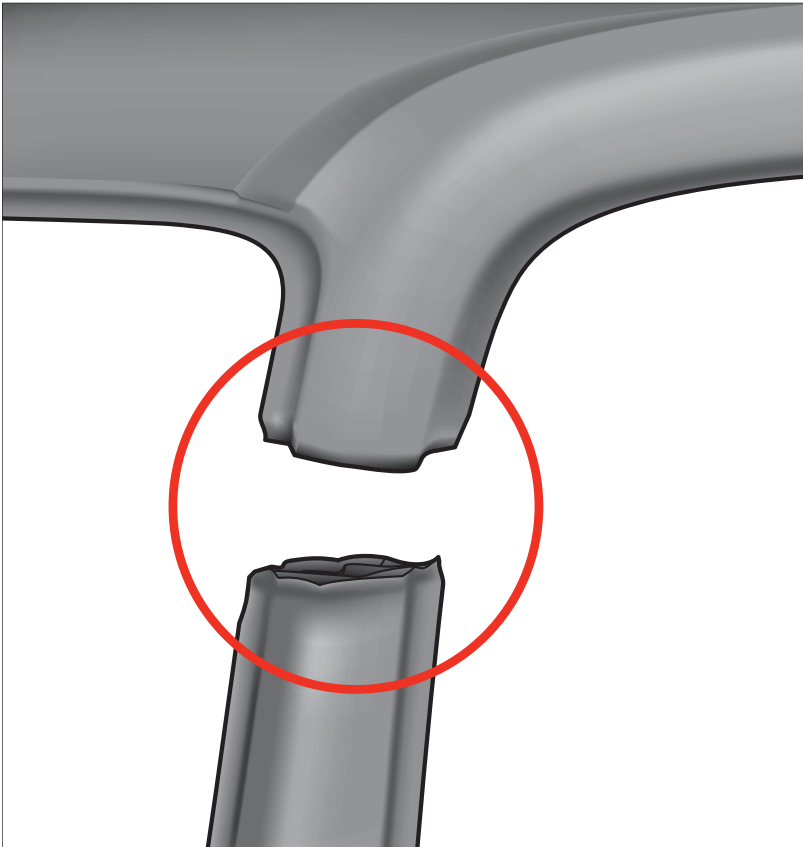
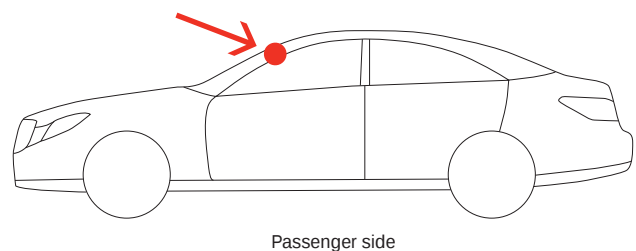
### 2.2 'A' pillar – cut

The 'A' pillar of a vehicle which has been cut (e.g. by emergency services personnel to permit occupant extraction).

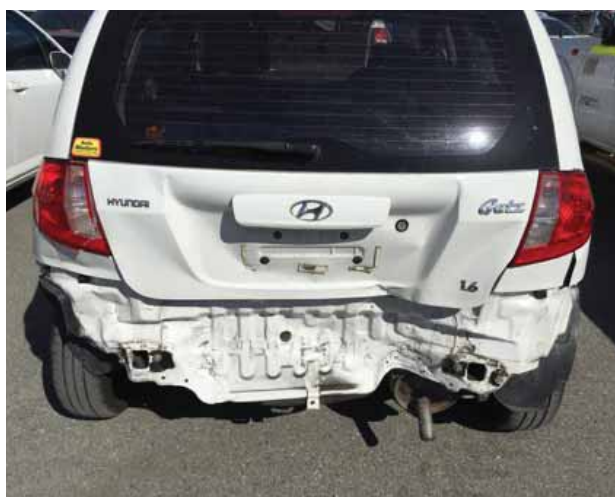
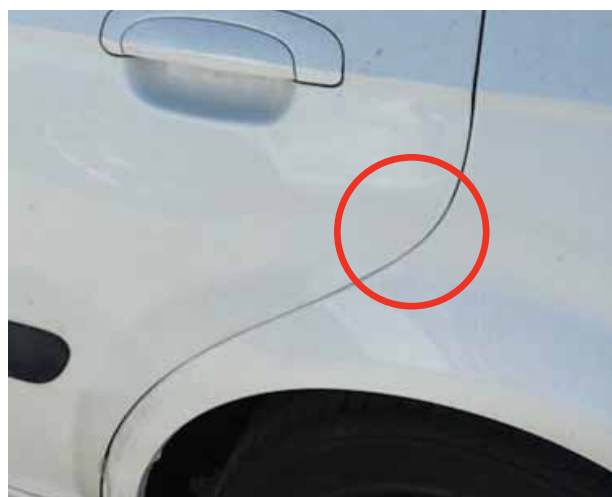
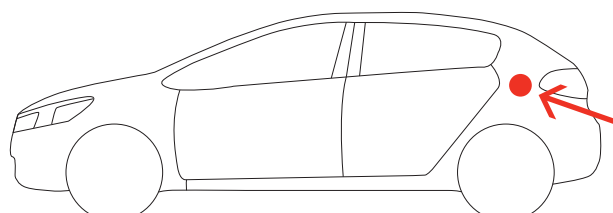
In small cars, closed rear door apertures should be regarded as symptomatic evidence of an underlying structural indicator being present but not readily visible or accessible.<sup>4</sup>

This is most likely to occur only in the smallest passenger vehicles involved in an off-set rear impact resulting in hidden damage to the rear longitudinal rail and pillar.

Small car – Rear offset impact resulting in closed rear door aperture

4. A 2017 audit of assessed total losses found several examples of body misalignment indicating a structural load in the rear pillars (evidenced by the closure of rear door gaps) without a visible load indicator eg. buckle, crack, cut, fold or fracture. In practice, this approach is already applied routinely in respect of many frontal impacts where it is obvious from adjoining damage that a structural load must have been transferred to, say, the vehicle's firewall but the physical evidence is hidden by contiguous damage or is inaccessible. In field audits, the problem was not evident in small-medium or larger vehicles.

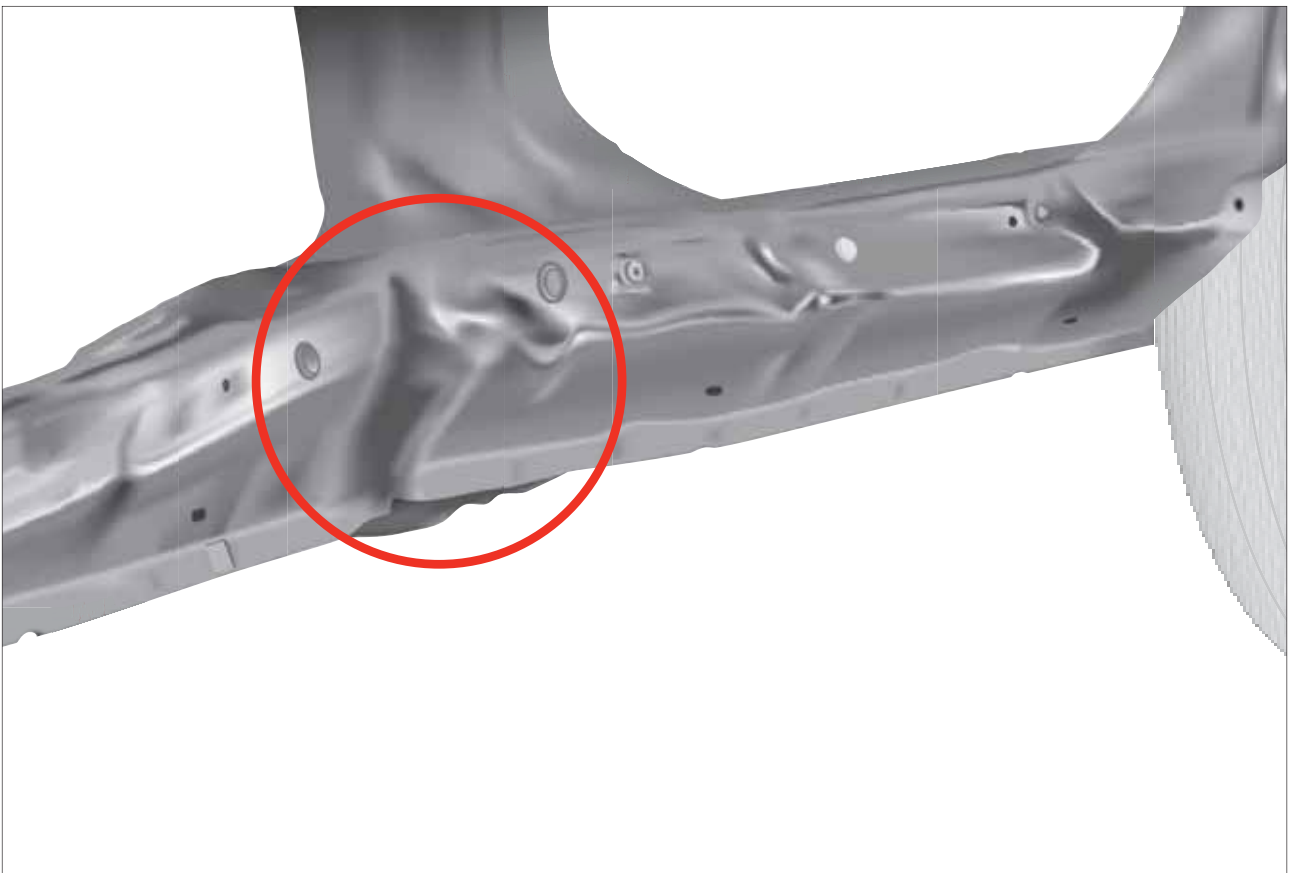
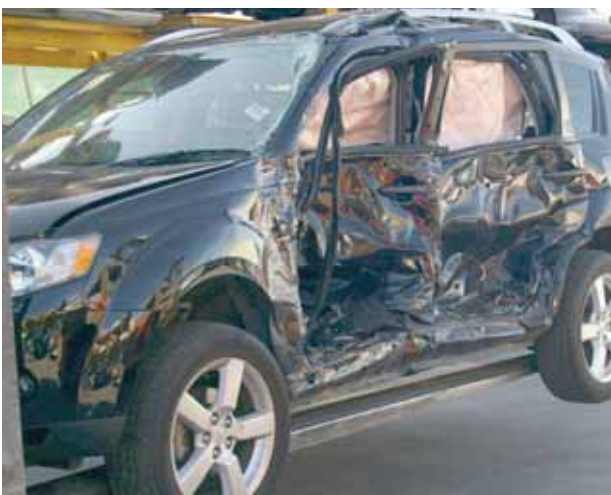
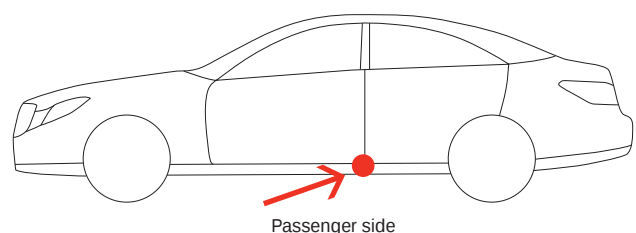
#### 3.1 Floor pan – buckled

A side view of a vehicle showing buckling and folding of the floor.

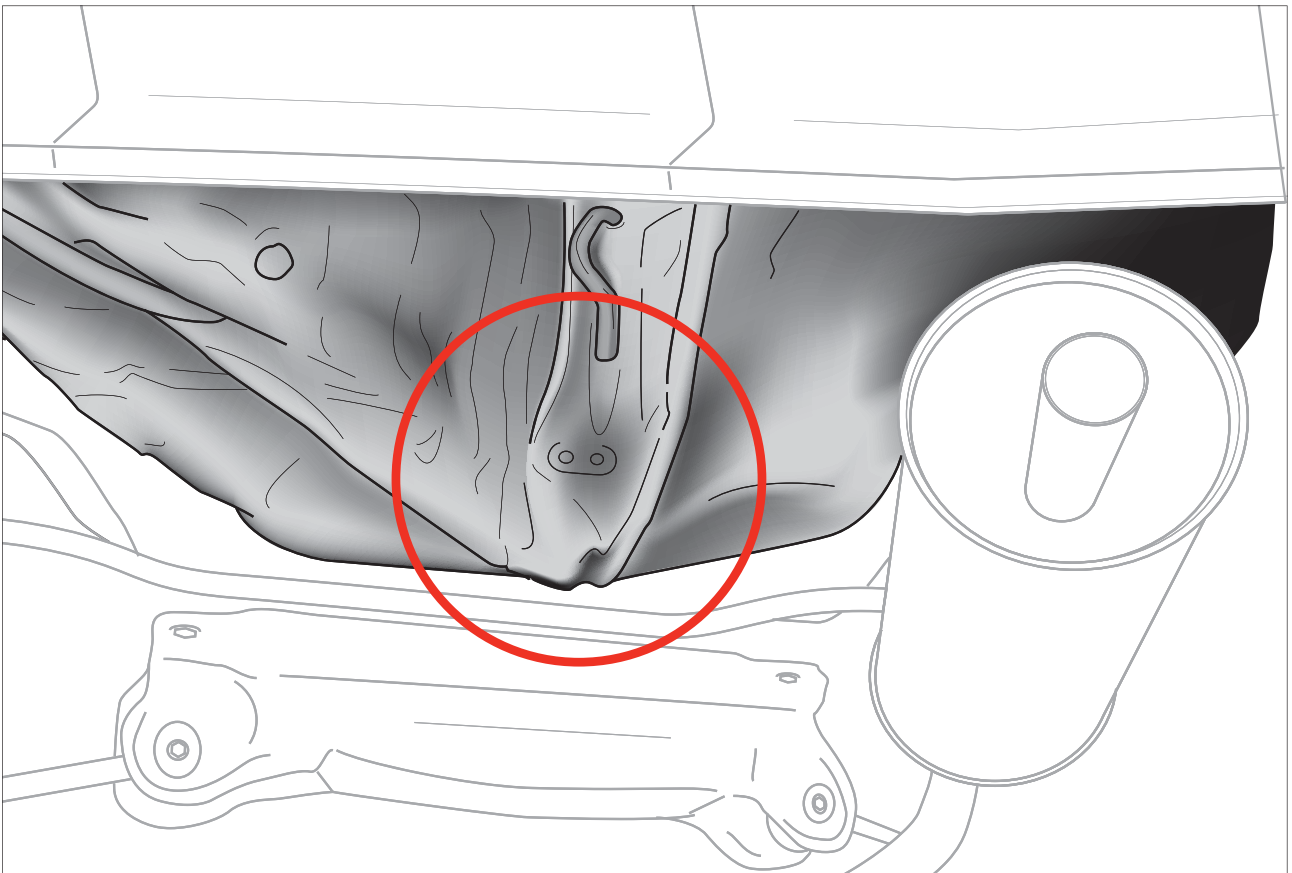
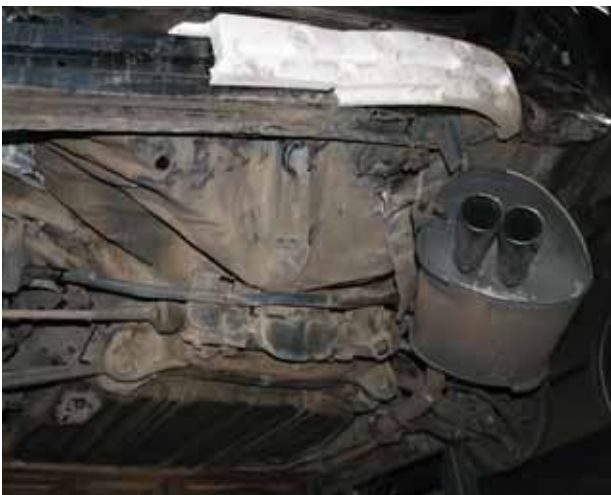
#### 3.2 Floor pan – buckled

View of the rear underneath of a vehicle showing buckling of the floor pan.

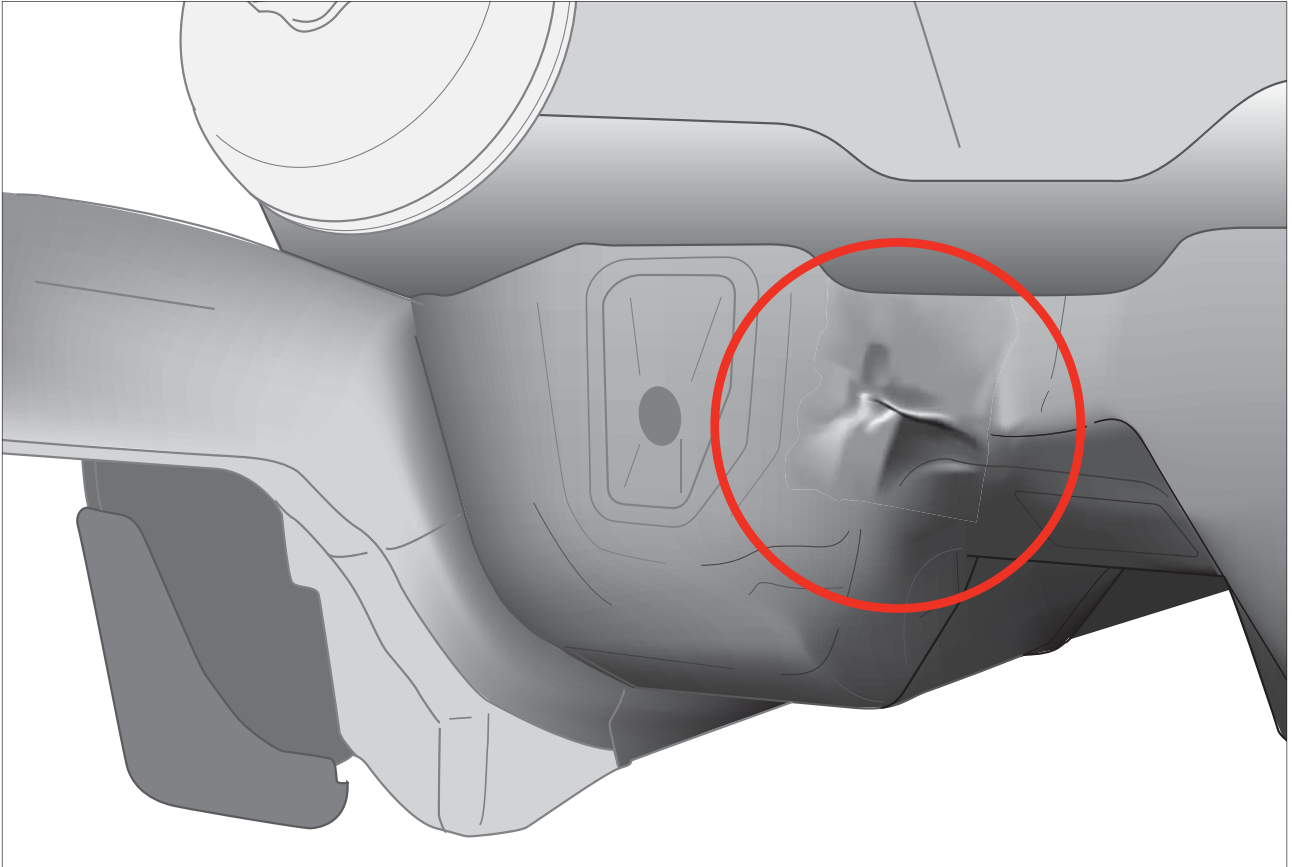
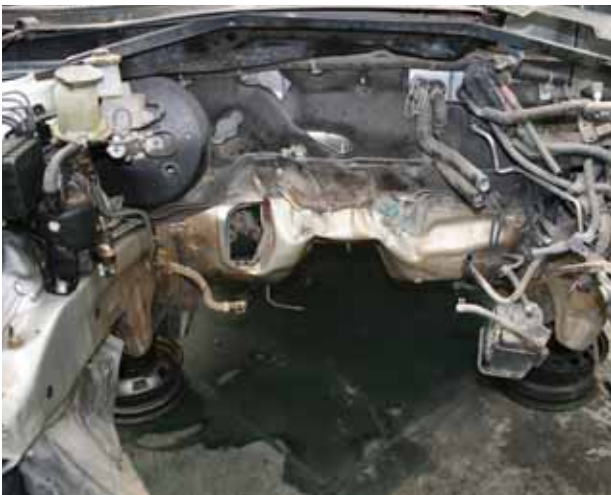
### 4.1 Firewall – folded

View of the firewall showing a fold induced by impact damage.

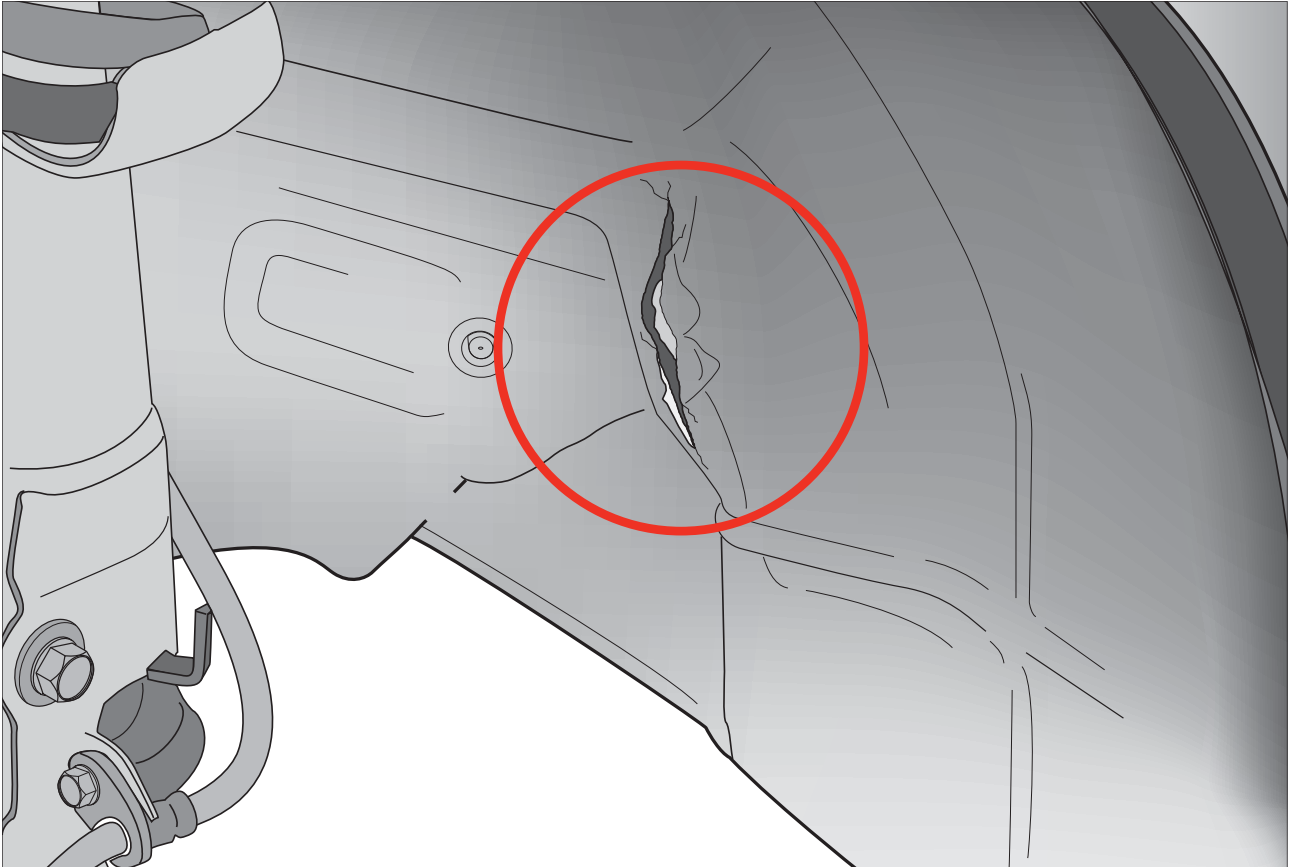
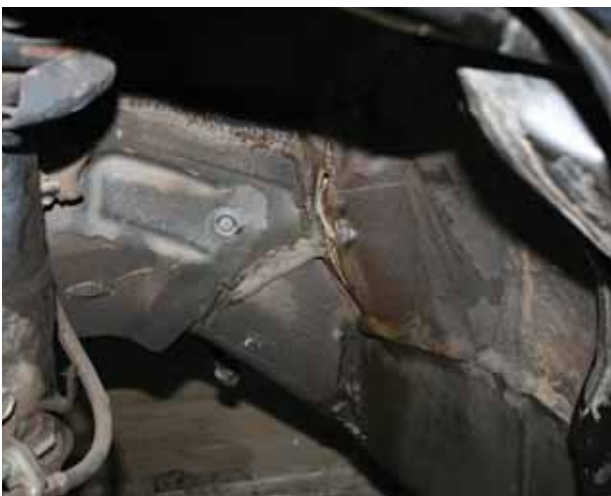
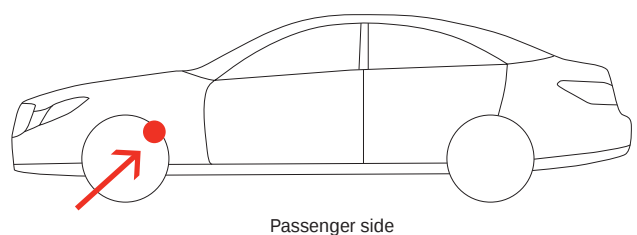
### 4.2 Firewall – cracked

View through the front left wheel-well of the firewall showing a crack in the firewall.

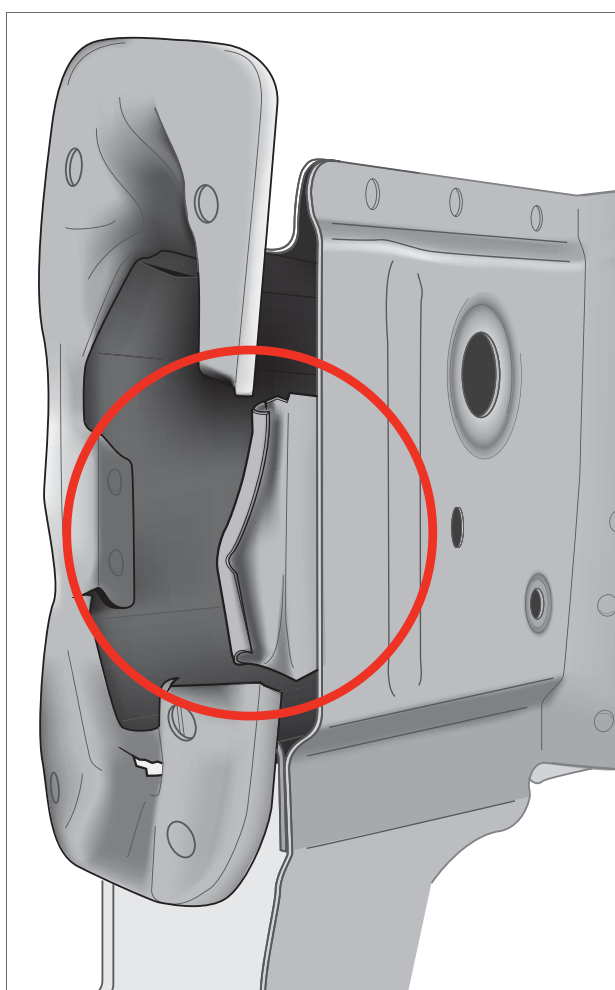
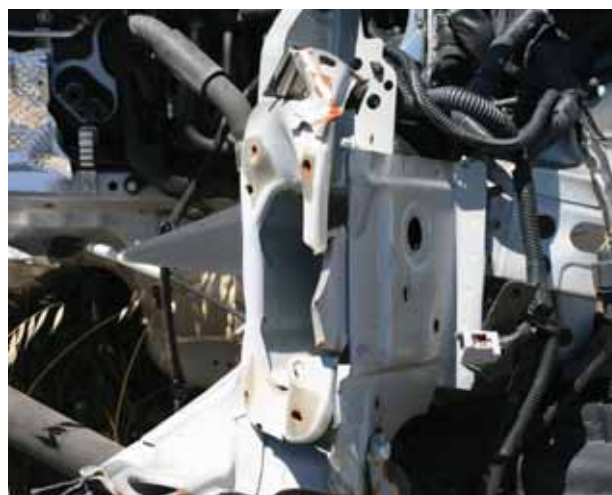
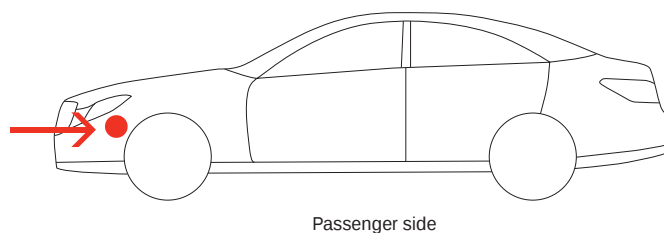
### 5.1 Chassis rail – fractured

View of longitudinal structural rail/chassis fractured due to impact.

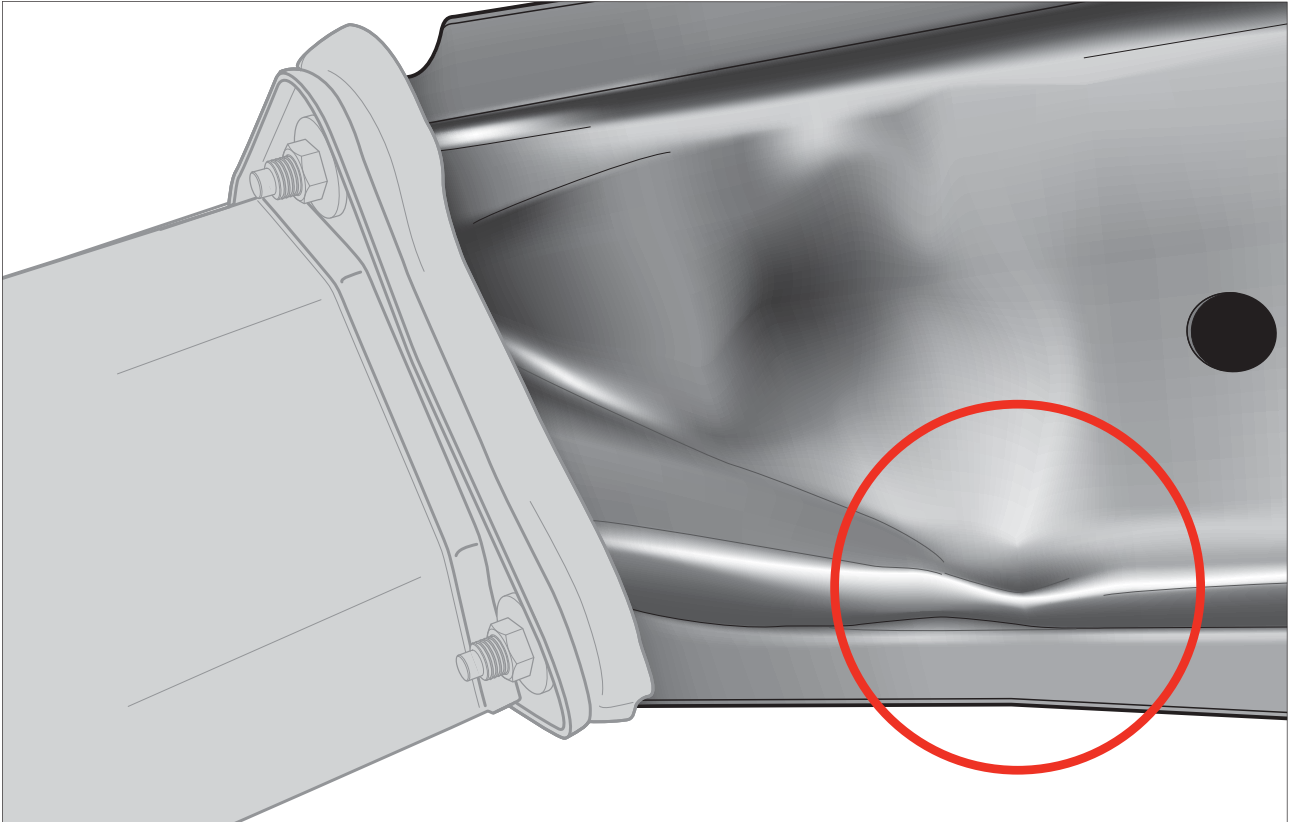
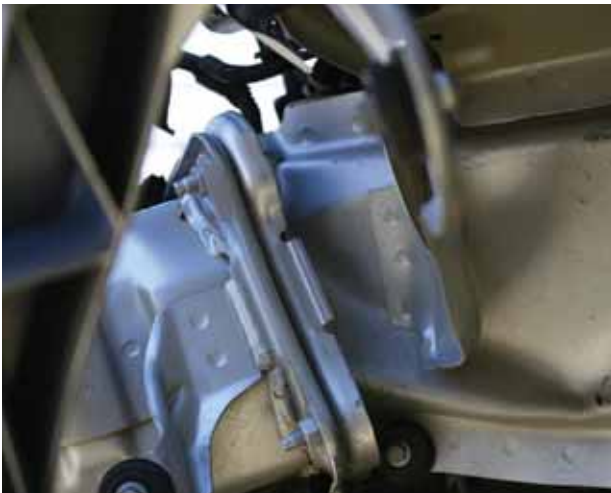
### 5.2 Chassis rail – buckled (side view)

View of a longitudinal structural/chassis rail which has buckled due to structural impact loading.

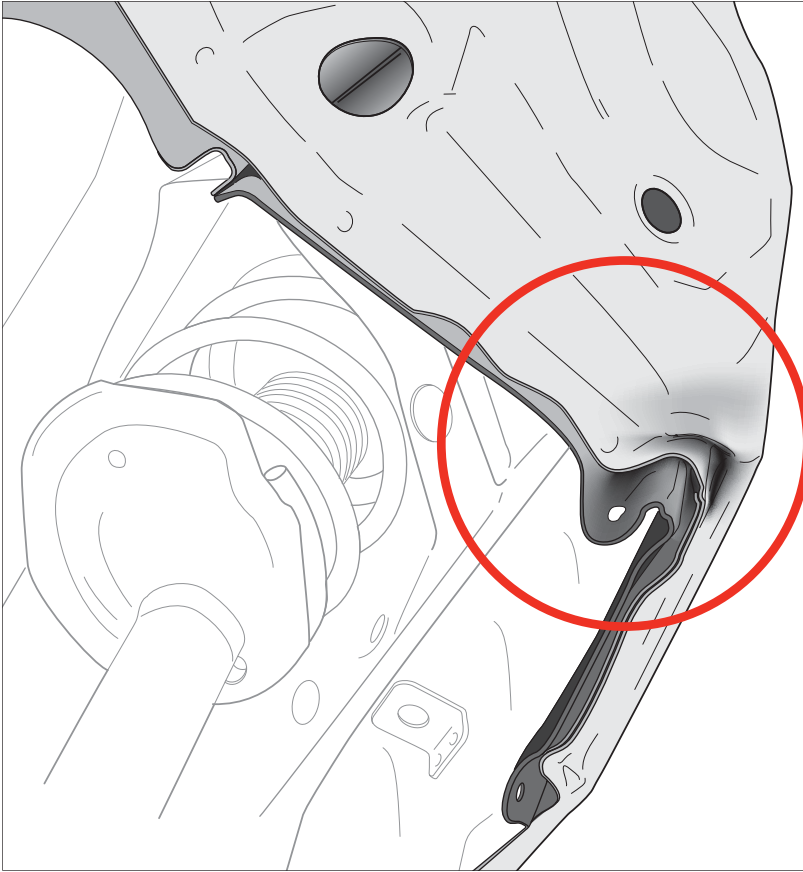
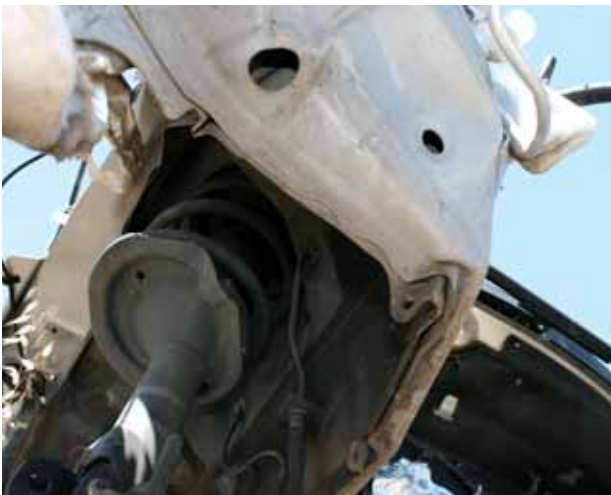
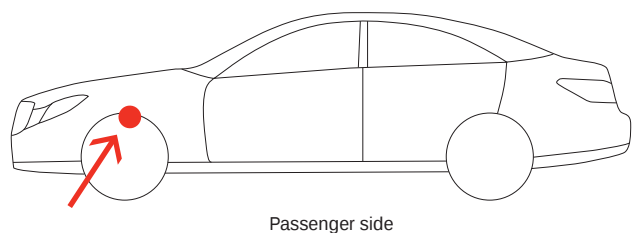
**5.3 Chassis rail – folded**  
View of a longitudinal structural/ chassis rail which has folded due to a side impact.

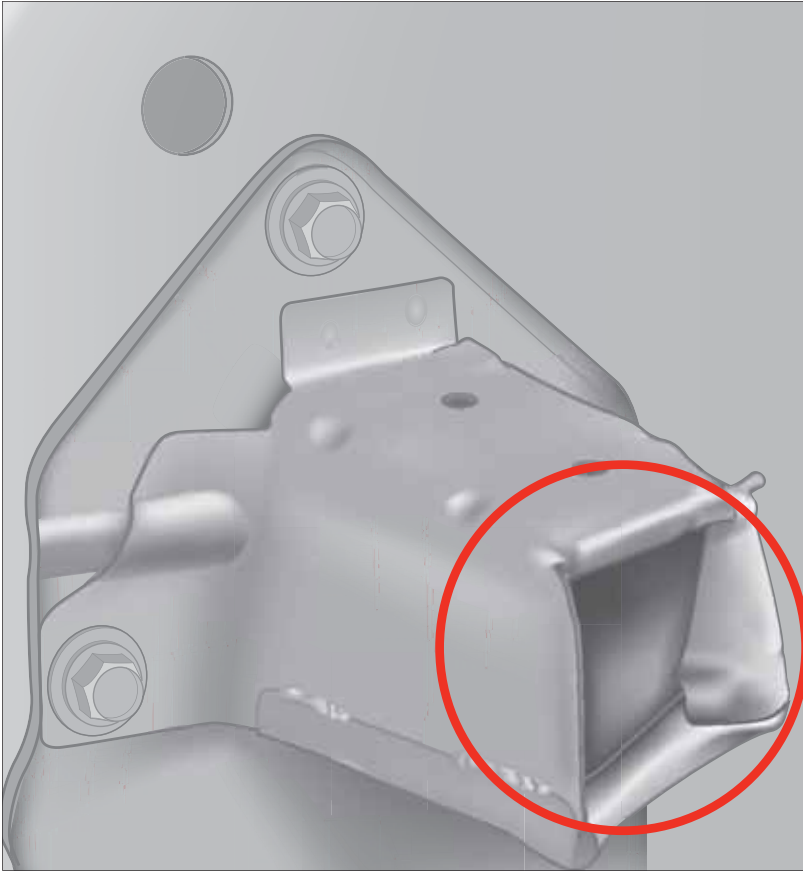
### 5.4 Deformable crush tube – damaged

This is an example of a deformable end plate that is designed to be removed and replaced. Such components are not to be registered as a damage count.

Note: A deformable member that is designed to be removed and replaced is not considered a fundamental structure of the vehicle if damaged and such components are not to be registered as a damage count.

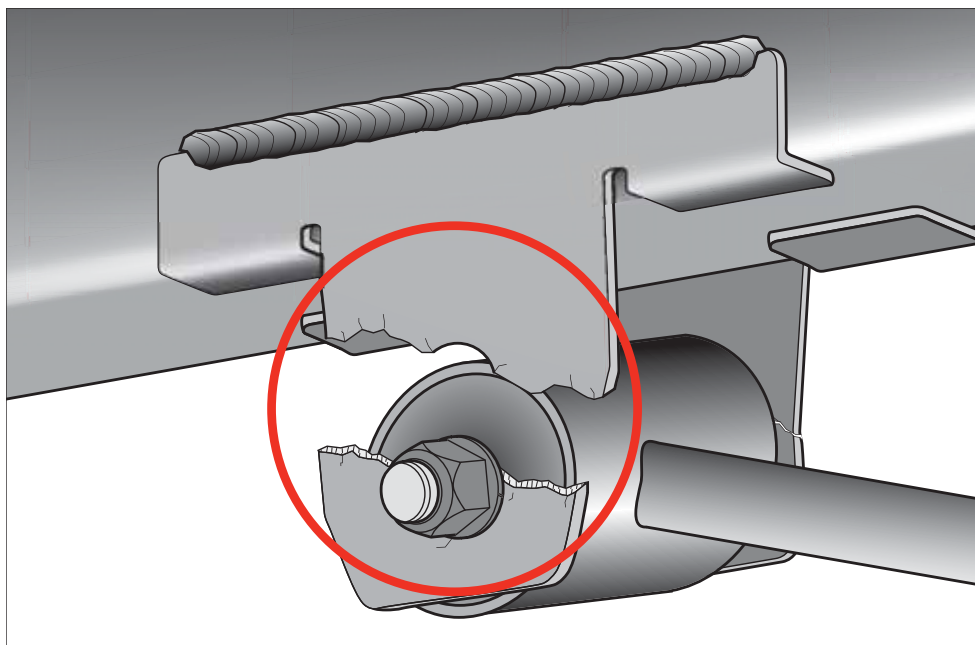
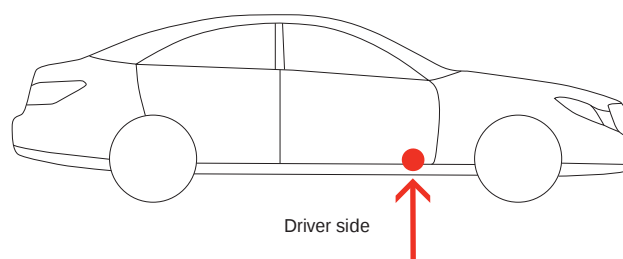
### 6.1 Suspension mount – fractured

View of a fractured suspension mount.

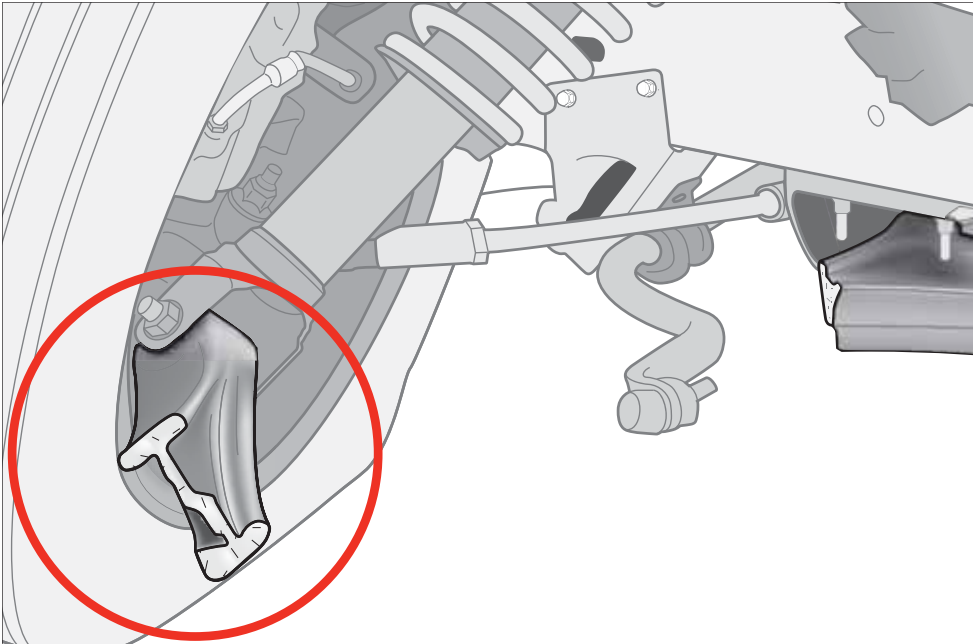
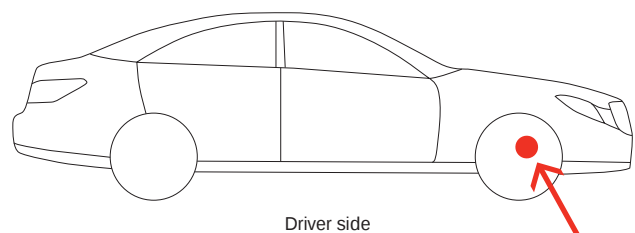
### 6.2 Suspension and linkages – damaged

This is an example of damaged suspension components that do not form part of the damage criteria because components such as suspension arms and linkages are designed to be removed and replaced.

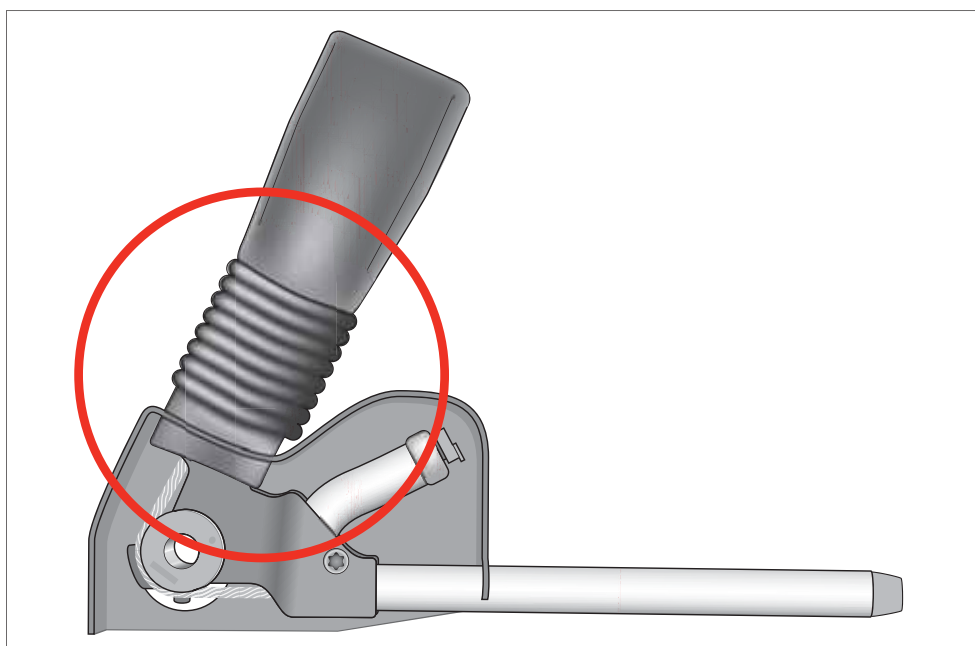
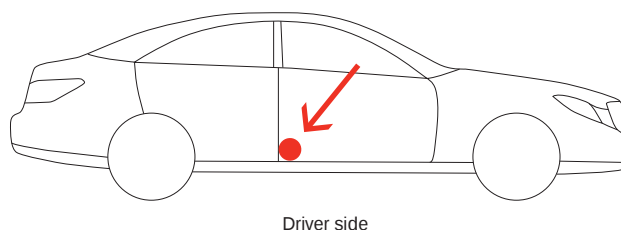
### 7.1 Pre-tensioner – active

View of a seat belt buckle showing a buckle with an active pre-tensioner.

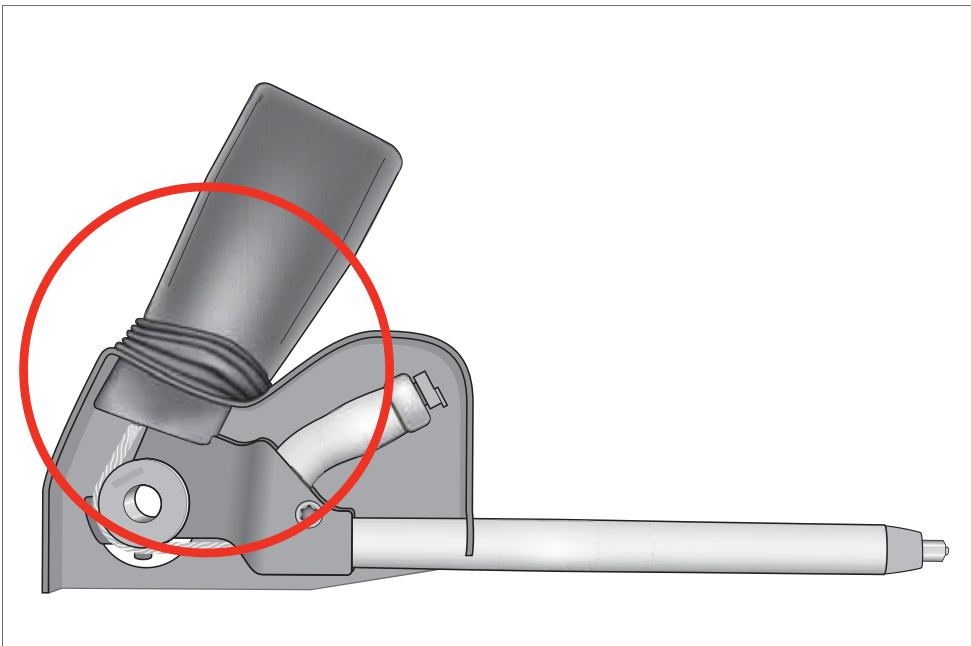
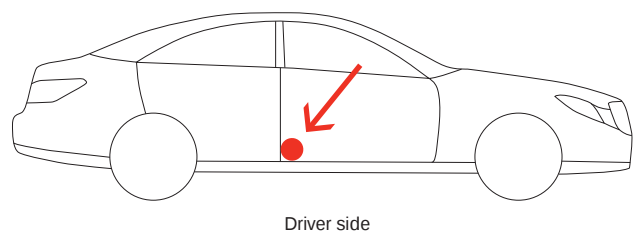
### 7.2 Pre-tensioner – fired

View of a seat belt buckle showing a buckle with a used pre-tensioner.

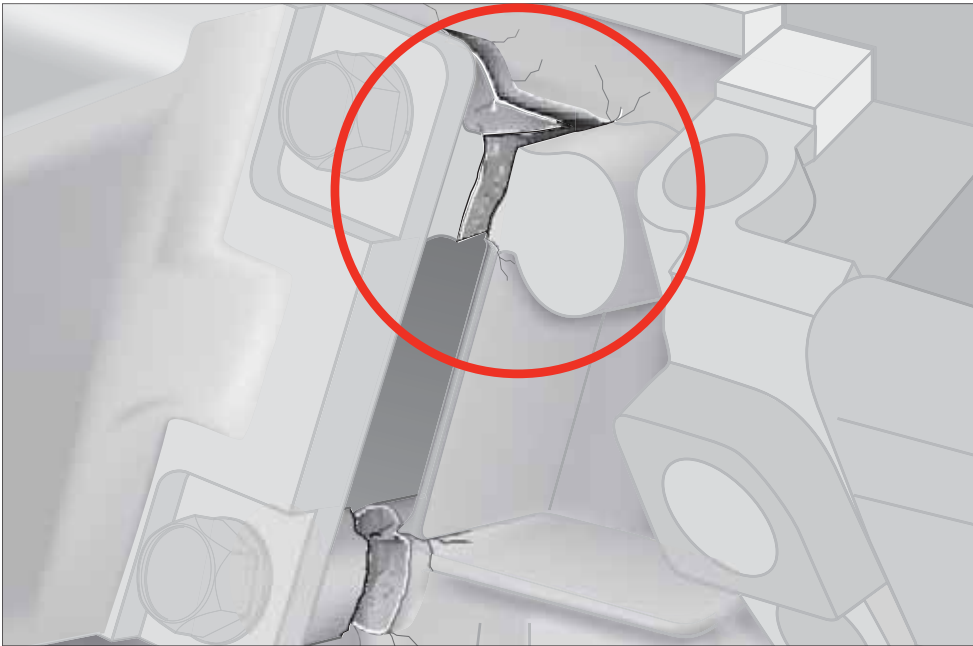
### 8.1 Engine mount – fractured

View of fractured engine and mount induced by a collision.
