# 13.1 Pilot Transfer Arrangements – Marine Notice 04/2023

Marine Notice 2023/04

## Pilot transfer arrangements

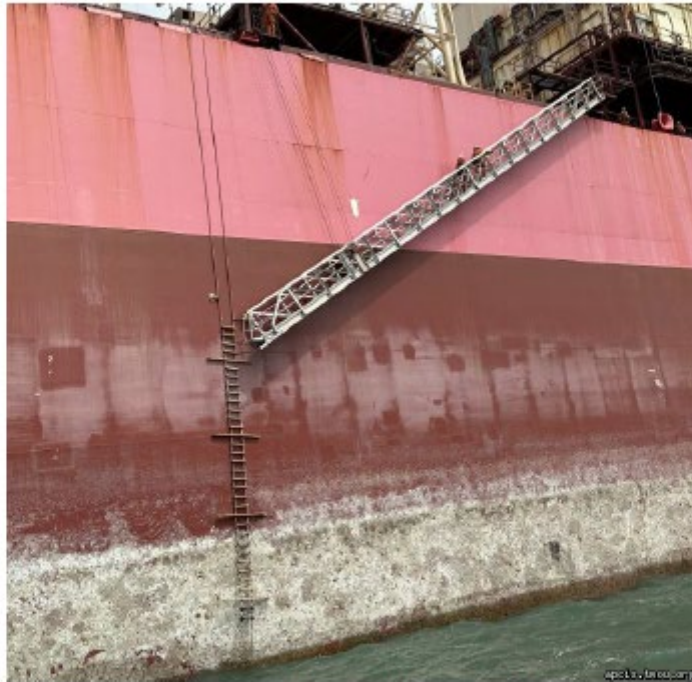
One common issue found is that the pilot ladder does not extend the required 2.0 m past the accommodation platform when a combination arrangement is used. Photo 2 illustrates an example of a pilot ladder not extending the required height past the platform.

*Photo 2: Example of non-compliant combination pilot ladder arrangements.*

As shown in photos 2 and 3 persons cannot climb the pilot ladder to a level where they can move safely onto the accommodation ladder.

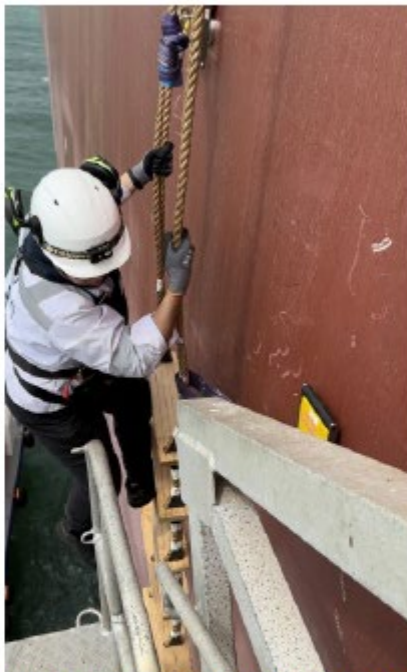
*Photo 3: Person unable to safely access accommodation ladder platform from pilot ladder.*

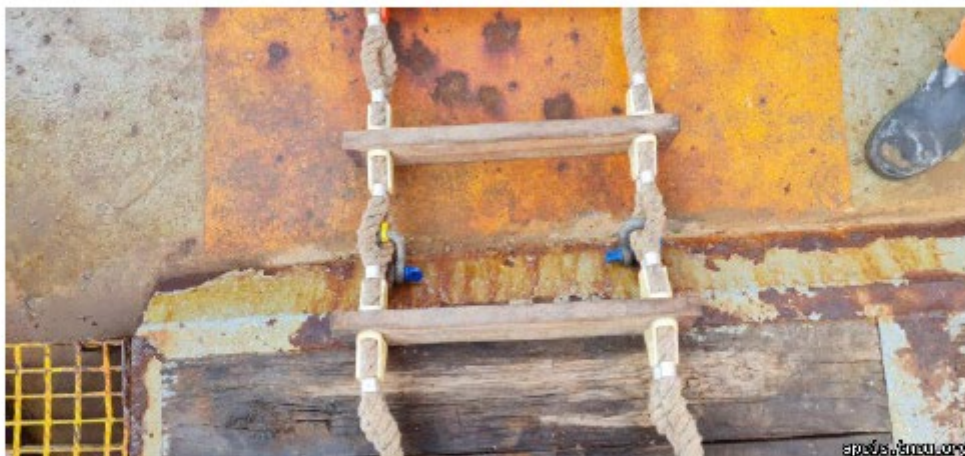
*Photo 5: Unsafe pilot ladder securing arrangements.*

Photos 5 shows the pilot ladder being secured to the strong point by using a shackle passed through the pilot ladder side ropes. This puts increased load on the single part of the side rope and the chock securing arrangements.

It is common industry practice to use a rope stopper usually in the form of a rolling hitch knot between the pilot ladder sides ropes and the approved strong point on the main deck. This will transfer the weight of the ladder arrangement directly onto the designated strong point and will not damage the ladder.

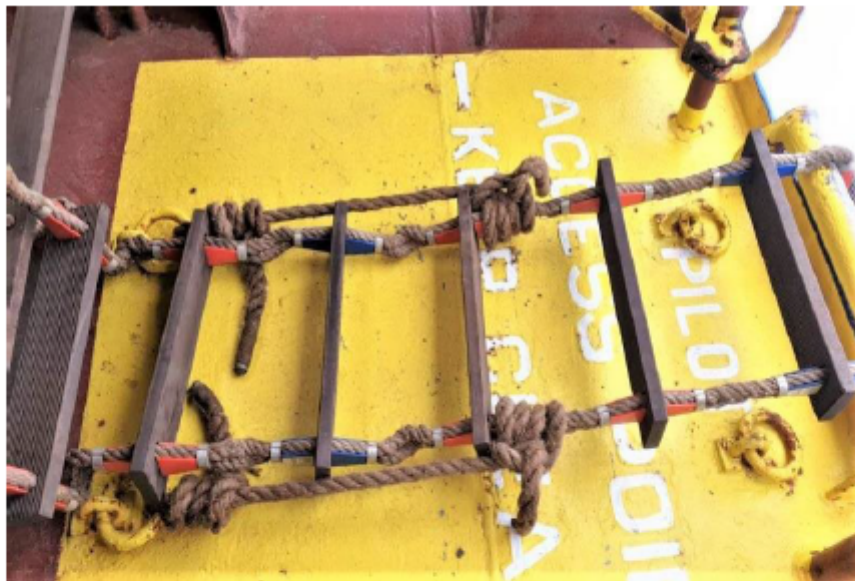
Photo 7 provides an example of rolling hitch knots being used to secure pilot ladders to approved main deck strong points.

Photo 7: Rolling hitch knots being used to secure pilot ladders to approved main deck strong points (Reproduced with permission from Fremantle Ports).

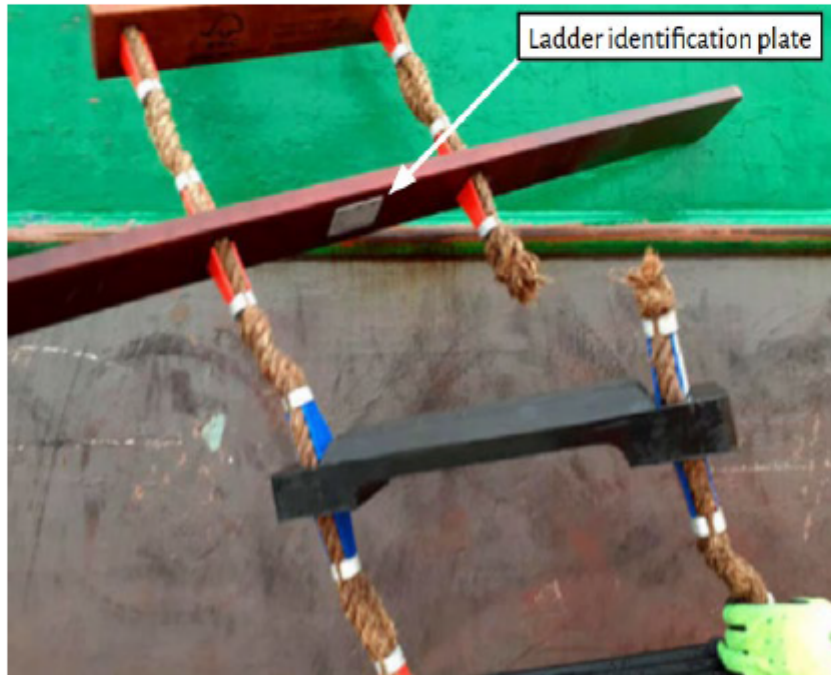
*Photo 8: Pilot ladder where side ropes parted when in use (Reproduced with permission of the MAIB).*

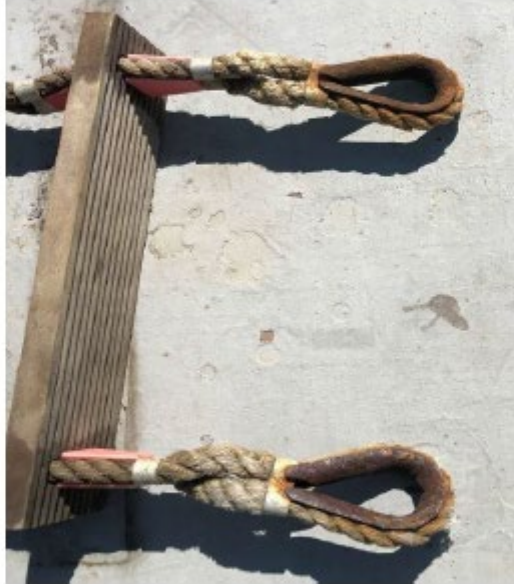
Common areas of defects can be the thimble ends of the pilot ladder. Corroded end point thimbles as illustrated in photo 9, can damage the side ropes leading to failure.

*Photo 9: Example of corroded end point thimbles (Reproduced with permission from Fremantle Ports).*

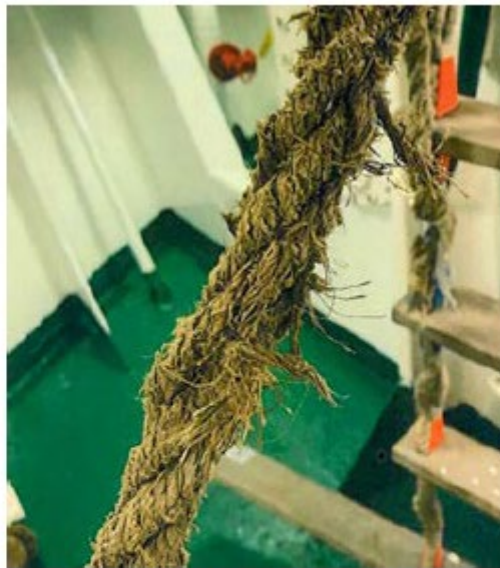
Another common area is the frayed or damaged side ropes as illustrated in photo 10. These should be detected during routine visual inspections.

*Photo 10: Frayed side rope.*

If side ropes are frayed, or in any way degraded the ladder should not be used.

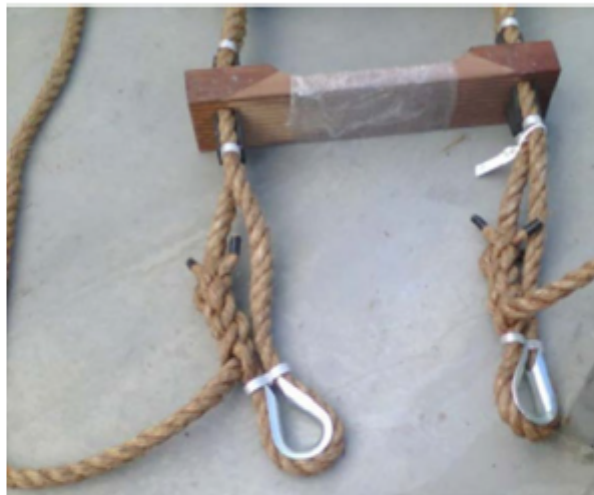
During recent PSC inspections AMSA surveyors have noted pilot ladders which have been constructed with splices in the side ropes.

Photo 12: Example of non-compliant pilot ladder with splices in side ropes.

Pilot ladders constructed like this are considered non-compliant by AMSA. Ship operators and masters are recommended to check their pilot ladders for splices in the side ropes. It should be noted by operators coming to Australian ports that the availability of compliant pilot ladders is limited in Australia. To prevent avoidable delays operators are recommended to have spare compliant pilot transfer arrangements onboard.

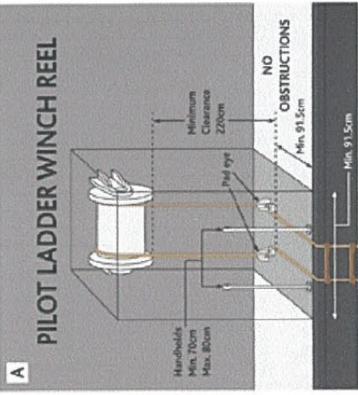
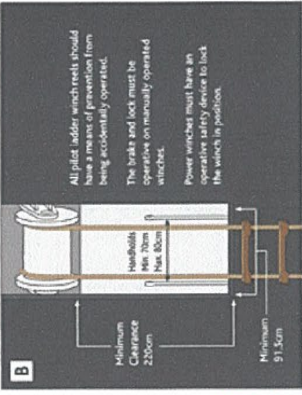
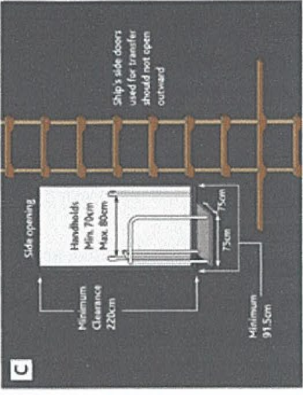
### PILOT LADDER WINCH REEL

All pilot ladder winch reels should have a means of prevention from being accidentally operated. The brake and lock must be operative on manually operated winches. Power winches must have an operative safety device to lock the winch in position.

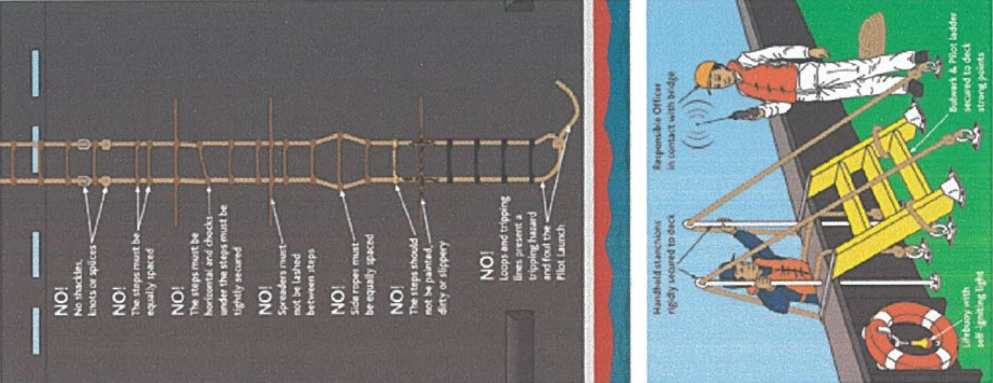
Figure 2 – Pilot boarding ladder arrangements
