Case study 3: In-line bioreactor bed Lower Burdekin

Project leader and partnerships	Department of Agriculture and Fisheries collaborating with Queensland University of Technology
Funding source	Department of Environment and Science (Queensland Government Reef Water Quality Program)
Project length	One and a half years (October 2018 – April 2020) of event-based monitoring completed Opportunity for continuation of monitoring
Region	Burdekin (Ayr)
Production system	Sugarcane
Date of installation	15th October 2018
Length of installation	Three working days for installation (2 weeks including design and site selection)
Bioreactor type	In-line drain bioreactor bed, below the floor of a pre-existing drain
Project objective	Research trial to quantify nitrate removal performance.

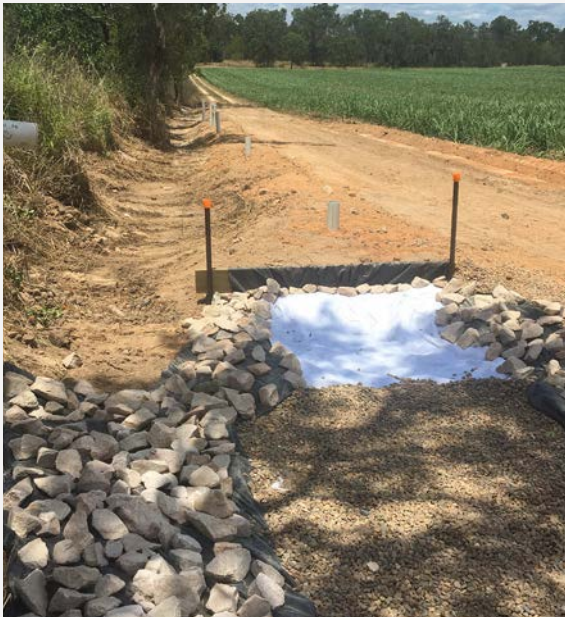
Figure 2 Inlet structure showing washed river gravel and geofabric designed to capture fine sediment.

The inlet structure (Figure 2) was constructed by excavating a funnel structure, which was sealed on the sides and at the bottom using heavy-duty plastic liner. A gabion basket (1.1 m long, 0.8 m deep, and 0.5 m wide) was placed to separate the inlet from the woodchip. The gabion basket was filled with rocks (diameter ≥ 75 mm). Washed river gravel (diameter = 25 mm) was positioned in the funnel inlet structure upslope of the gabion basket with a total volume of about 4.0 m³. A sediment trap was installed upslope of the inlet structure to capture sediment in the run-off prior to entering the woodchip section of the bioreactor. The sediment trap was constructed using geo-fabric ‘socks’ filled with gravel and placed on the liner, perpendicular to the flow of the water. Additional gravel was placed on the top of the sediment socks to support water infiltration and sedimentation. An additional geo-fabric layer was placed on top of this gravel to prevent sediment build-up and to enable the geo-fabric to be readily replaced before each irrigation event.

Geofabric on the surface of the inlet structure needed to be replaced regularly after it became blocked with sediment.

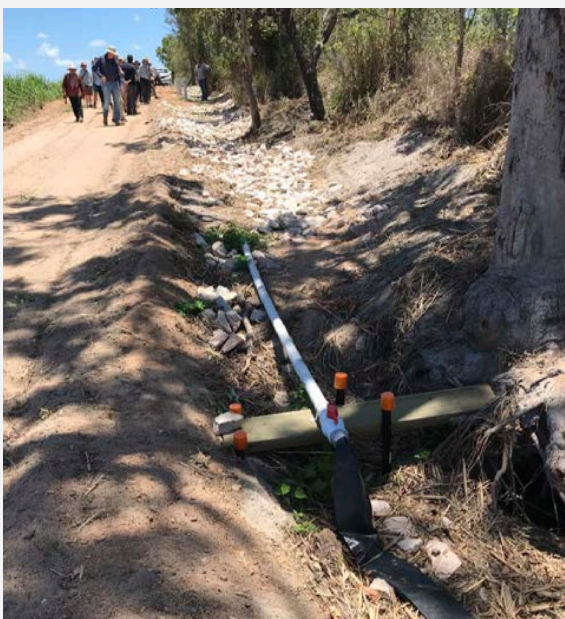
Figure 3 Bioreactor outlet showing single outlet pipe with valve to regulate flow, if required.

The outlet of the bioreactor was a single, 25 m length of 50 mm PVC pipe connected perpendicularly to a pre-drilled 100 mm PVC pipe wrapped in geo-fabric. At the end of the 50 mm PVC pipe a valve was installed to adjust the outflow from the pipe if required (Figure 3). The 50 mm pipe passed through a gabion basket (1.1 m long, 0.8 m deep, and 0.5 m wide). The basket was installed to support the woodchip from moving downslope.

There was a gradual reduction in hydraulic conductivity within bioreactor over time, leading to long hydraulic residence times. This was due to geofabric on the outlet pipes getting blocked. Removal of the geofabric restored flow through the bioreactor.

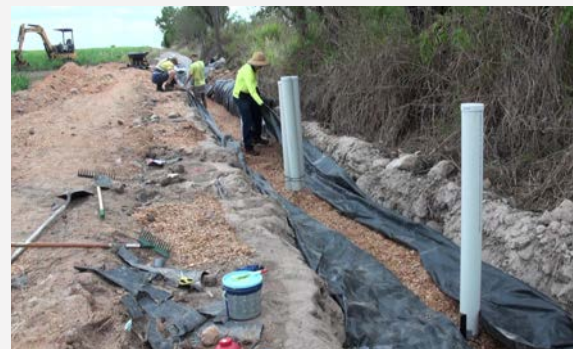
Figure 4 Bioreactor trench filled with woodchip, showing liner and piezometers.

The trench was backfilled with softwood woodchips (14.5 m³) (Figure 4). Heavy-duty plastic liner was placed on the top of the woodchip and all gaps and joints sealed with plumbing sealant before backfilling with soil. A spoon drain (surface bypass drain) was constructed adjacent to the bioreactor to accommodate excess runoff and was paved with rock to minimise erosion.
