Level 1 Mine Emergency Exercise 2016

Grasstree coal mine

November 2016

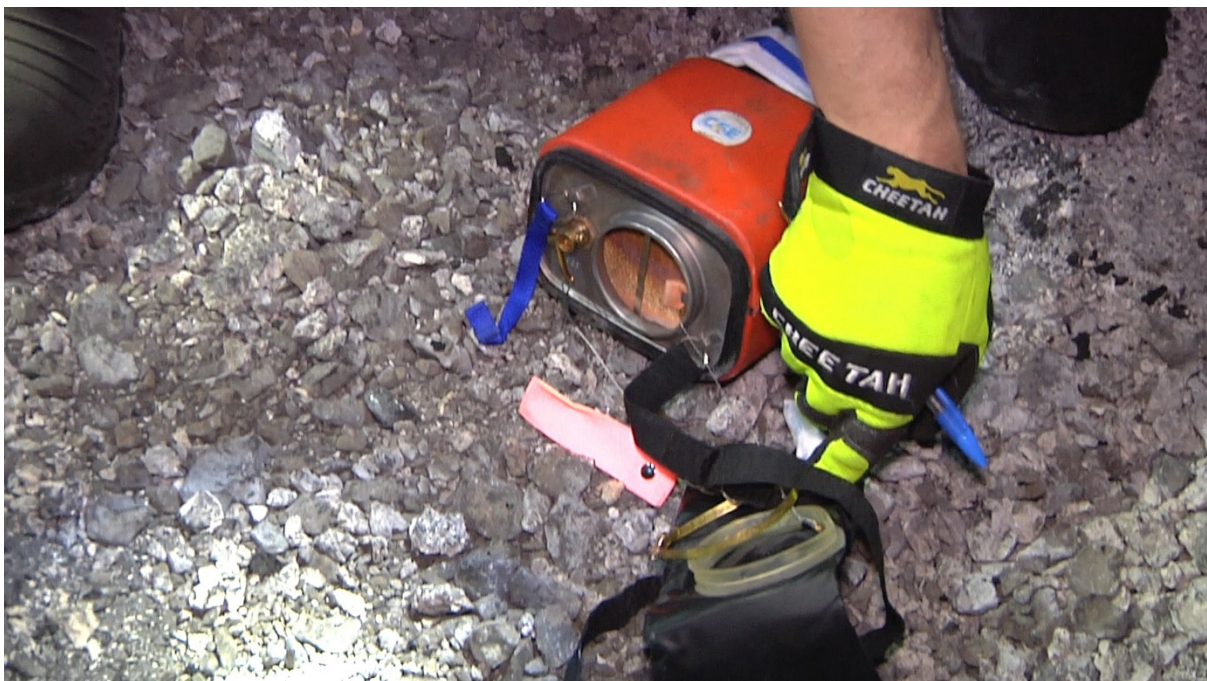
Figure 4 Damaged SCSR

One of the expired SCSRs was damaged on opening. (Figure 4)

There were some issues noted with the out of service SCSRs namely that one of them was damaged; and several goggles had deteriorated.

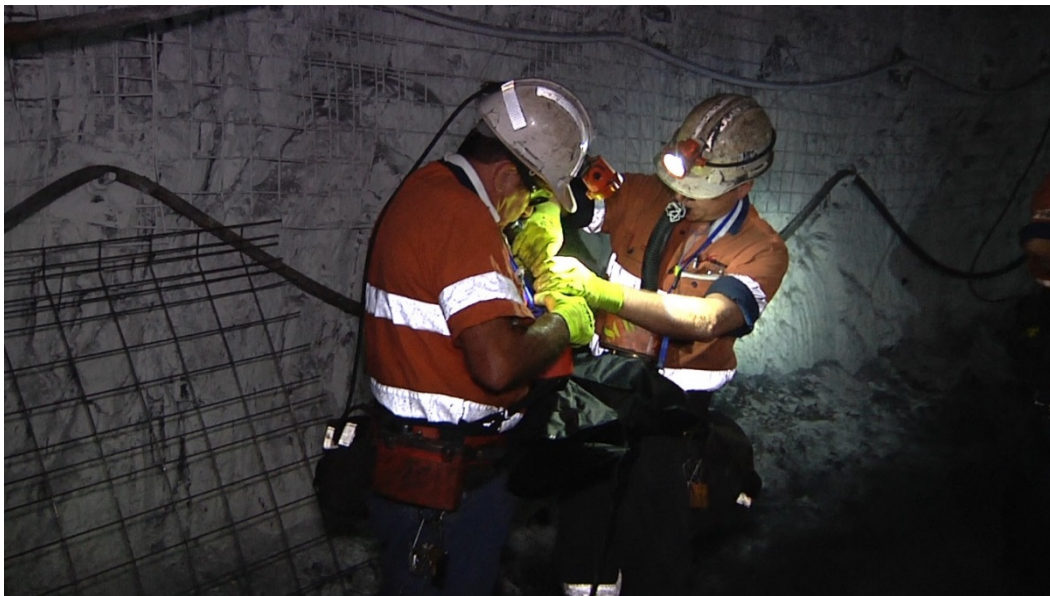
Figure 5 CMWs checking each other on donning SCSR

- Communication between team members when they were aware that an exercise would be on.
- CMWs checked on each other. (Figure 5)
- The lead team member evacuated at a good pace and was checking the team as he walked.
- Concise and controlled leadership from the deputy.
- When travelling on foot, crews formed single file, maintained physical contact, used candy canes to maintain contact with wall, tapping pipes when reaching cut through.
- Walking pace was consistent and efficient but did not overly exert any crew member. Road conditions were good for safe and efficient travel by foot.
- Communication with the crew was good, once they had reached the surface. This included tag board requirements, first aid treatment and a debriefing process.
- Excellent attitude from crew in embracing the Level 1 incident.

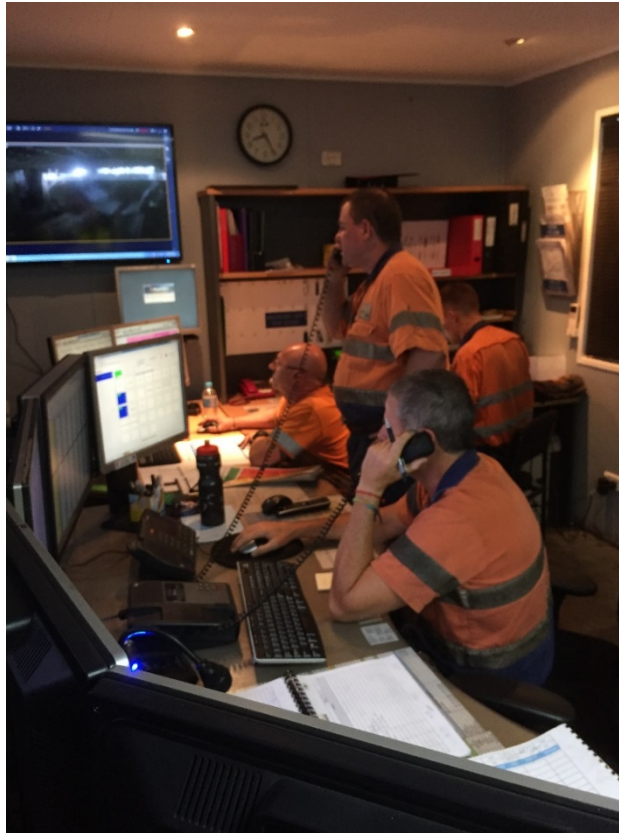
Figure 9: Multiple phone conversations and crowded operating conditions in control room

- The initiation of the incident caused the control room to be full of people with multiple phone conversations occurring at once (Figure 9).
- A number video cameras were out of service including one key location (907 MG).
