Level 1 Mine Emergency Exercise
Grosvenor coal mine
13 July 2018

This report has been compiled by the 2018 Level 1 Mine Emergency Exercise Organising Committee (the Committee) with input provided by each of the assessors involved in the exercise. Assessors have provided an account of their part of the exercise for this report.

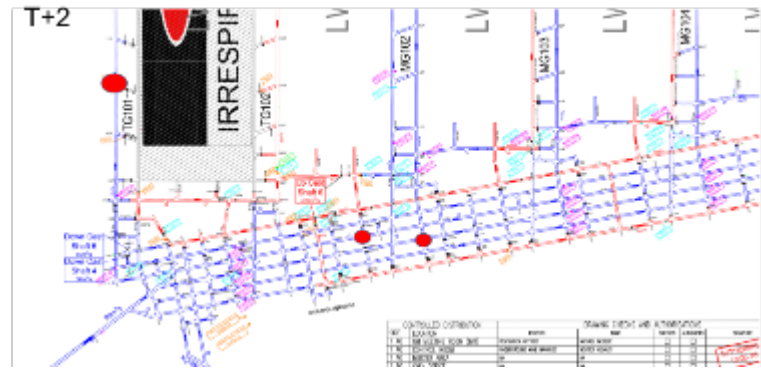
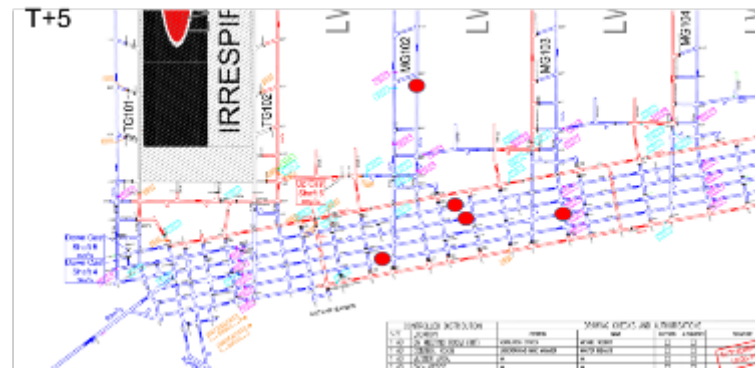
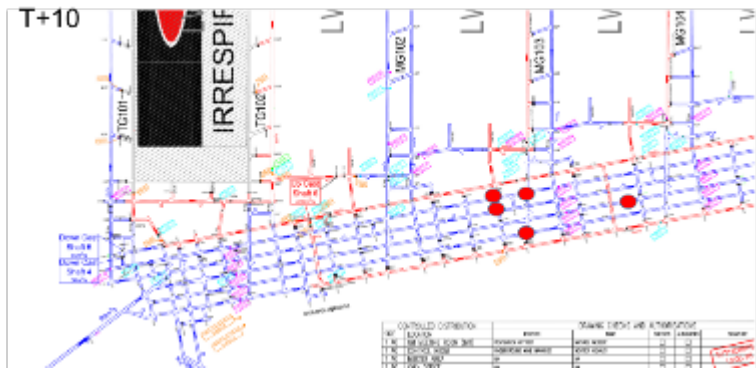
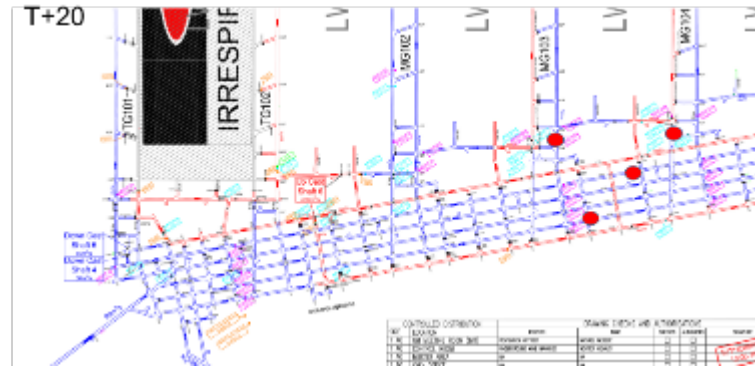
Figure 3 Smoke spread 2, 5, 10 and 20 minutes after the explosion

The scenario deemed that ventilation control devices (VCDs) were damaged by the coal dust explosion, with a cloud of gases and dust having travelled through the mine. For the purposes of the scenario, the time it took for this to occur depended upon the velocity predicted by the mines ventilation simulation in Ventsim. Plans were prepared for the underground assessors which indicated the contaminated air locations and the approximate predicted arrival time for the pollutants (Figure 3). The red dots show the approximate location of the dust and gas clouds after 2, 5, 10 and 20 minutes after the simulated explosion.

These clouds of dust and gas would impair the evacuation of the CMWs and cause any diesel vehicle to stop. The atmosphere was deemed to have passed by within two minutes and then the vehicle would re-start if tried by the CMWs.

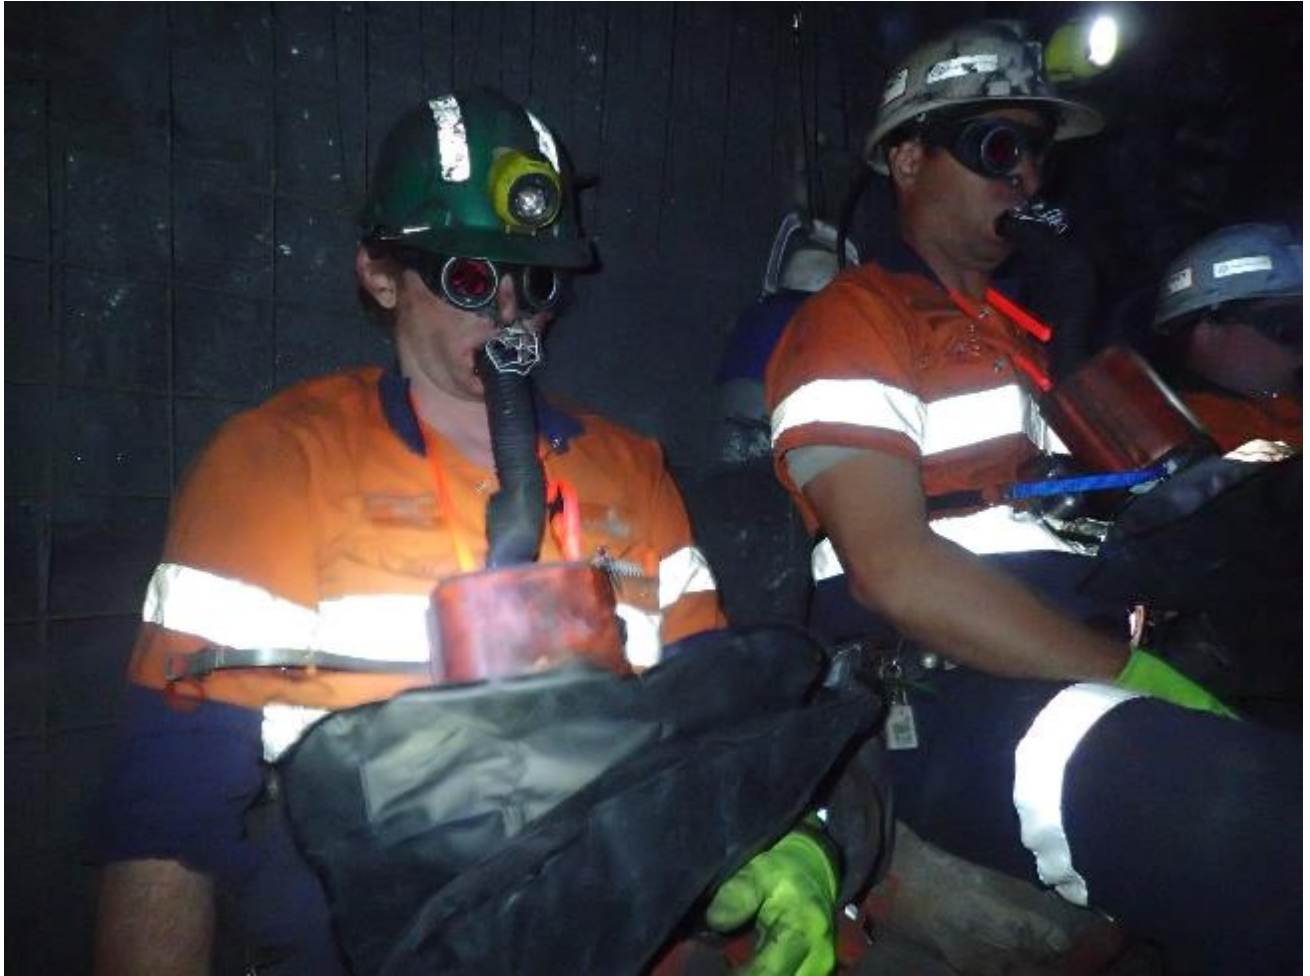
Figure 4 CMWs at rest wearing SCSR

The longwall crew was asked if they would participate in testing the donning of live SCSR and timing their duration at rest. The crew were very happy to participate and the test SCSRs were handed out along with vision limiting goggles. The crew donned the goggles and SCSR in six minutes. They were very fluent at the process, assisting each other once their own SCSR was on and checking each other that fitting was correct. It was explained to the crew to keep the SCSR unit off their chest to limit the heat and to allow air flow around the unit. One of the crew placed one of the end caps under the unit to keep it off his chest, which was a great idea and the rest of the team did the same. The crew were sitting on stone dust bags and were very comfortable during the test of the SCSRs. See Figure 4.

At 2.00 pm, the Minova team had finished pumping Carbofill on the face and the exclusion zones were removed. At the same time, two more CMWs stopped using SCSR. The longwall crew then made their way down the belt road to the face. One CMW was still wearing a SCSR. The team walked from 9ct B hdg to 10.5ct B hdg and as soon as the CMW reached the longwall DCB he stopped wearing the SCSR some **3 hours and 18 minutes** after donning.

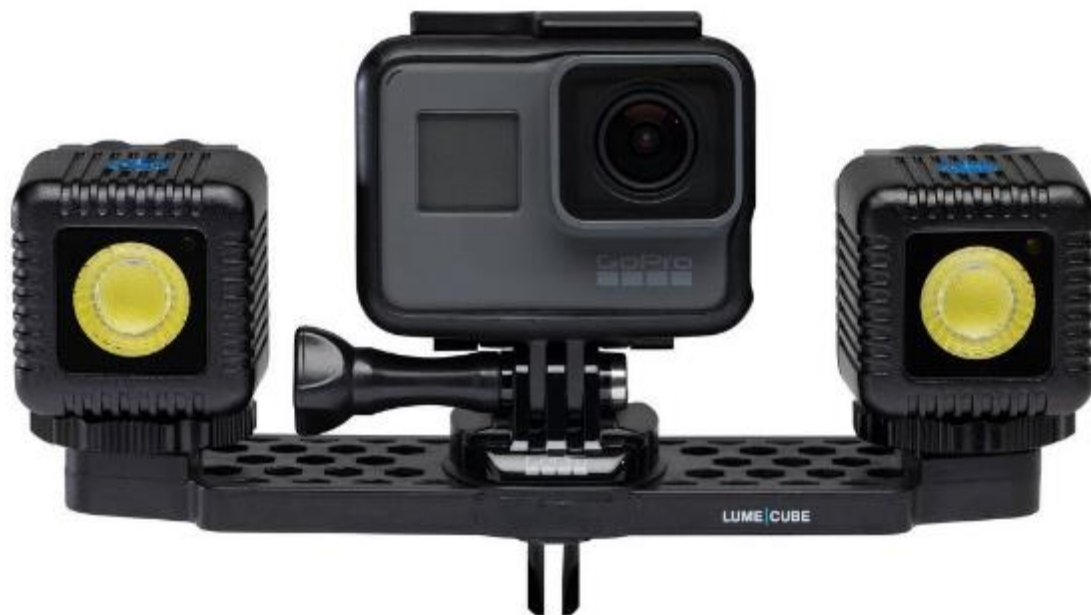
Figure 5 GoPro and Lume cube equipment

Video footage was taken of this evacuation and will be made available to clarify this content. The video was taken using a GoPro camera and a lume cube lighting system. See Figure 5.

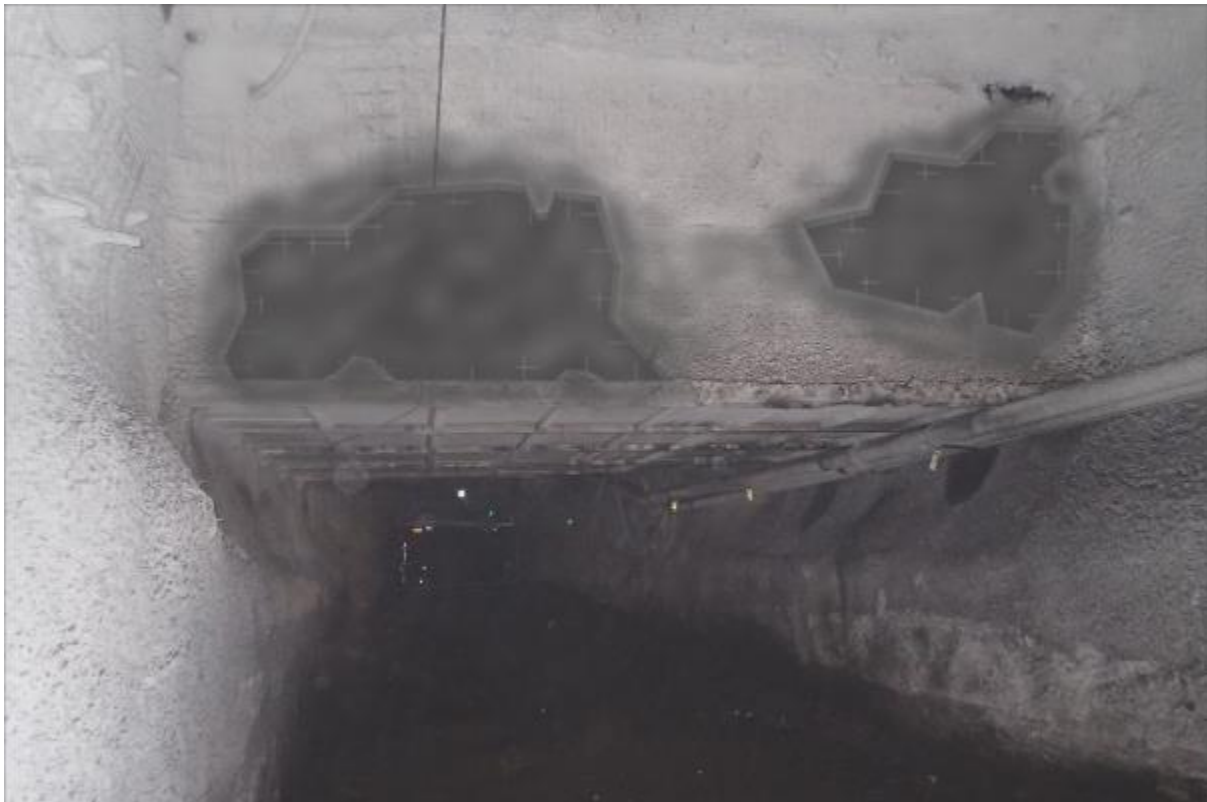
Figure 6 damaged 9 c/t overcast

When the crew reached 9 c/t they inspected and saw that the C hdg overcast had been damaged and required patching up. The ERZC attempted to call both of the CRO numbers and went to the reception both times and reception was unable to connect them to the CRO. After several attempts to connect to the control, the ERZC then passed on the information to reception regarding the overcast and where the MG103 crew was in regard to evacuating the mine. The ERZC told reception that this information needed to be passed onto the IMT and the CRO.

The ERZC then rang the CRO again at the bottom of the drift and got reception who was able to connect him to control this time and he was able to relay the information to the CRO regarding the crew and the damaged overcast that had been seen at 9 c/t C hdg. Three PJBs then came and the crew was able to get a ride to pit top.

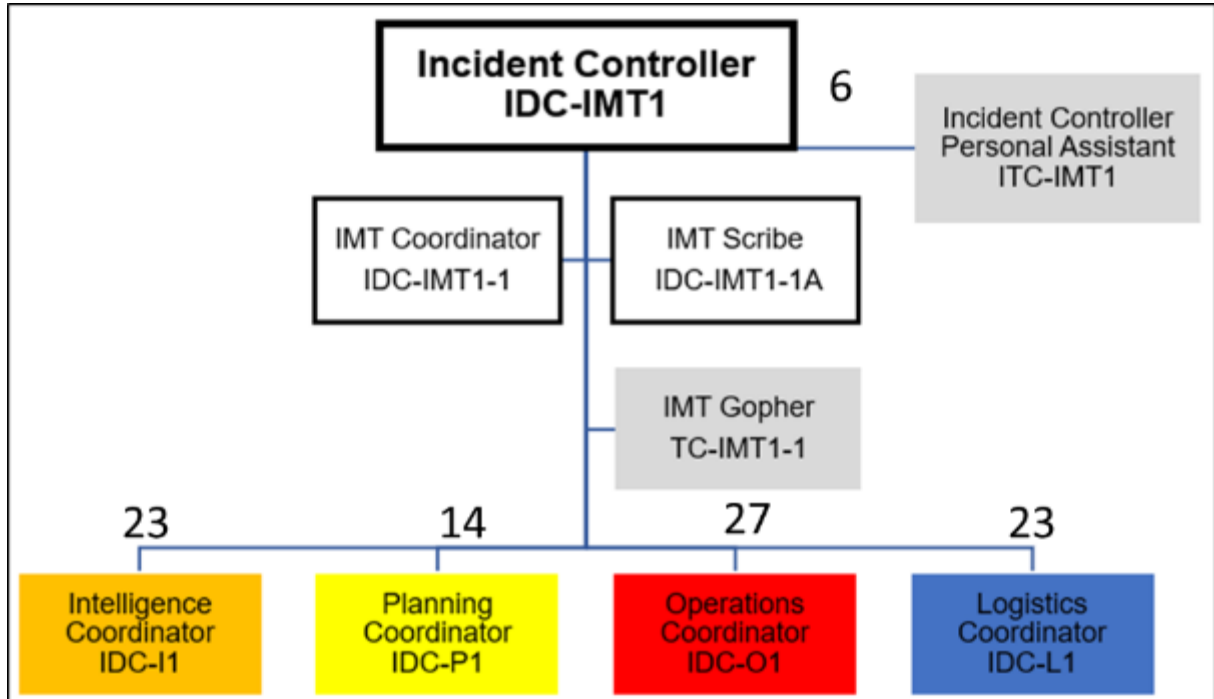
Figure 7 IMT Structure at Grosvenor Mine

That is a total of 93 possible options/roles not including the EMT which has 11 duty cards.

Figure 7 shows the IMT structure and no of duty cards for each group.

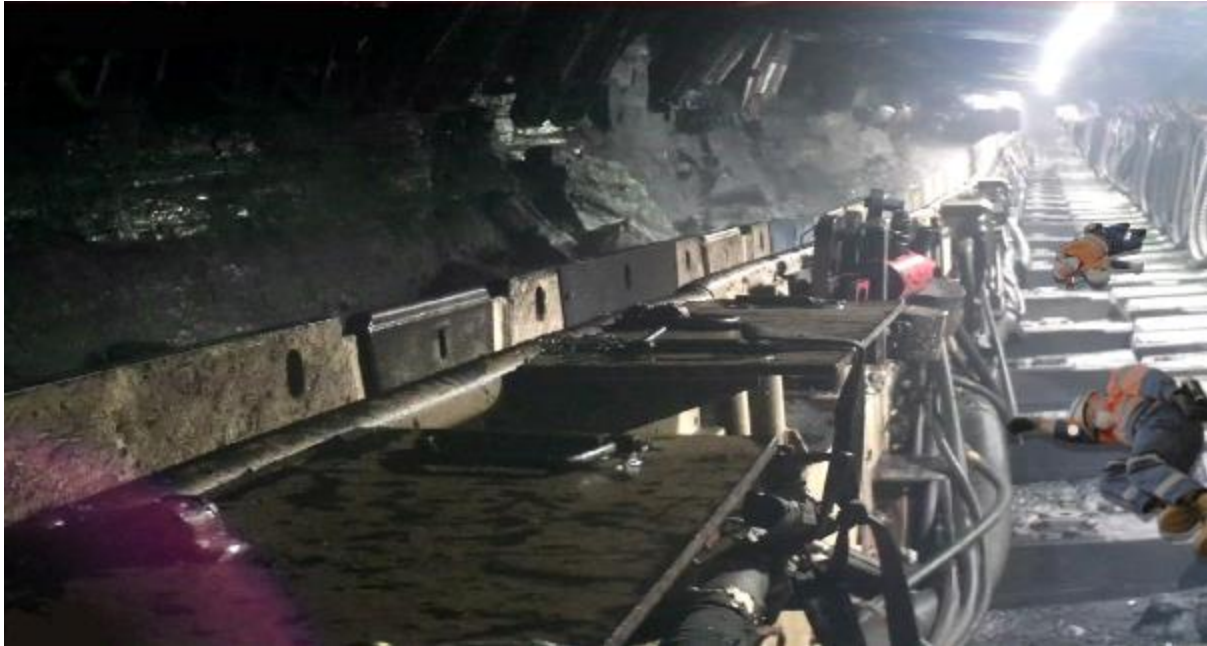
Figure 9 Incapacitated CMWs at the maingate end of the longwall face

The level 1 exercise commenced at 11 am on 13 July 2018 when the Control room gas alarms for Longwall 102 were activated and the CRO was given photographs which depicted the scene the MG end of the Longwall face which would have been visible from the installed cameras. See Figure 9. The scene at the TG was described to the CRO and the information provided that there were three CMWs who were obviously dead from the visible injuries. No mock up picture was prepared for this.

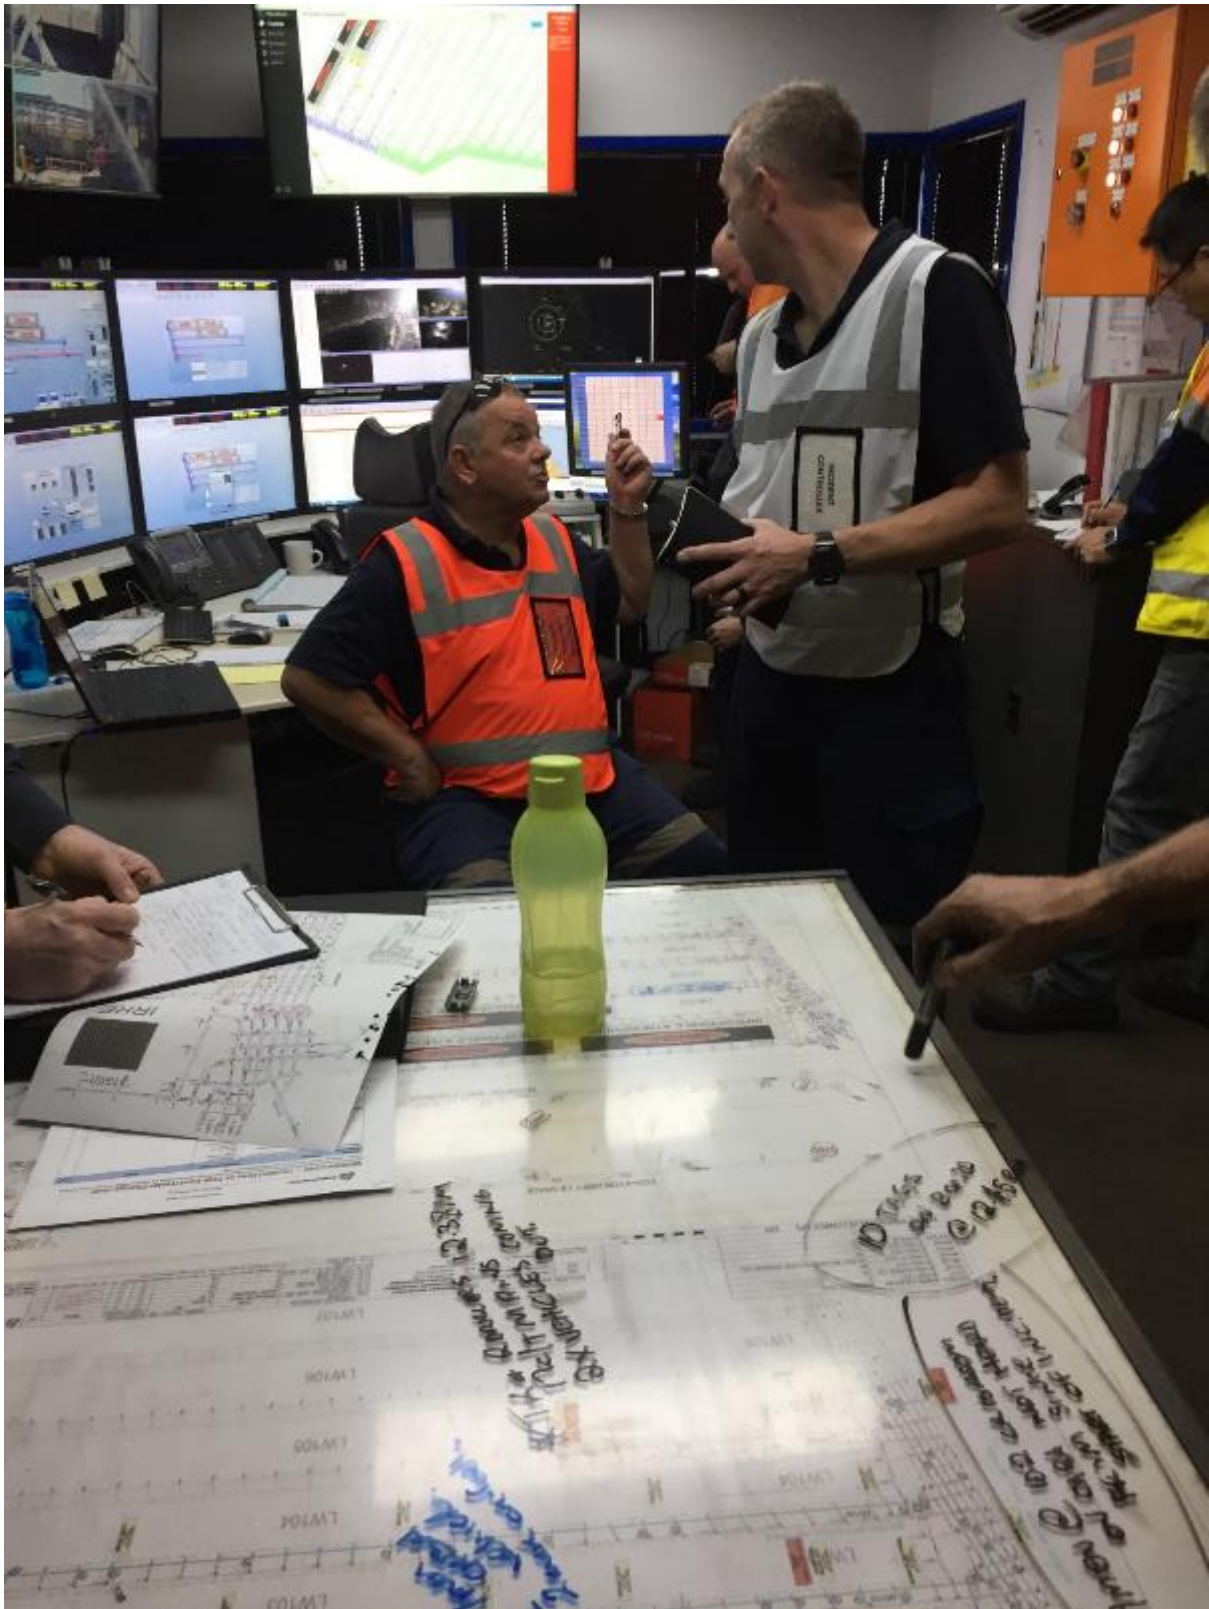
Figure 10 mini IMT in the control room

Once the IMT process had started information continued to come into the control room and a mini IMT was formed even down to sourcing a whiteboard for noting key information. See Figure 10 and Figure 11.

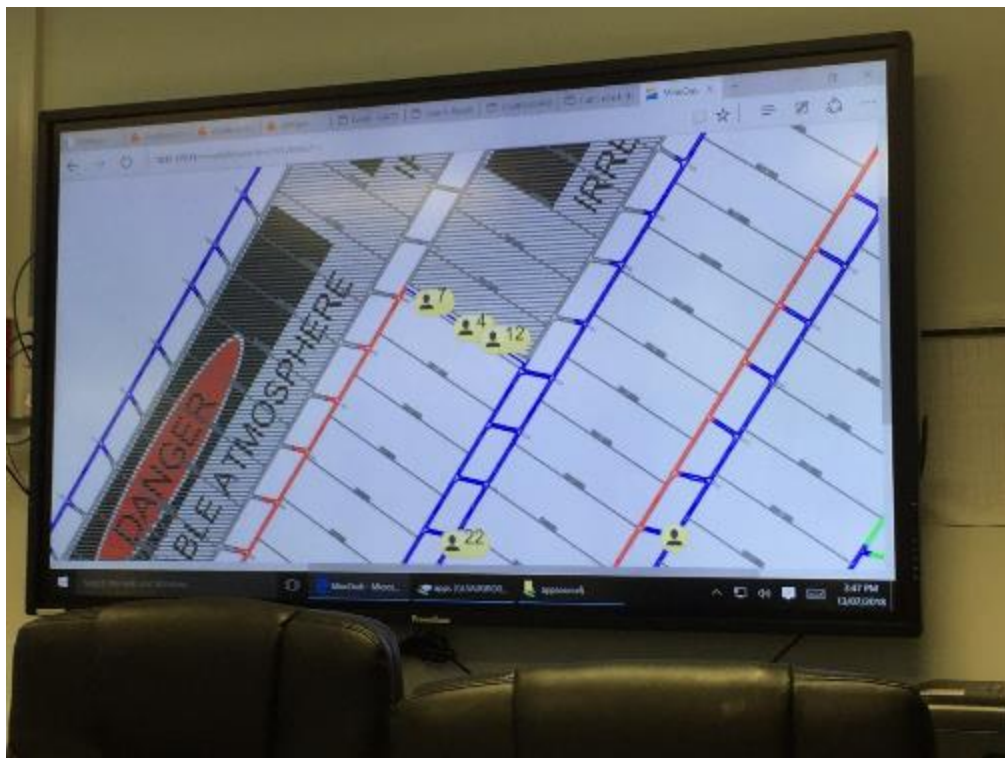
Figure 12 MINEDASH Screen

- IMT did not directly track gas concentrations or smoke distribution underground relying on reports from functional groups. IMT did have direct access to Safegas if required.
- There were two large touch screen monitors in the IMT room, one of these could have been used to display the mine plan and current location of persons underground and whether or not they were injured – link to MINEDASH for example. MINEDASH was eventually activated at 3:30 pm (Figure 12). This screen is displaying the mine personnel location on the monitor and included the crew quarantined to do carbofilling, outbye inspections as well as rescue teams and assessors.
- Underground personnel were marked up on a glass covered mine plan (Figure 13). This could have been done better using the touch screen monitors, allowing visibility to the whole IMT.

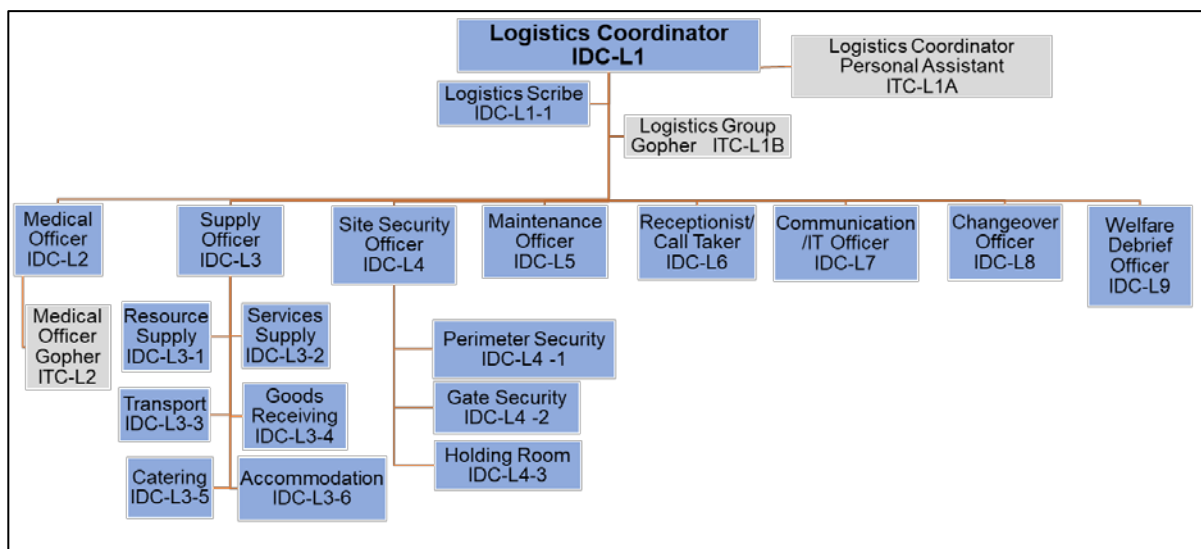
Figure 17 logistics group structure

The Logistics room is of a good size, containing tables set out in a u-typed fashion with plenty of seating, white boards on the wall to the rear of the room, a projector attached to the centre of the ceiling, a projector screen to the front of the room and plans available. The duty cards for the Logistics team were held in a cabinet in the corner of the room. Figure 17 shows the structure of the Logistic team.

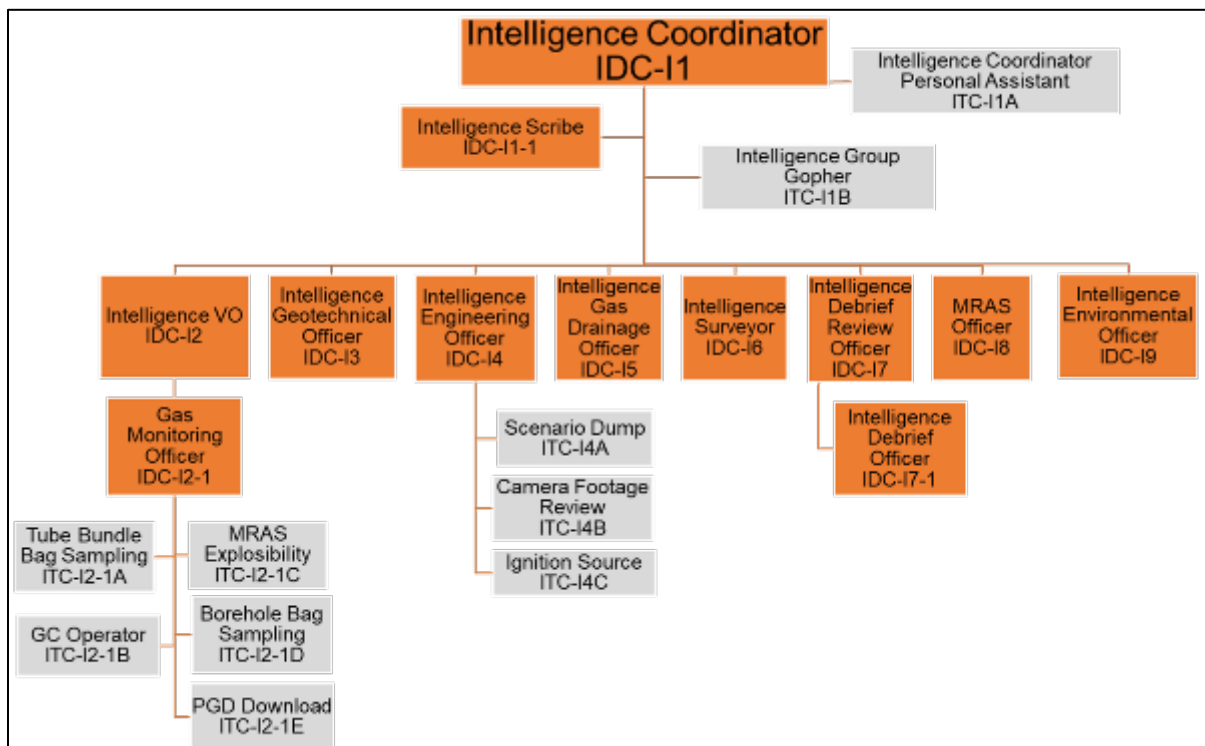
Figure 18 Intelligence group structure

During the initial response/activation it was evident that the planning and intelligence groups were covering off on the majority of the basics solely from experience rather than following the duty card process. There were times during the first 45 minutes where the teams were working faster than the systems and processes that were there for use. This did not have an adverse effect during the initial phase. Eventually they settled into roles and the duty card system caught up and they were able to use some of its functionality to structure the response. Initially there was time spent debating who should do what based on skill sets due to the number of duty cards that needed to be issued for the event. This could be streamlined with a better general understanding of the duty card system. The Intelligence group structure is shown at Figure 18.

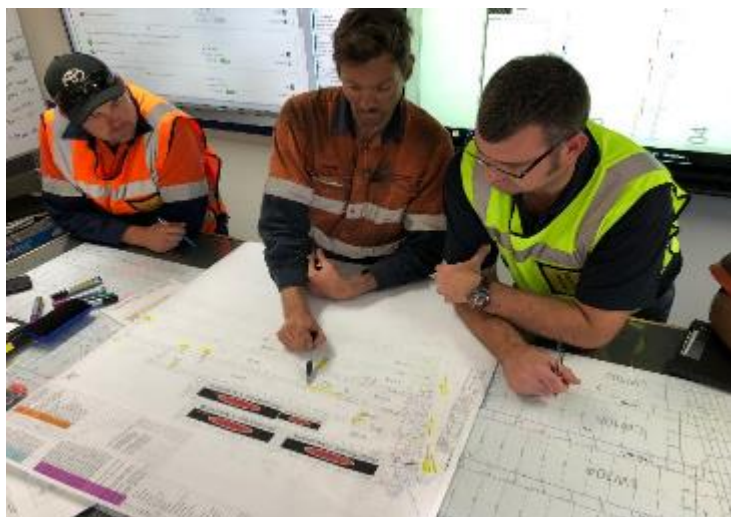
Figure 20 debrief information being presented to intelligence cell

- Switched on personnel assigning many tasks correctly much quicker than the duty card system would allow during the first 1hr of the event.
- The debrief officer created a ventilation plan with notes and current debrief information (Figure 20). Worked well for passing on information and led to clarification on a few key points they were not picked up straight from the debrief forms.
- During the response (Planning meeting) the Mines inspector made excellent observations and contributed to highlighting some key areas that would underpin decisions coming from the Planning team.
- The Mines Rescue Officer also made timely inquiries with the planning team to assist with a key focus of continuous monitoring of gas data during the mines rescue team's deployment into the mine.
