16.1 Pilot Transfer Arrangements – Marine Notice 04/2023

MARINE NOTICE

Marine Notice 2023/04

Pilot transfer arrangements

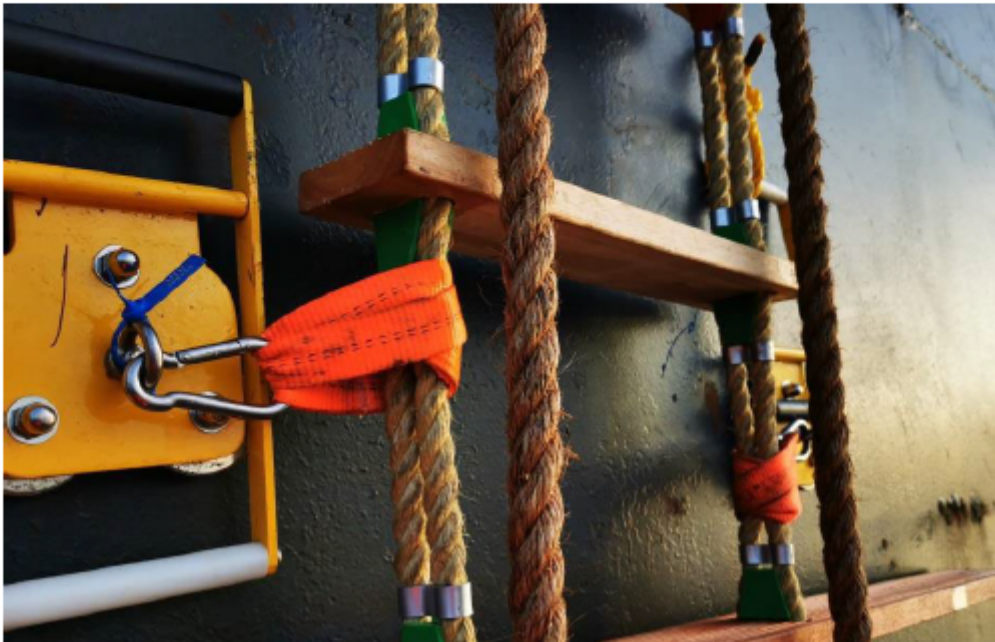
When using a combination pilot ladder arrangement, the pilot ladder and accommodation ladder are required to be secured to the ship's side. A common means of securing both the pilot ladder and accommodation ladders is with magnetic pads (refer to photo 1 below as an example).

Photo 1: Example of securing both the pilot ladder and accommodation ladders with magnetic pads (Reproduced with permission from Fremantle Ports).

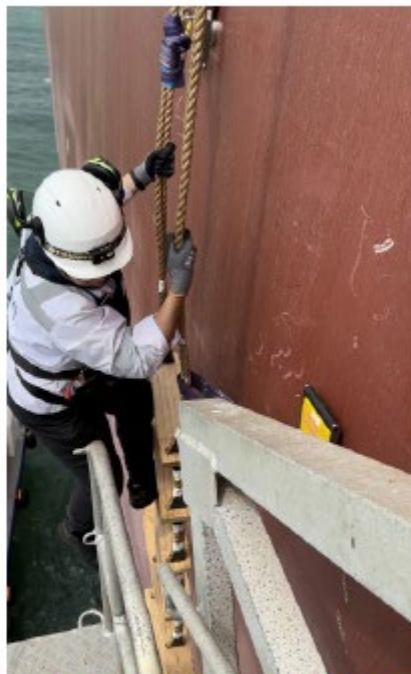
As shown in photos 2 and 3 persons cannot climb the pilot ladder to a level where they can move safely onto the accommodation ladder.

Photo 3: Person unable to safely access accommodation ladder platform from pilot ladder.

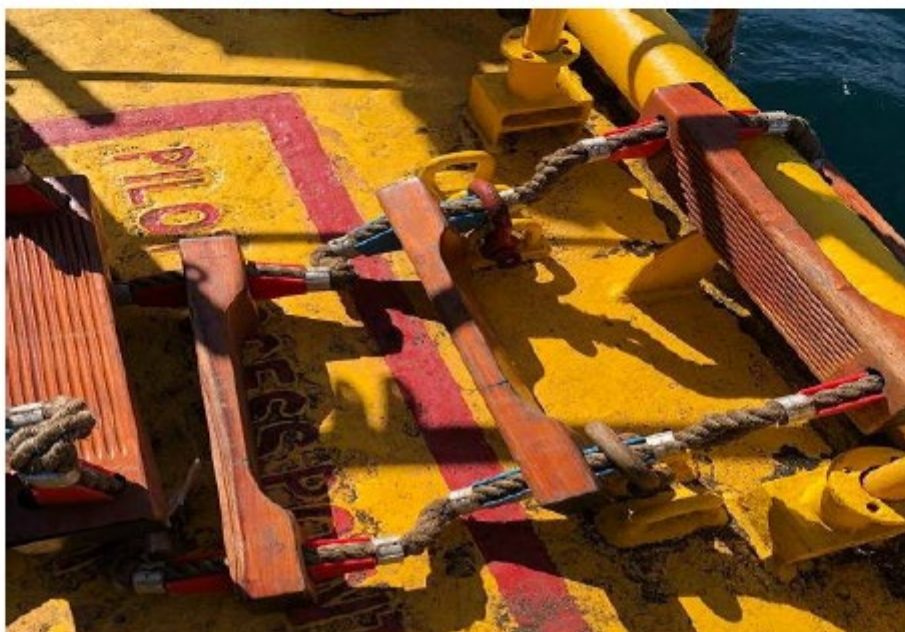
The ladder's steps, spreaders or chocks should not be used to carry the weight of the ladder as they are not designed for this and do not have sufficient strength. For this reason, shackles, bars and tongues should not be used to secure the ladder to the deck. They will damage the ladder and put weight on the parts which are not designed to carry the weight.

Photo 4 shows an example of an unsafe use of shackles to secure pilot ladders.

Photo 4: Unsafe pilot ladder securing arrangements (Reproduced with permission from Fremantle Ports).

It is common industry practice to use a rope stopper usually in the form of a rolling hitch knot between the pilot ladder sides ropes and the approved strong point on the main deck. This will transfer the weight of the ladder arrangement directly onto the designated strong point and will not damage the ladder.

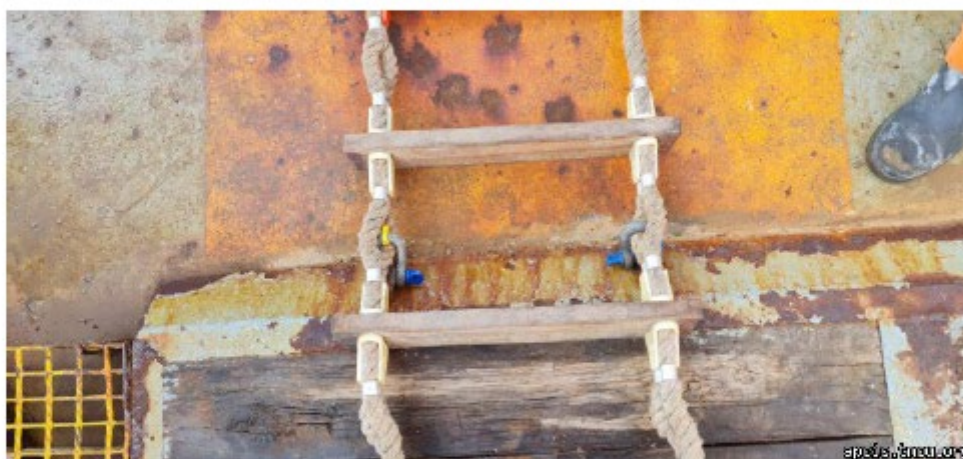
Photo 5: Unsafe pilot ladder securing arrangements.

Photos 5 shows the pilot ladder being secured to the strong point by using a shackle passed through the pilot ladder side ropes. This puts increased load on the single part of the side rope and the chock securing arrangements.

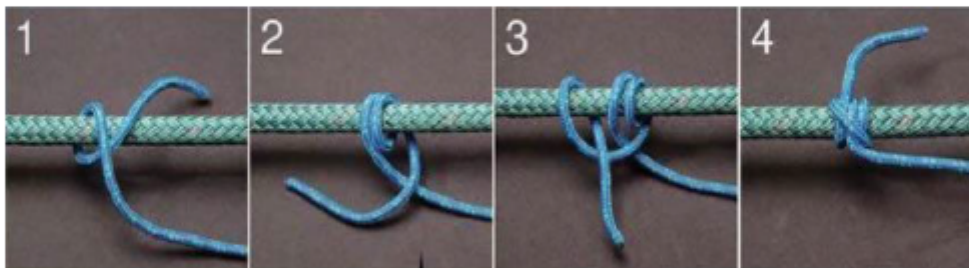
It is suggested that two strong (at least 2 x 24 kN) manila ropes be used to secure the pilot ladder. Photo 6 illustrates a method of tying a rolling hitch knot.

Photo 6: The rolling hitch knot. (Reproduced with permission from Fremantle Ports).

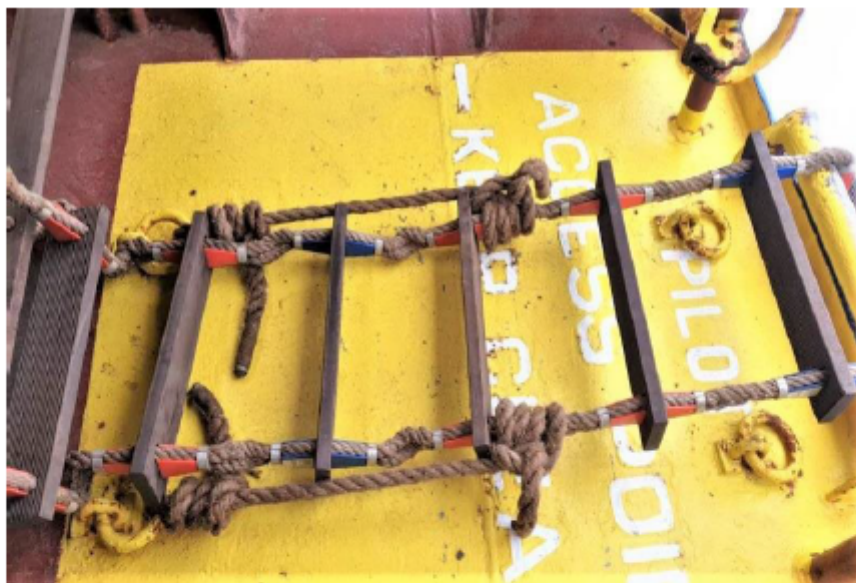
Photo 7 provides an example of rolling hitch knots being used to secure pilot ladders to approved main deck strong points.

Photo 7: Rolling hitch knots being used to secure pilot ladders to approved main deck strong points (Reproduced with permission from Fremantle Ports).

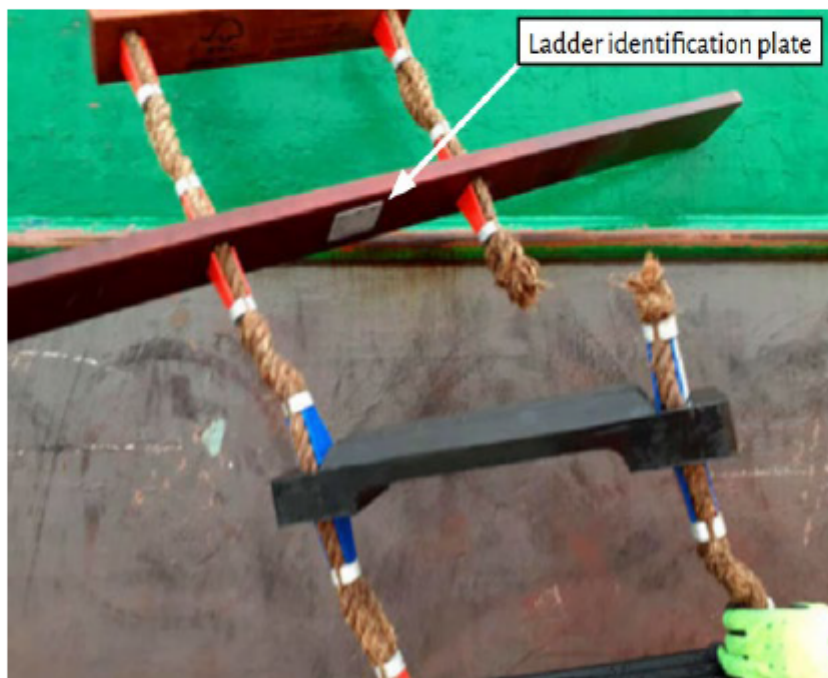
Photo 8: Pilot ladder where side ropes parted when in use (Reproduced with permission of the MAIB).

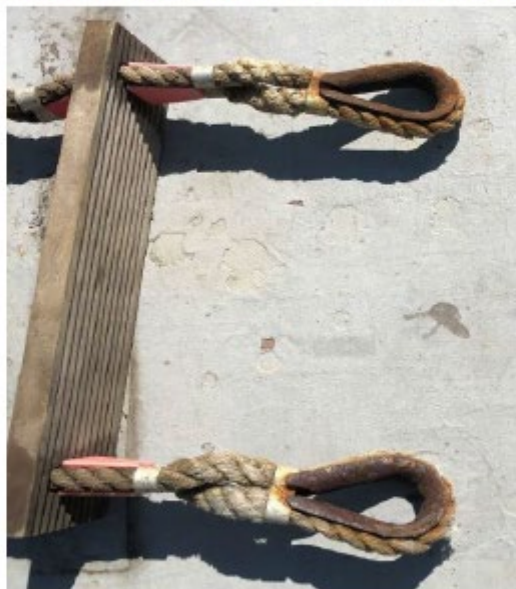
Common areas of defects can be the thimble ends of the pilot ladder. Corroded end point thimbles as illustrated in photo 9, can damage the side ropes leading to failure.

Photo 9: Example of corroded end point thimbles (Reproduced with permission from Fremantle Ports).

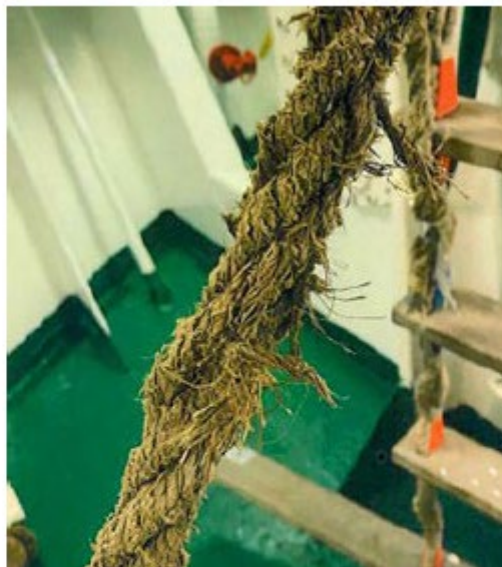
Another common area is the frayed or damaged side ropes as illustrated in photo 10. These should be detected during routine visual inspections.

Photo 10: Frayed side rope.

If side ropes are frayed, or in any way degraded the ladder should not be used.

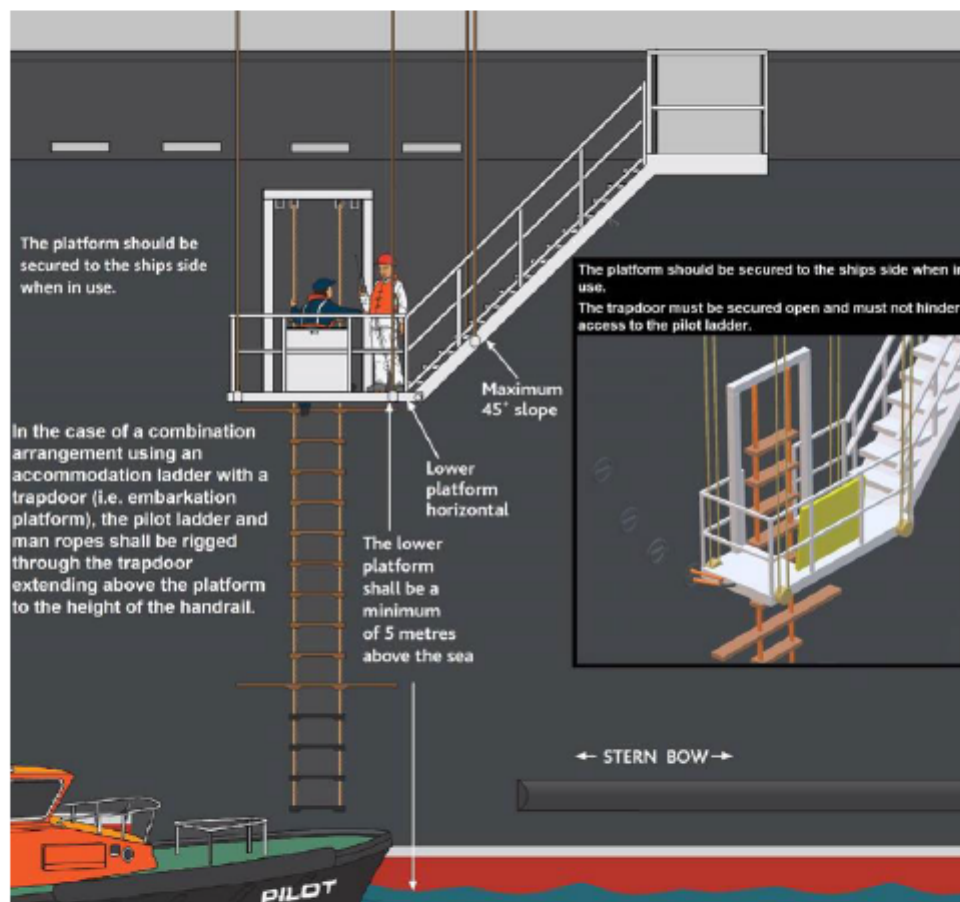
There has been an increase in ships fitted with trapdoor arrangements. The additional requirement for their use is "the pilot ladder and man ropes shall be rigged through the trapdoor extending above the platform to the height of the handrail".

Figure 1: Pilot card depicting trap door arrangements.

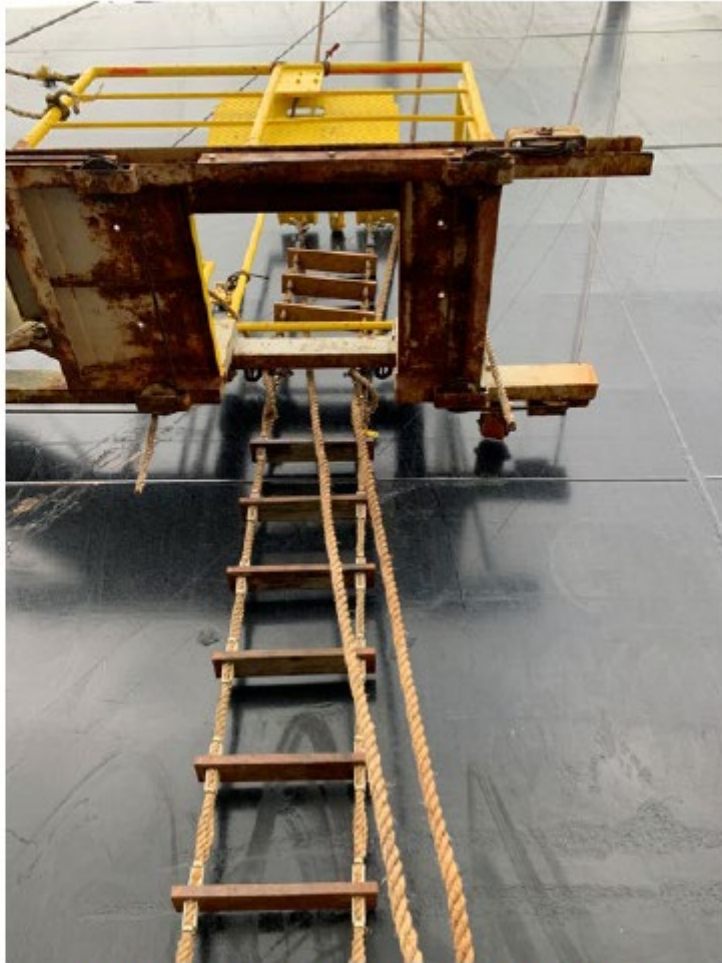
If the pilot ladder and man ropes are not rigged through the trapdoor this creates an unsafe arrangement for persons as illustrated in photo 11

Photo 11: Unsafe trapdoor pilot transfer arrangement.

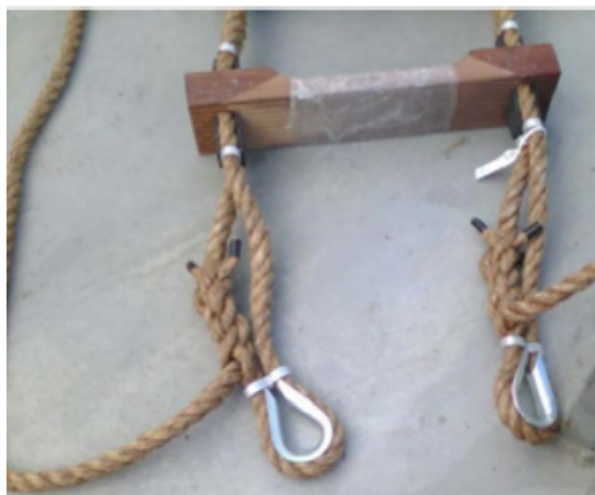
During recent PSC inspections AMSA surveyors have noted pilot ladders which have been constructed with splices in the side ropes.

Photo 12: Example of non-compliant pilot ladder with splices in side ropes.

Pilot ladders constructed like this are considered non-compliant by AMSA. Ship operators and masters are recommended to check their pilot ladders for splices in the side ropes. It should be noted by operators coming to Australian ports that the availability of compliant pilot ladders is limited in Australia. To prevent avoidable delays operators are recommended to have spare compliant pilot transfer arrangements onboard.

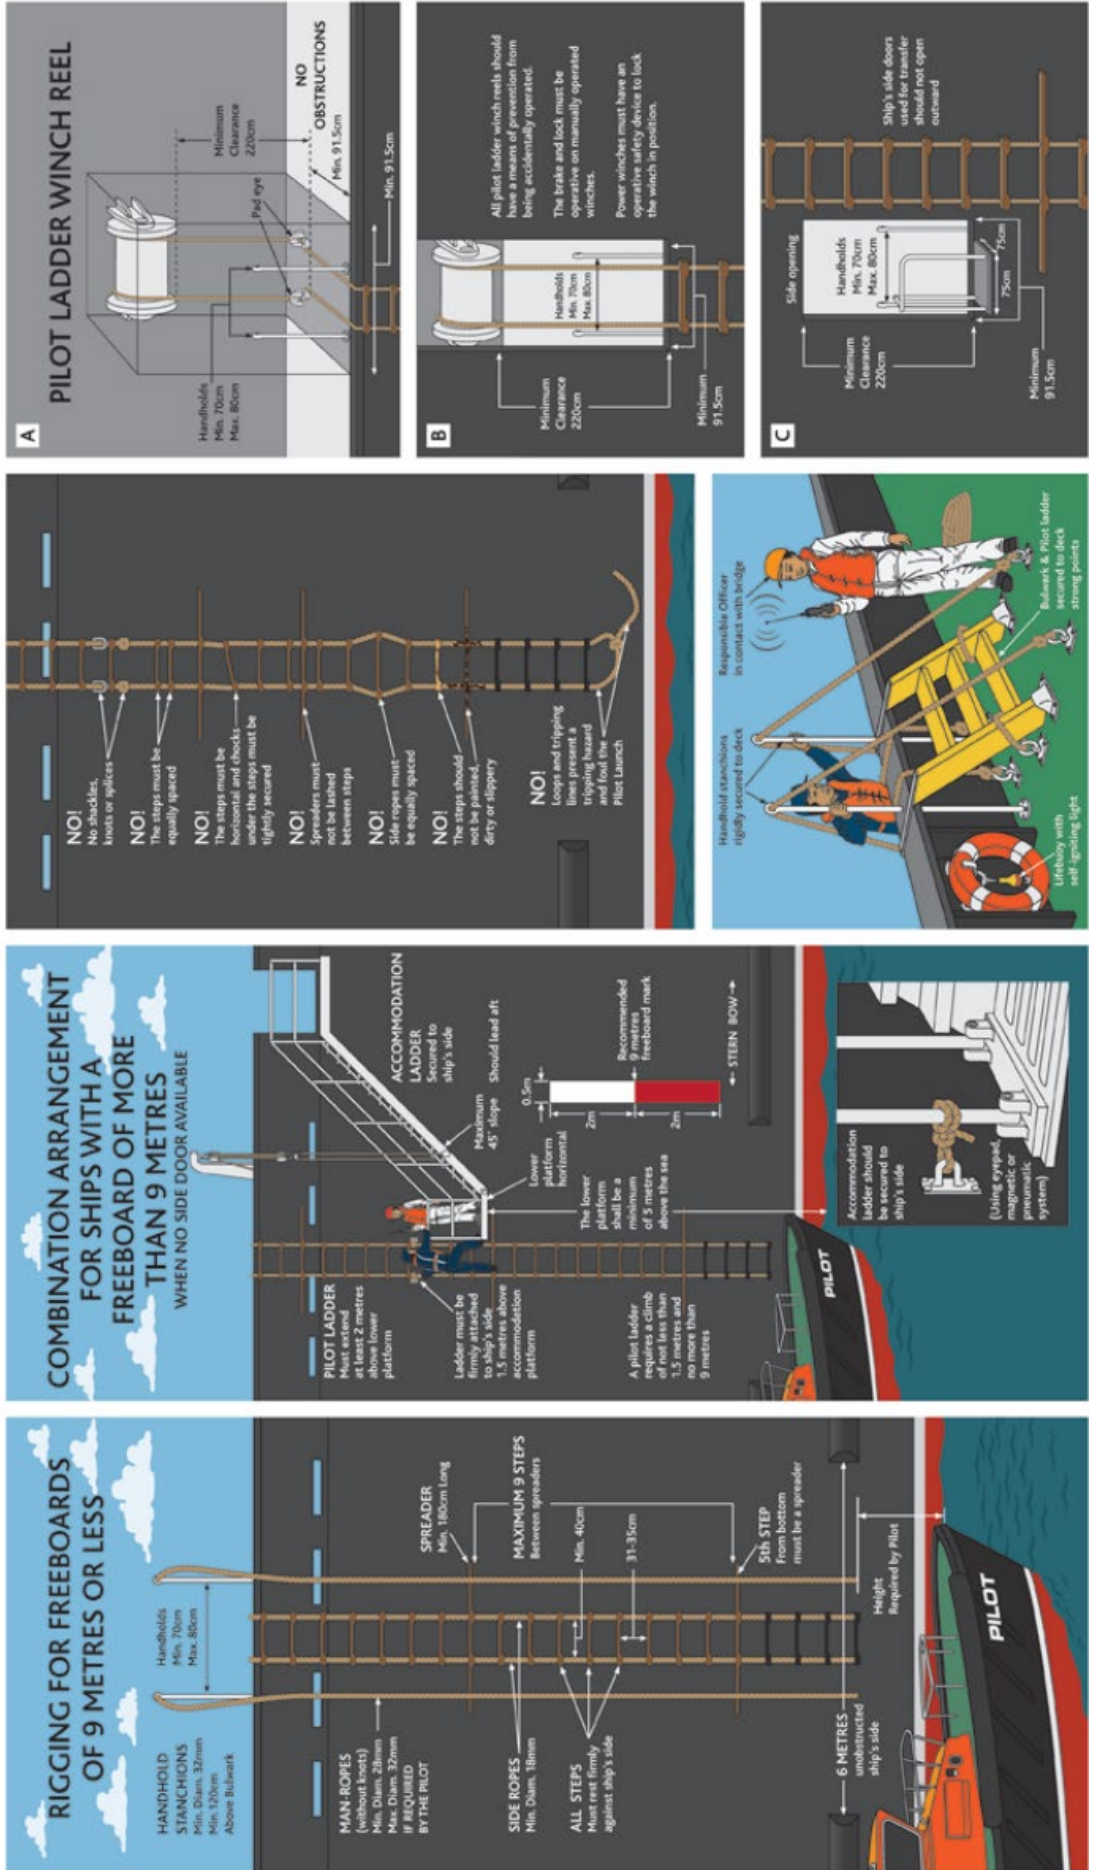
REQUIRED BOARDING ARRANGEMENTS FOR PILOT

Figure 1 – pilot boarding ladder arrangements
