## **Streambank erosion baseline establishment project**

Burnett & Kolan Rivers 2015

# **Appendix F**

Site report cards summarising  
streambank condition transects

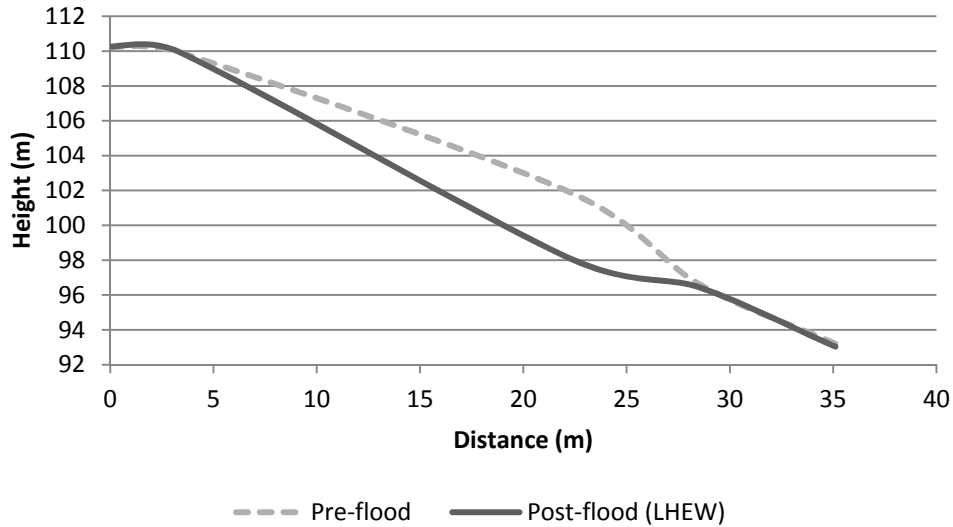
### Site 8 - Transect 1

**Note:** Discrepancy between transect lengths shown in cross-section and on report card is due to different starting positions at top of bank. Slope trend shown is accurate.

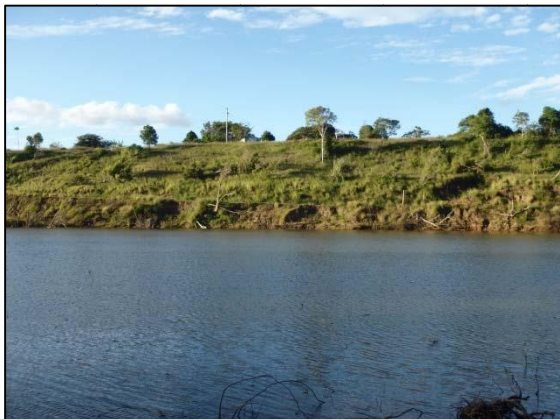
#### PHOTO:

View of site from opposite bank. Image encompasses both transects.

Flood waters covered almost all of the property and rose well above the revegetation sites. Infrastructure (including fences) and equipment were damaged. Scouring occurred along the whole bank, with moderate slumping along the lower section below the railway, causing approximately 3m of land to be lost.

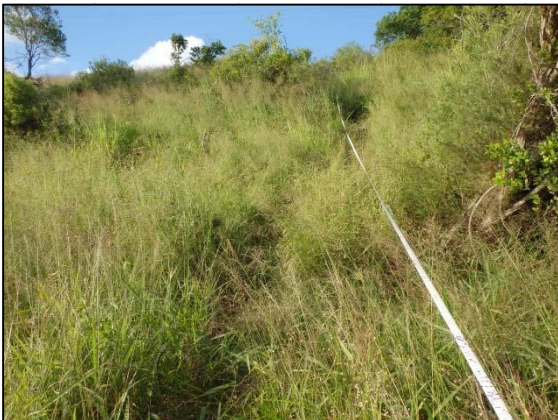
**PHOTO:** LB1R22a(iii)

View of middle of segment 2, looking upslope.

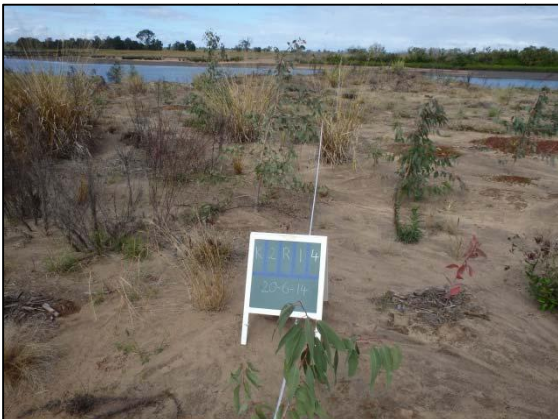
**PHOTO:** K2R14(i)

Photo taken at Segment 4 of Transect 1, looking south (downslope) towards the river.

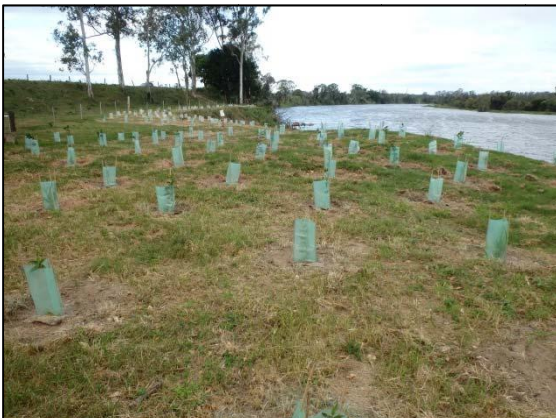
**PHOTO:** K3R1&2F

Photo shows general view of the revegetation area, at the base of Transects 1 and 2.

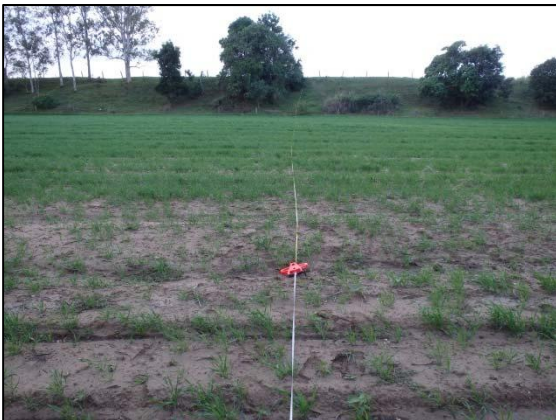
**PHOTO:** K3N35(iii)

Photo taken at Segment 5 of Transect 3, looking along transect (upslope) towards the start.

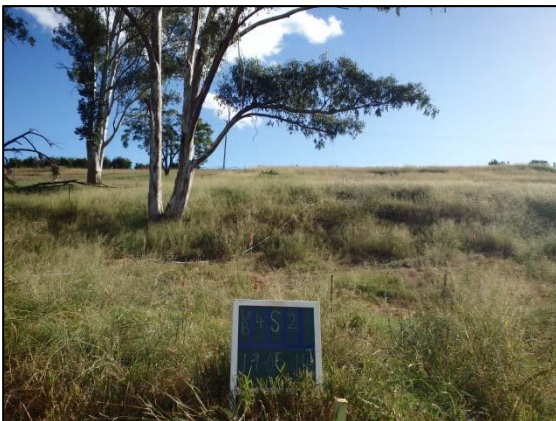
**PHOTO:** UB4S2D

Photo taken looking (upslope) diagonally across Transect 2.

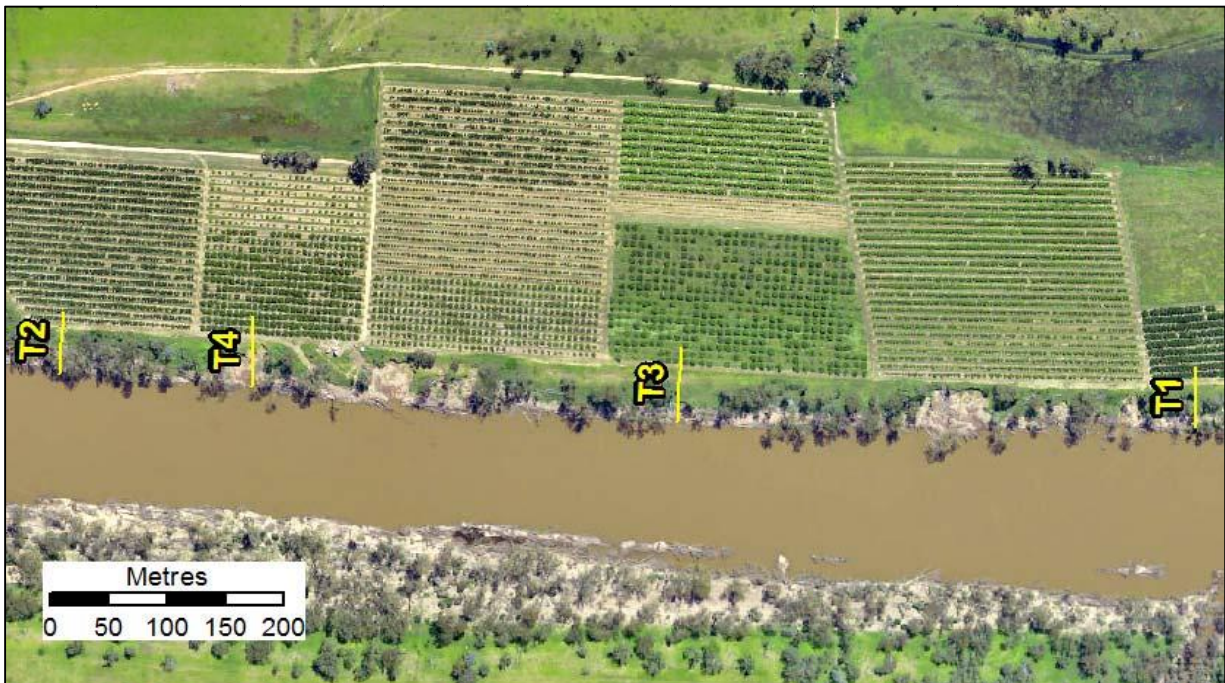
### Post-Flood Image

Floodwaters covered approximately 95% of the citrus orchard. Pump site and infrastructure were lost/damaged, as well as some irrigation equipment. Approximately 1000 citrus trees were pushed over (and stood up post flood). Significant slumping occurred along the river bank, including at site T2, T3 and T4.

No remedial works were undertaken by the landholder prior to BRMG project. Earthworks were completed at site T2 and T4 in May 2014 and revegetation in August 2014. Farm management practices will not change and no site maintenance regime is planned.

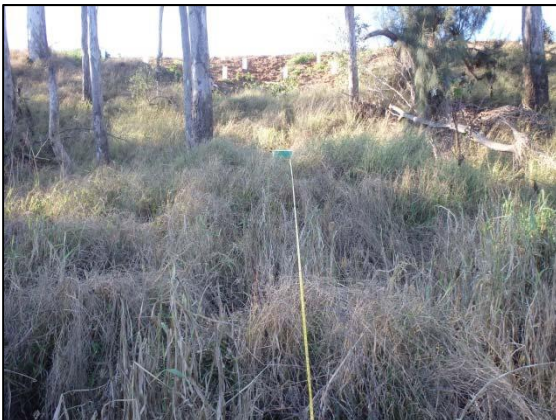
**PHOTO:** UB6N14(ii)

Photo taken in Segment 4 of Transect 2, looking upslope along transect.

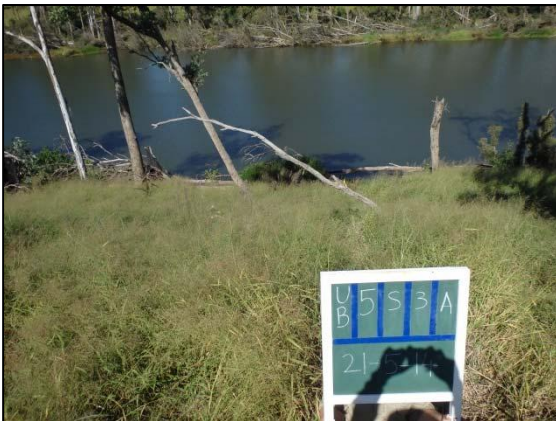
**PHOTO: UB5S3A**

Photo taken at edge of riparian area (also break of slope) at Segment 3 of Transect 3, looking (downslope) towards river.

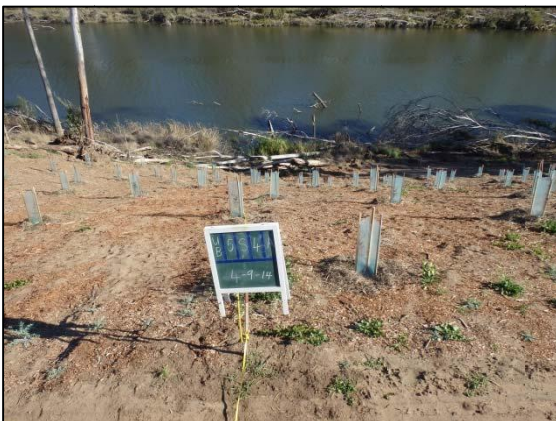
#### PHOTO: UB5S4A

Photo taken at edge of replanted riparian area (also break of slope) at Segment 2 of Transect 4, looking (downslope) towards river. Post-earthworks and replanting.

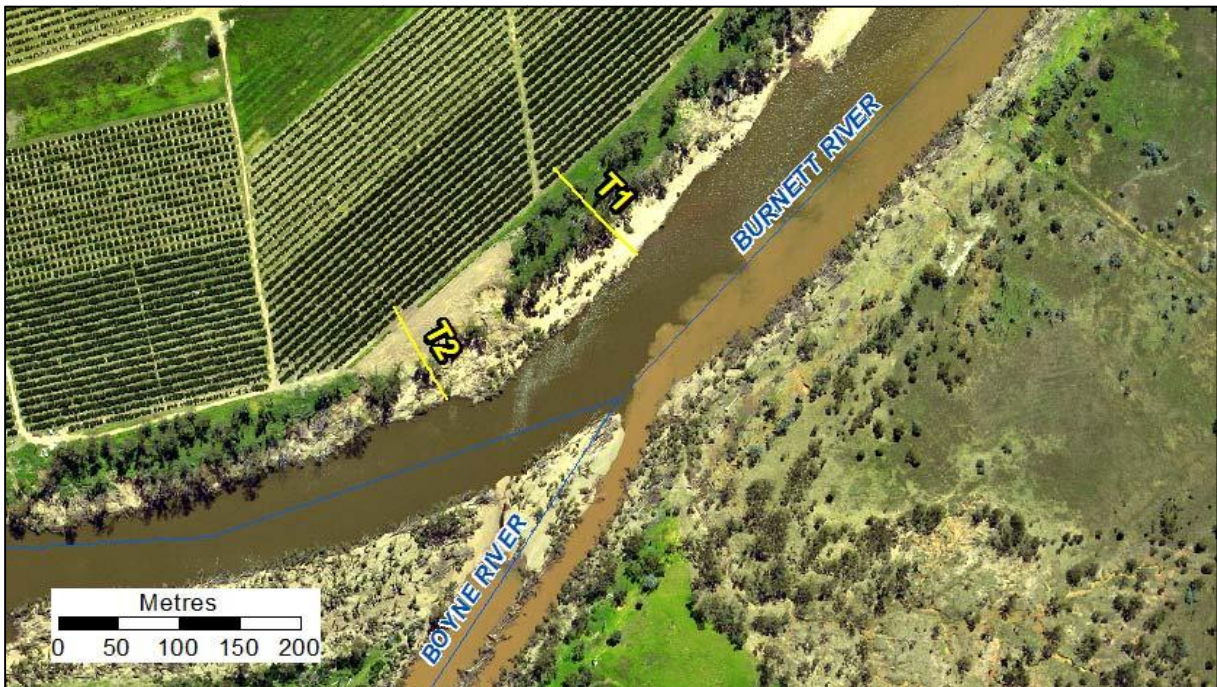
### Post-Flood Image

Floodwaters covered approximately 95% of the citrus orchard, reaching to approximately halfway through the third block of citrus from the river. Significant slumping and scouring and sand deposition occurred along the river bank. Site T1 experienced sand deposition.

No remedial works were undertaken by the landholder prior to BRMG project. Some earthworks were undertaken along the riverbank, however not at either monitoring site. Revegetation at site T2 was completed in August 2014. Farm management practices will not change and no site maintenance regime is planned.

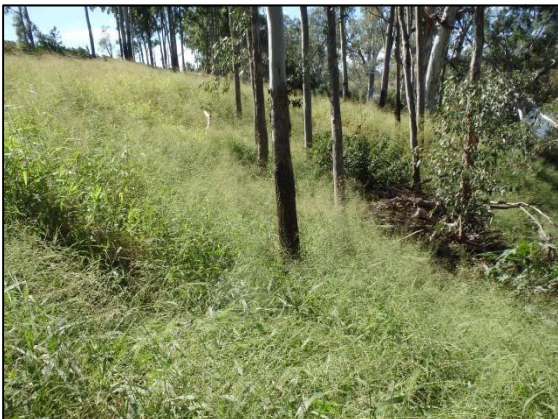
**PHOTO:** UB6N13(iv)

Photo taken at Segment 3 of Transect 1, looking northeast (across slope).

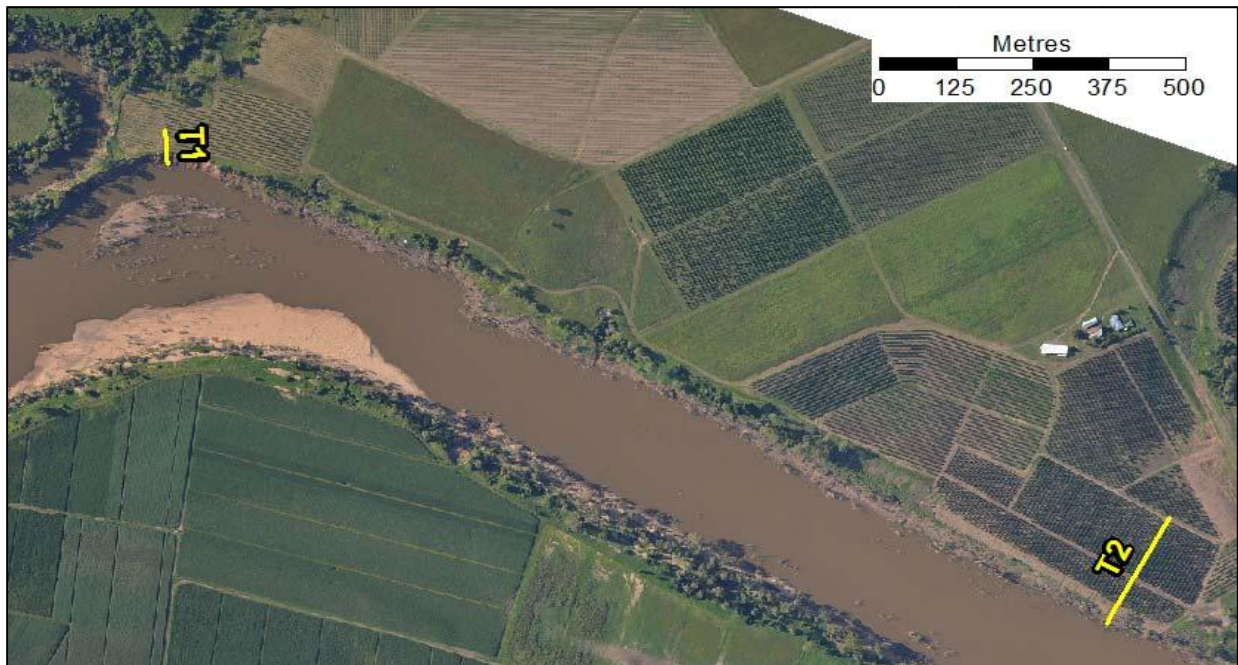
### Post-Flood Image

Floodwaters covered approximately 60% of the property. Damage to irrigation, 6000 trees and fruit quality occurred, with debris deposition in crops. Significant riverbank slumping occurred at T1 and sand deposition at T2.

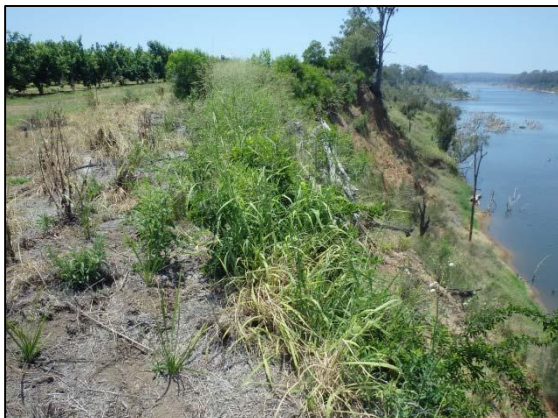
**PHOTO:** UB7R14(iv)

Photo taken at Segment 4 of Transect 1, looking east along edge of slump.

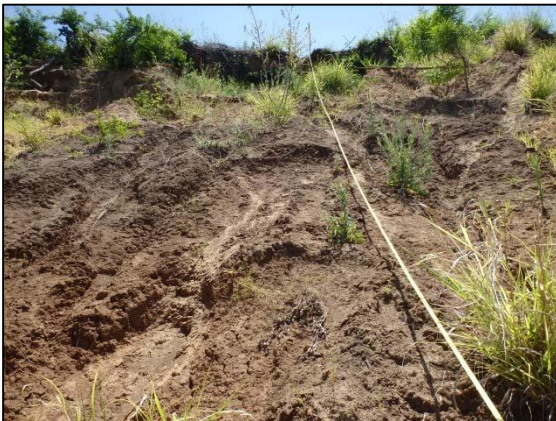
**PHOTO:** UB7R15(iii)

Photo taken at Segment 5 of Transect 1, looking (upslope) along transect towards top of slump.

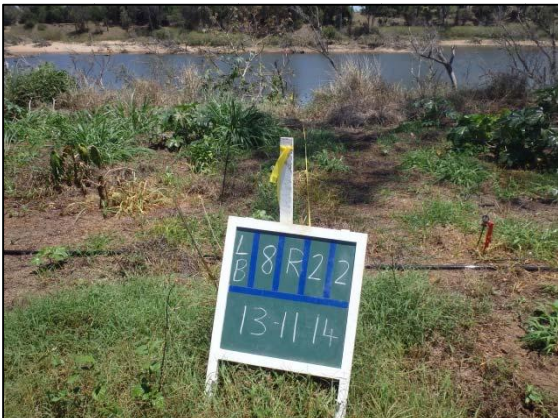
**PHOTO:** UB7R22(i)

Photo taken at Segment 2 of Transect 2, looking (downslope) towards river. Photo point is at edge of revegetation area.

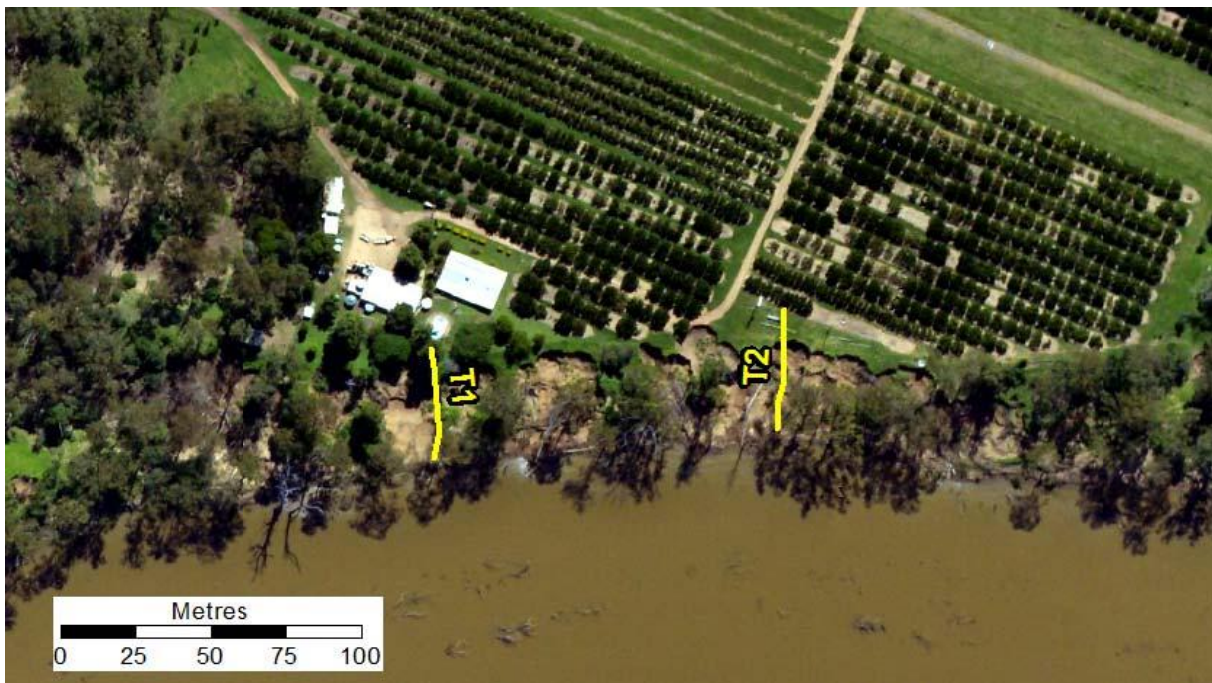
### Post-Flood Image

Floodwaters covered 75% of property (water through house approximately 0.5m high). Damage to infrastructure; and loss of equipment and 300 citrus trees. Significant slumping along riverbank (including both monitoring sites).

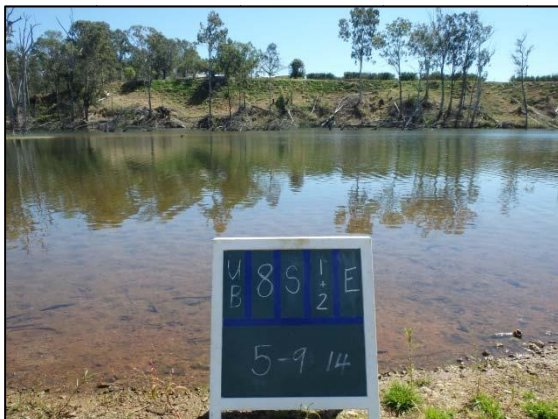
**PHOTO:** UB8S1&2E

Photo taken from opposite site of bank, looking north at Transects 1 and 2.

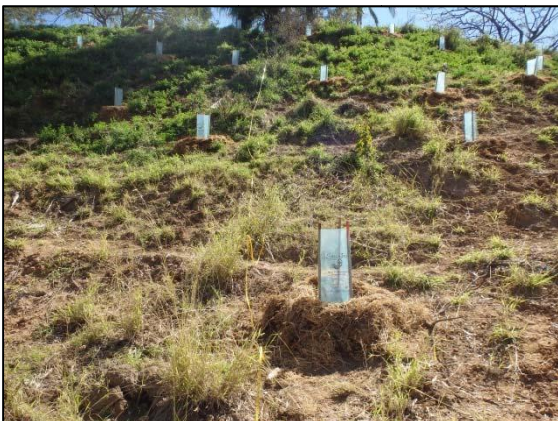
**PHOTO:** UB8R14(iii)

Photo taken at Segment 4 of Transect 1, looking (upslope) north along transect.

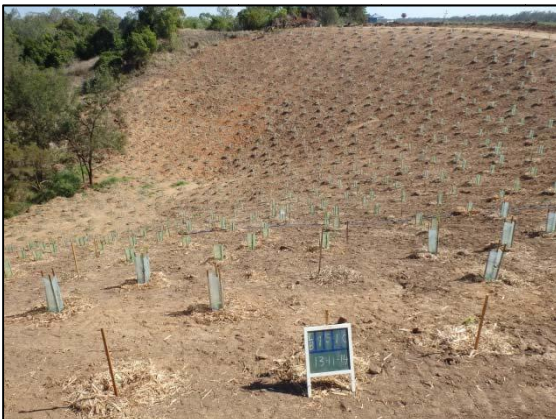
**PHOTO:** UB9S1C

Photo taken from northern side of site, looking south across the site.

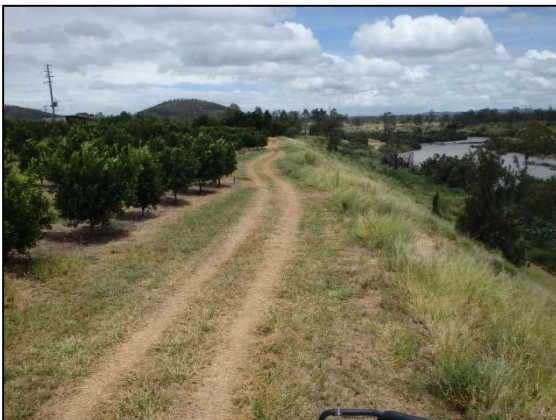
**PHOTO:** UB10S1x

Photo taken at Segment 2 of Transect 1 (from on top of vehicle) looking west (upstream) towards Transect 2.

Post-flood earthworks were undertaken by the landholder (date unknown) prior to project commencement. Project works included weed treatment, further battering to reduce slope steepness (completed September 2014) and revegetation (completed October 2014). Secondary planting was required in January 2015 to replace 60% of plants, which had died due to hot, dry weather in December (and low water holding capacity of the sandy soil). Planned maintenance regime is unknown.

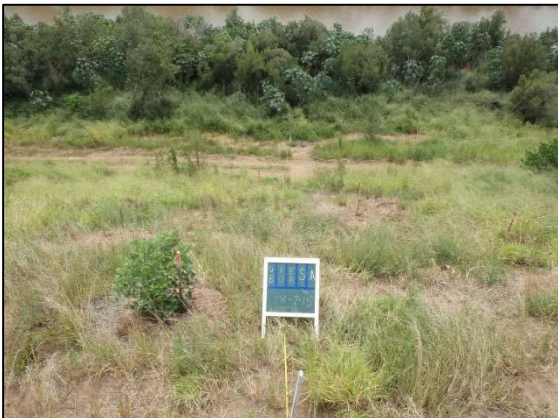
**PHOTO:** UB10S2A

Photo taken at Segment 2 of Transect 1 (from on top of vehicle), looking along transect (downslope) towards the river.

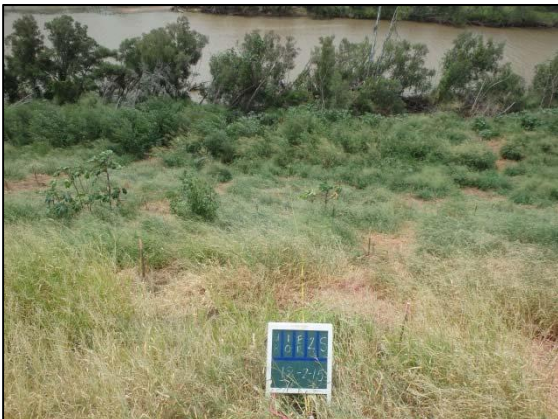
**PHOTO:** UB10S2A

Photo taken at Segment 2 of Transect 2 (from on top of vehicle), looking along transect (downslope) towards the river.
