16.1 Pilot Transfer Arrangements – Marine Notice 04/2023

MARINE NOTICE

Marine Notice 2023/04
Supersedes 2022/03

Pilot transfer arrangements

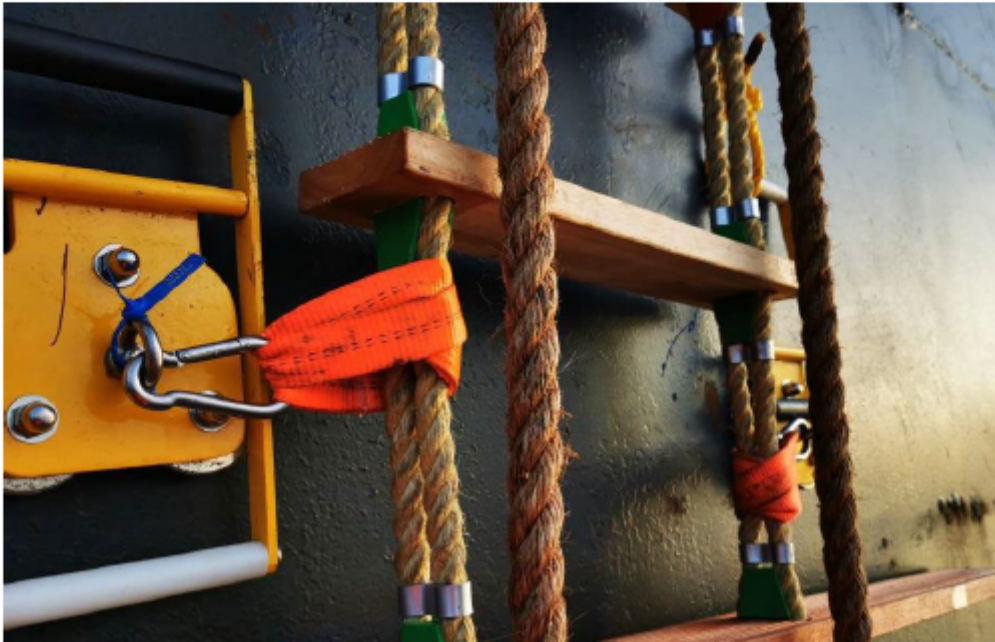
When using a combination pilot ladder arrangement, the pilot ladder and accommodation ladder are required to be secured to the ship's side. A common means of securing both the pilot ladder and accommodation ladders is with magnetic pads (refer to photo 1 below as an example).

Photo 1: Example of securing both the pilot ladder and accommodation ladders with magnetic pads (Reproduced with permission from Fremantle Ports).

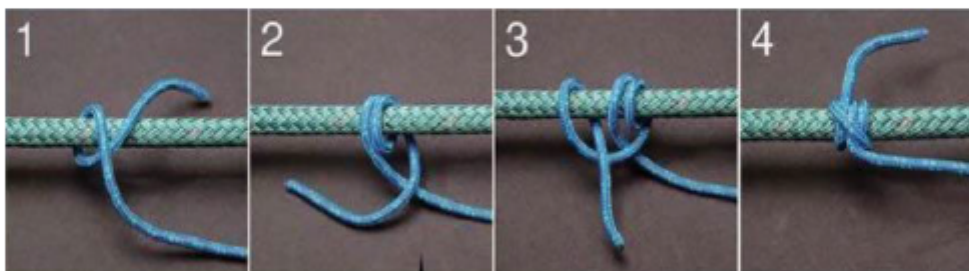
Photo 6: The rolling hitch knot. (Reproduced with permission from Fremantle Ports).

It is suggested that two strong (at least 2 x 24 kN) manila ropes be used to secure the pilot ladder. Photo 6 illustrates a method of tying a rolling hitch knot.

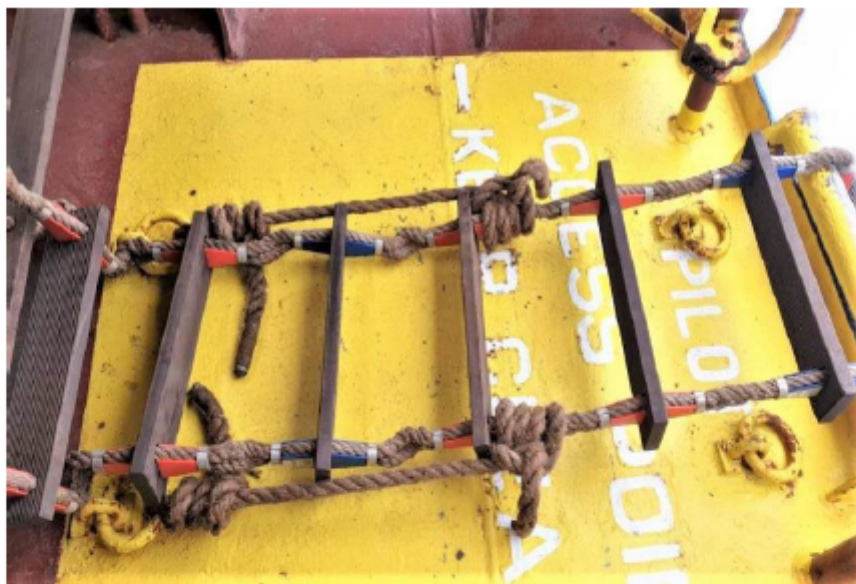
Photo 7 provides an example of rolling hitch knots being used to secure pilot ladders to approved main deck strong points.

Photo 7: Rolling hitch knots being used to secure pilot ladders to approved main deck strong points (Reproduced with permission from Fremantle Ports).

It is common industry practice to use a rope stopper usually in the form of a rolling hitch knot between the pilot ladder sides ropes and the approved strong point on the main deck. This will transfer the weight of the ladder arrangement directly onto the designated strong point and will not damage the ladder.

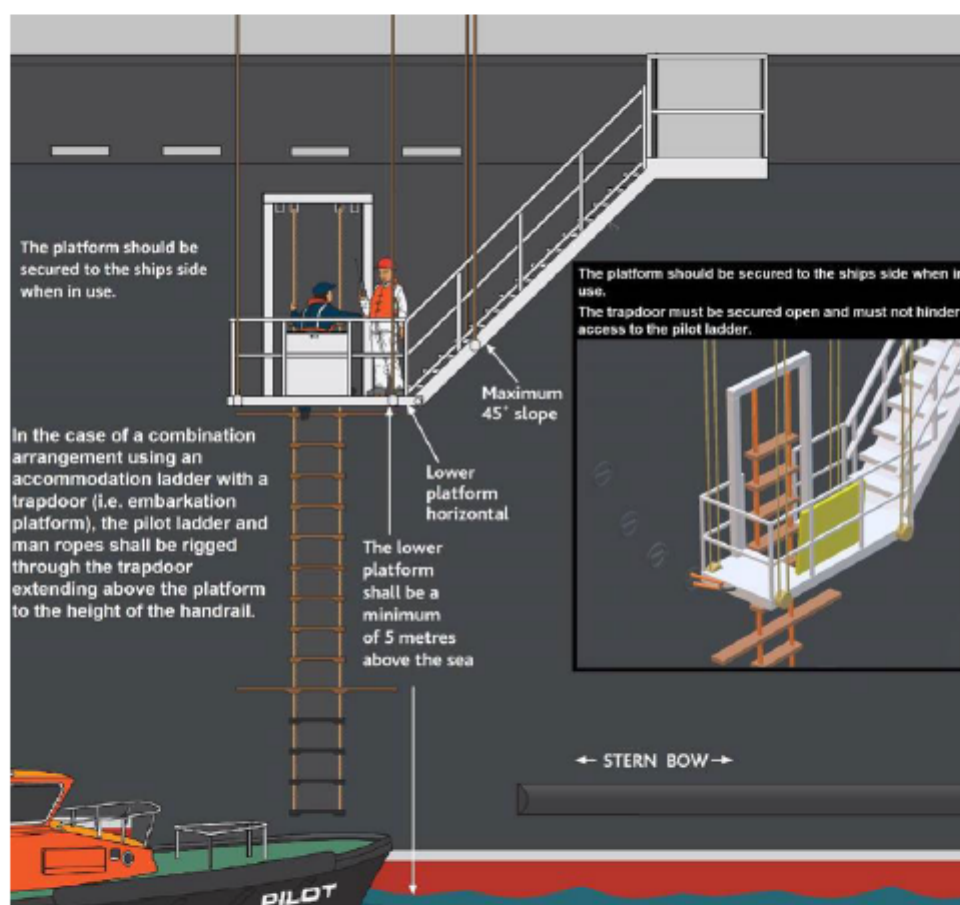
There has been an increase in ships fitted with trapdoor arrangements. The additional requirement for their use is "the pilot ladder and man ropes shall be rigged through the trapdoor extending above the platform to the height of the handrail".

Figure 1: Pilot card depicting trap door arrangements.
