Resources Safety & Health  
Queensland

# 2020 Level 1 exercise

Held at Moranbah North coal mine

Monday 6 December 2020

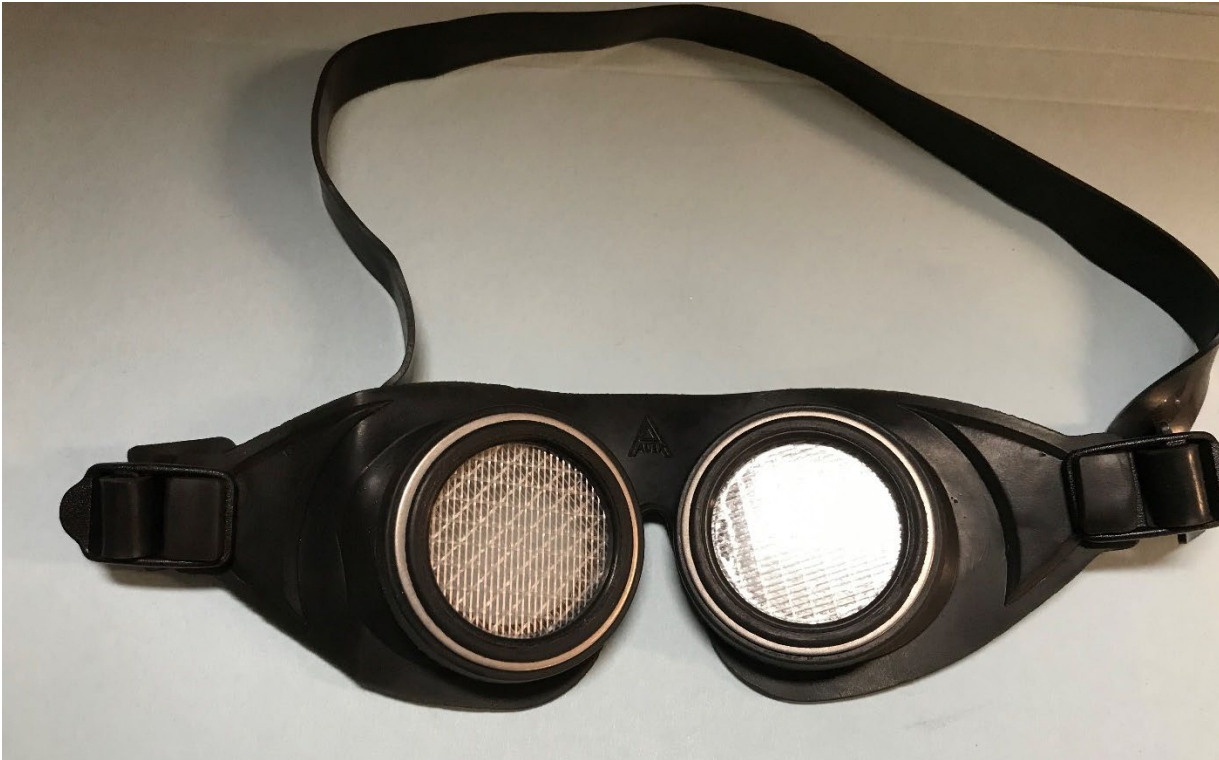
*Figure 3 Smoke goggles*

real emergency, the securing of the face would not have continued. The briefing notes for the assessors are included in the appendices at *Briefing notes for Assessors*. The explosion risk zone controller (ERZ controller/deputy) instructed his CMWs to don the training SCSRs and smoke goggles provided (see Figure 3) and proceeded to assist them. He stated his intentions were to get the CMWs under SCSR and then proceed out into the travel road and then inbye to the fresh air from the end of panel shaft and contact the control room.

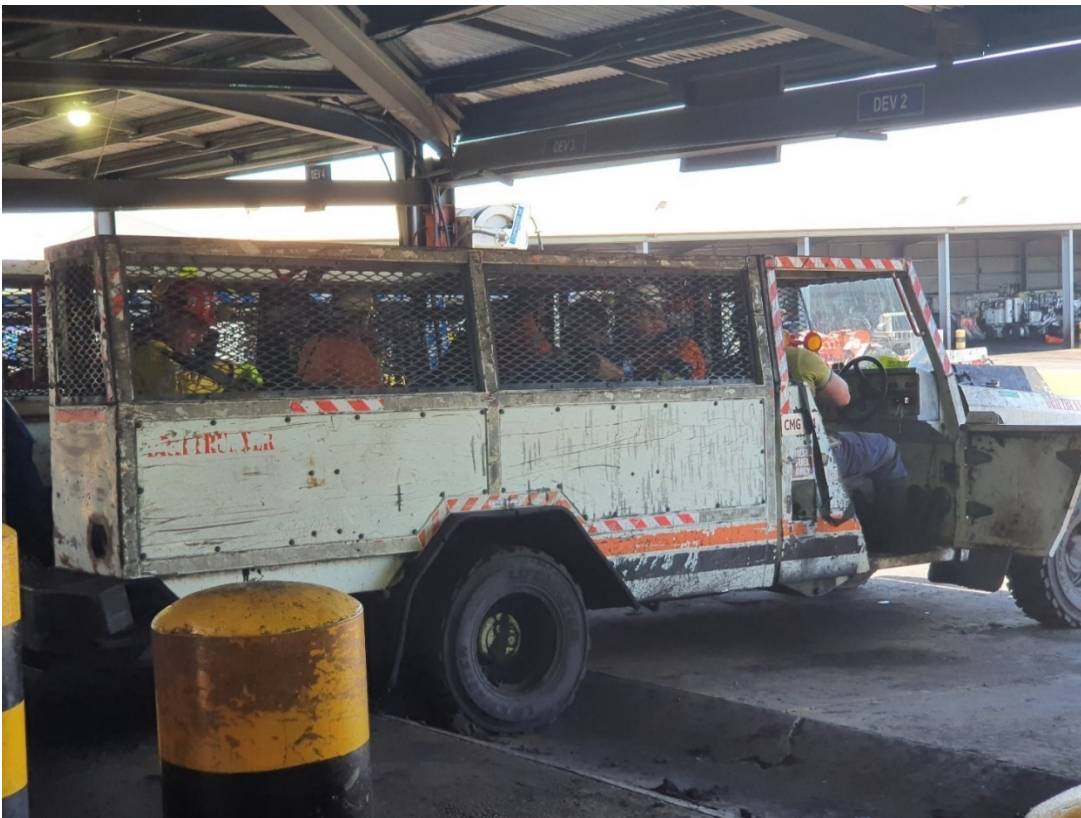
*Figure 4 Image of Drift runner on the surface*

1. There was only one vehicle in the panel which could not accommodate the full crew.
2. There was a delay in starting the vehicle as it was out of air and required multiple deputy resets due to a false methane trip. This was reported as a regular issue with this vehicle.
3. The CMWs successfully evacuated via the appropriate escapeways while consistently and monitoring their CABA pressures at each CABA refill station on the way out. After challenging some of the CMWs on CABA duration and escapeways, it identified gaps in CABA training and familiarisation with outbye refill stations.
4. During the refill process, it was also identified the need for better communication systems as the phone at the refill station could not contact control.

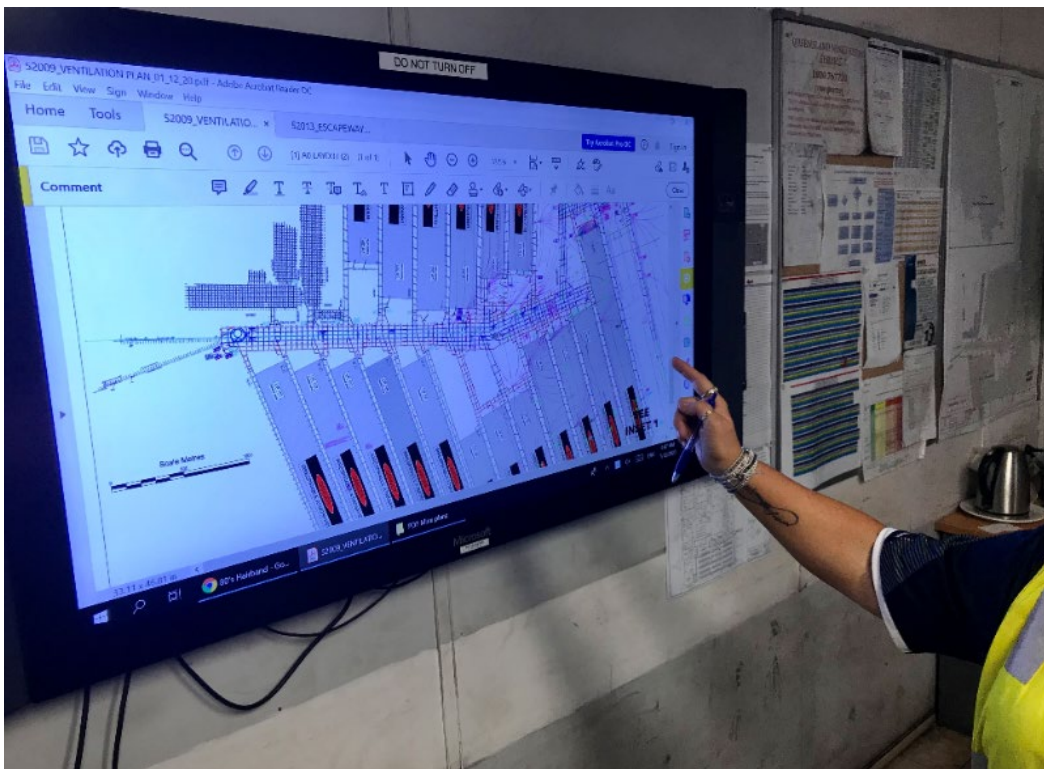
Figure 8 control room touch screen display

5. The control room had a large touchscreen with the latest ventilation plan on display, which proved to be very useful in the first hour of the emergency when analysing which CO sensors were in alarm and the ventilation system (see Figure 8).
