# Report: 2021 Level 1 emergency exercise

Exercise date: Tuesday 26 October 2021

Exercise location: Oaky North Coal Mine

Report author: Geoff Nugent, Inspector of Coal Mines &

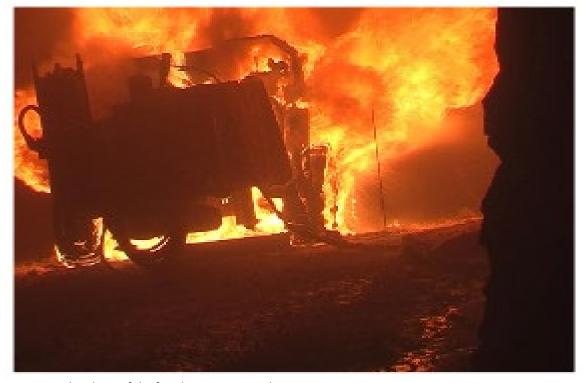
Figure 4 The photo of the fire shown to responders

Assessor Note: Fire fighters are using blue high expansion drums of foam which do not seem to be very effective. The fire had burnt through the pipe work inbye but this was not identified for some time

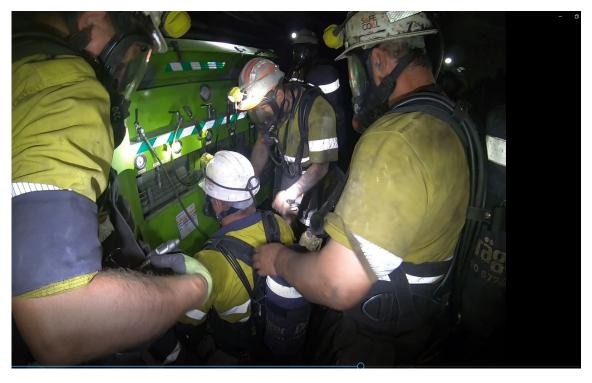
Figure 6 MG 705 crew connecting incapacitated CMW to CABA refill station

- Self-escape training should provide varied physical activities when wearing breathing apparatus to provide experience and knowledge for CMWs to understand their physical and equipment limitations.
- Self-escape training should include more regular desktop exercise analysis with diverse scenarios including potential aided escape situations for incapacitated crew members.

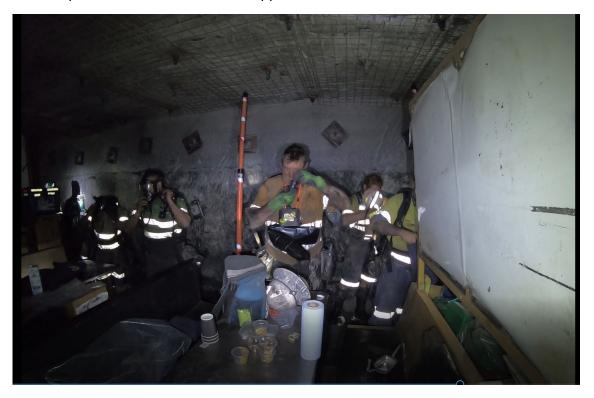
Figure 7 LW705 crew donning CABA and SCRSs at crib room

Increased training if SCSR/CABA/Fire and first response – the donning of equipment was good in this group however willingness to assist in rescue/ firefighting was minimal (which is assumed due to lack of confidence/competence)

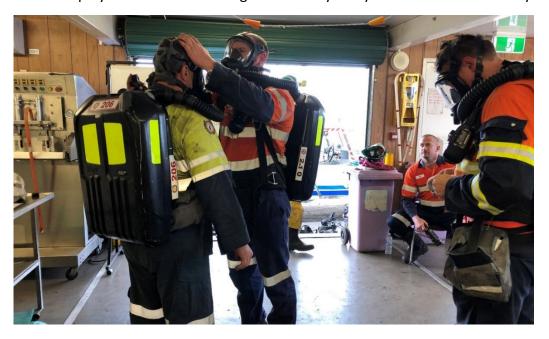
Figure 8 QMRS Surface Captain Checks of Team Member

- All rescue team members to confirm they have adequate personal equipment such as helmets, cap lamp belts etc available to respond to an emergency either from home, camp, or site. Ensure QMRS rescue team member identification is also available.

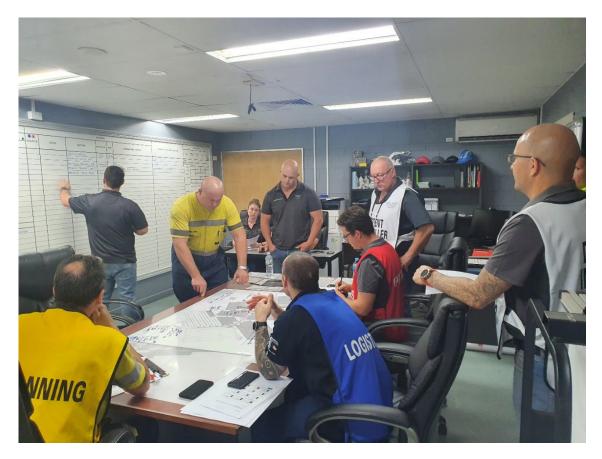
Figure 11 IMT room and meeting

- Implement a computerised incident management system to facilitate the communication of information in and out of the IMT.
- QMRS to review their process to ensure suitability qualified personnel are deployed to respond to emergencies, alternate positions must be adequately supported.
