Level 1 Mine Emergency Exercise 2019

Cook Colliery

25 September 2019

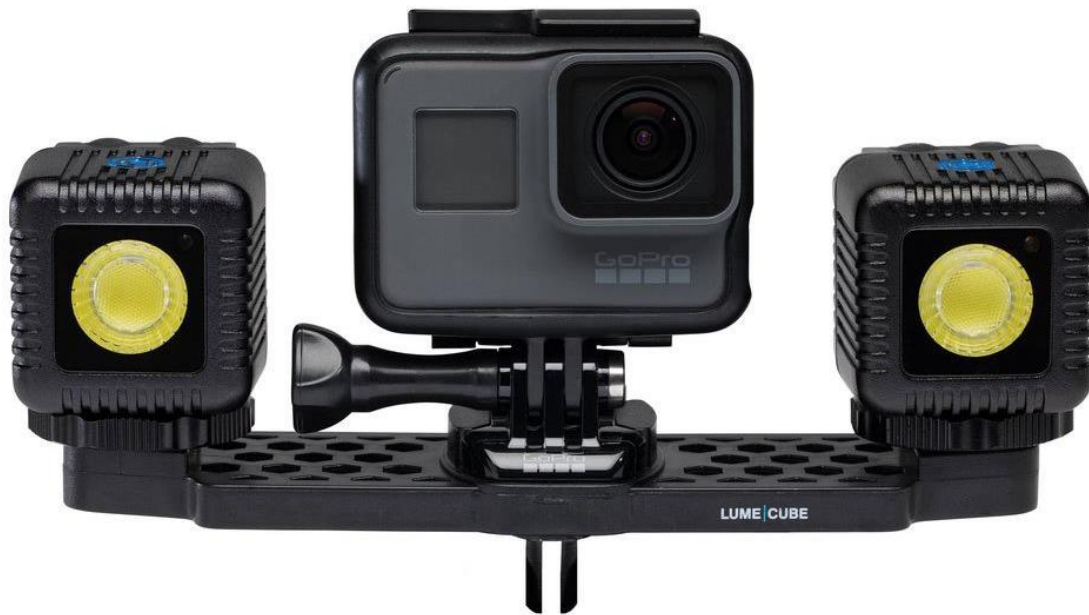
Figure 5 GoPro and Lume Cube equipment

Evacuation video footage was taken using a GoPro camera and a Lume Cube lighting system. (See *Figure 5*). The footage is used:

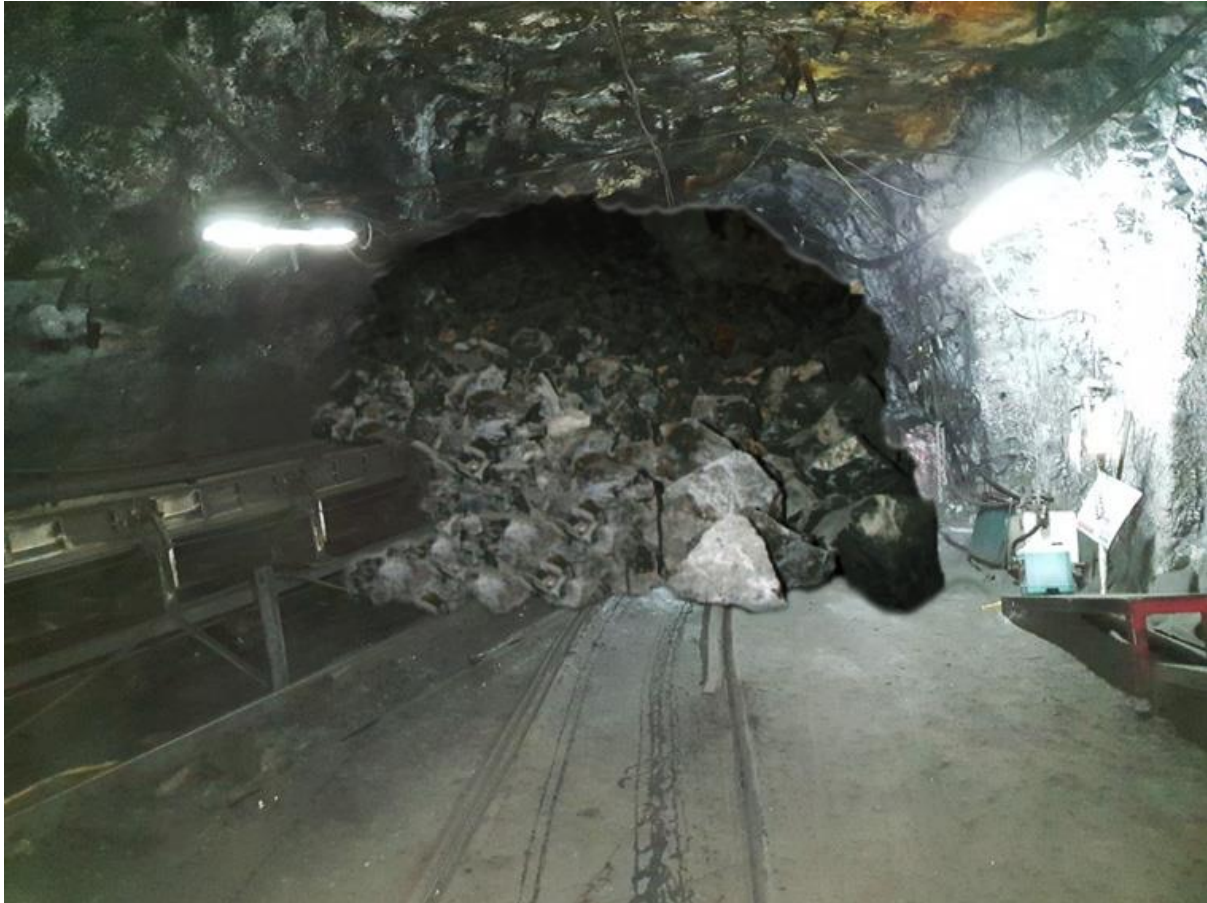
Figure 6 Roof fall at the bottom of the dolly car drift

At 14:55, the UM were informed that an inspection of the weigh station and transfer point of the drift belt was required (*see Figure 6*). Two ERZCs went to the area and discovered a substantial roof fall at pit bottom which was restricting ventilation. This had also damaged a 4 inch water pipe. The pipe was then isolated, the area demarcated, and the relevant information was passed on to CRO at 15:15.

The mine was conducting critical maintenance on the dolly car winder. This impacted on the underground CMWs escape plan and they went straight to the secondary shaft winder and did not see the 'fall' in the main drift, (See Figure 6). This fall was not recognised until late in the exercise. This would have had an impact on any risk assessment for mine re-entry as the mine was effectively in single entry conditions.

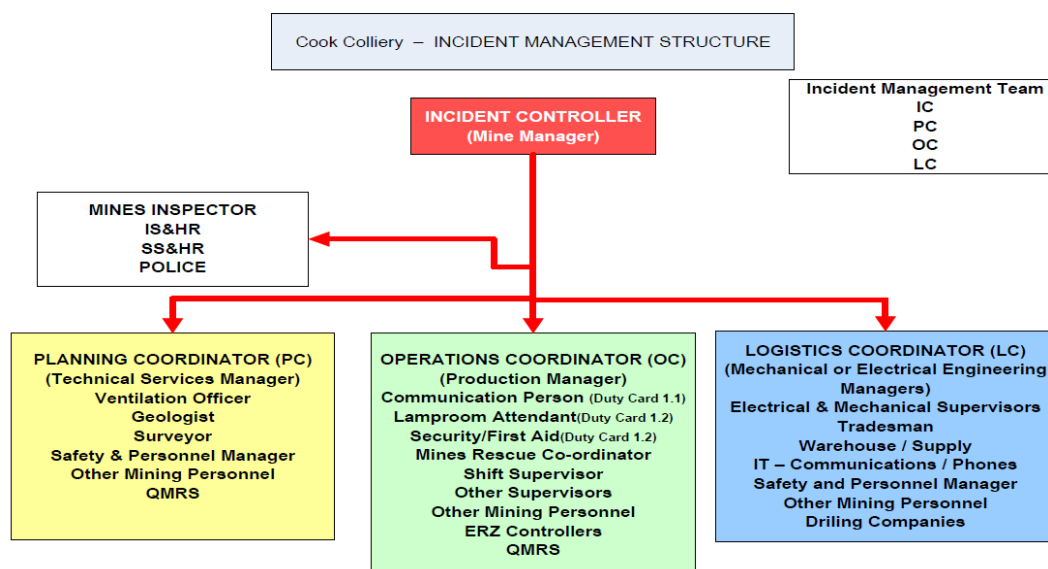
Figure 7 Cook Colliery Incident Management Structure

Cook Colliery uses the Mine Emergency Management System (MEMS) for emergency response. MEMS was developed by Queensland Mines Rescue Service (QMRS) to provide an outline and structure for mines to coordinate their emergency response. The system is based on the Australasian Inter-service Incident Management System (AIIMS 2017). See Figure 7.
