Compliance Report

Coomera Connector Stage 1 - EPBC 2020/8646, 18 March 2024 – 17 March 2025

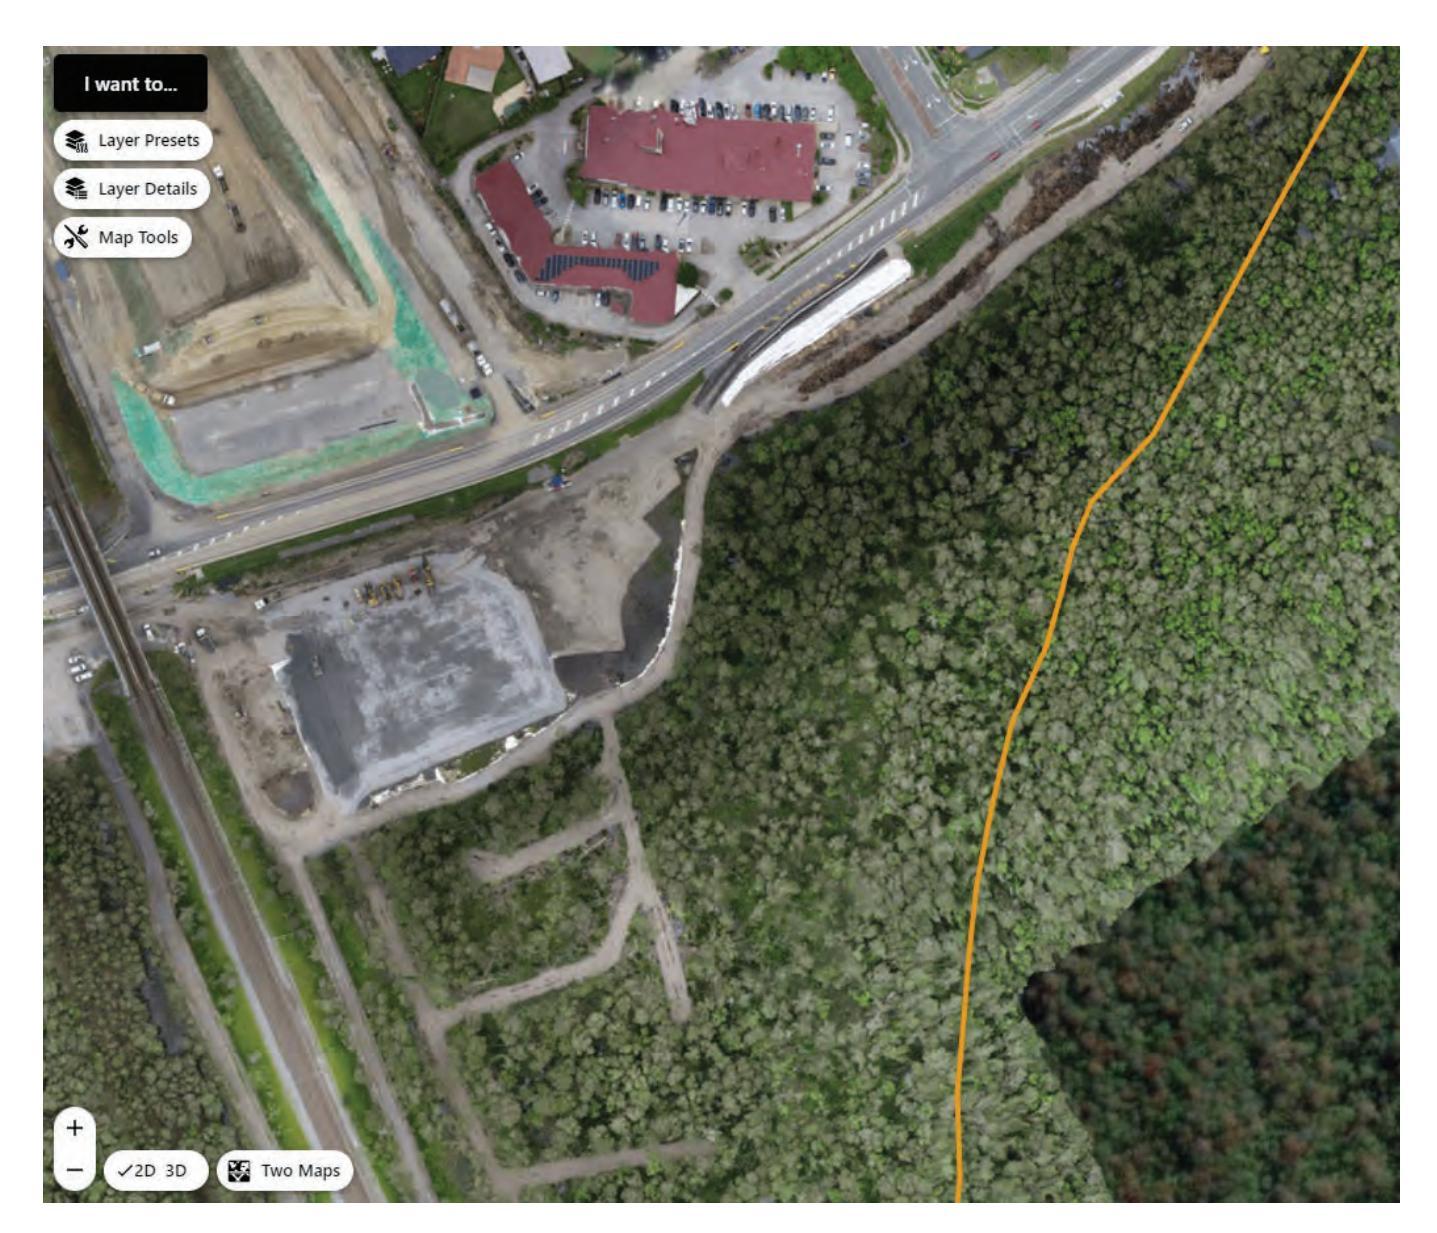
Figure 1: Aerial view of Helensvale Road before storm

The North package experienced vegetation damage south of Helensvale Road both within, and outside of the corridor. Images of before and after the storm below show the extent of damage.

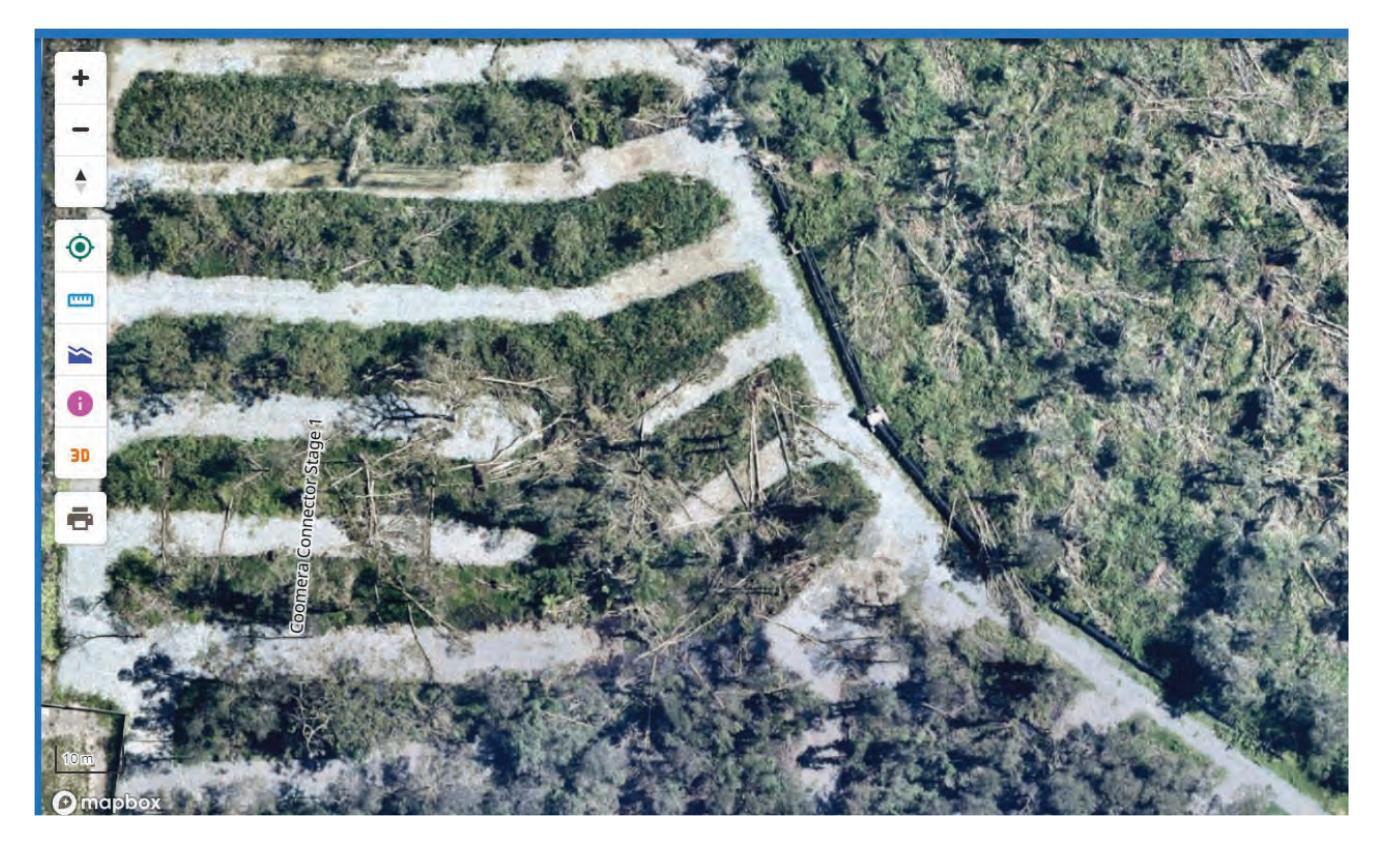
Figure 4: Aerial view of Gold Coast Highway vegetation damage zoomed in

The Central package experienced vegetation damage north of Gold Coast Highway, both within and outside of the corridor. Images after the storm below (28 December 2023) show the extent of damage.

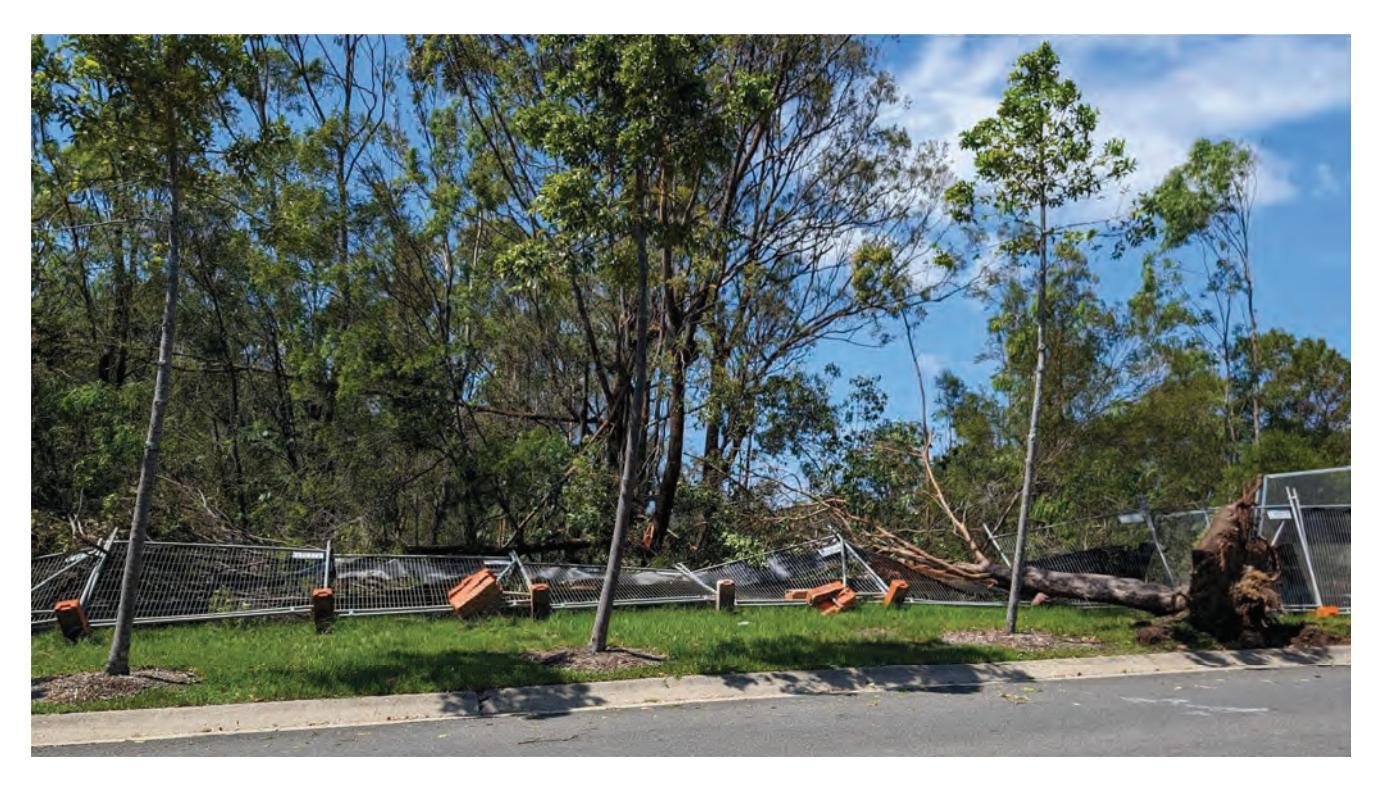
Figure 5: Post-storm damage to fencing/vegetation, Ridgevale Drive, north side

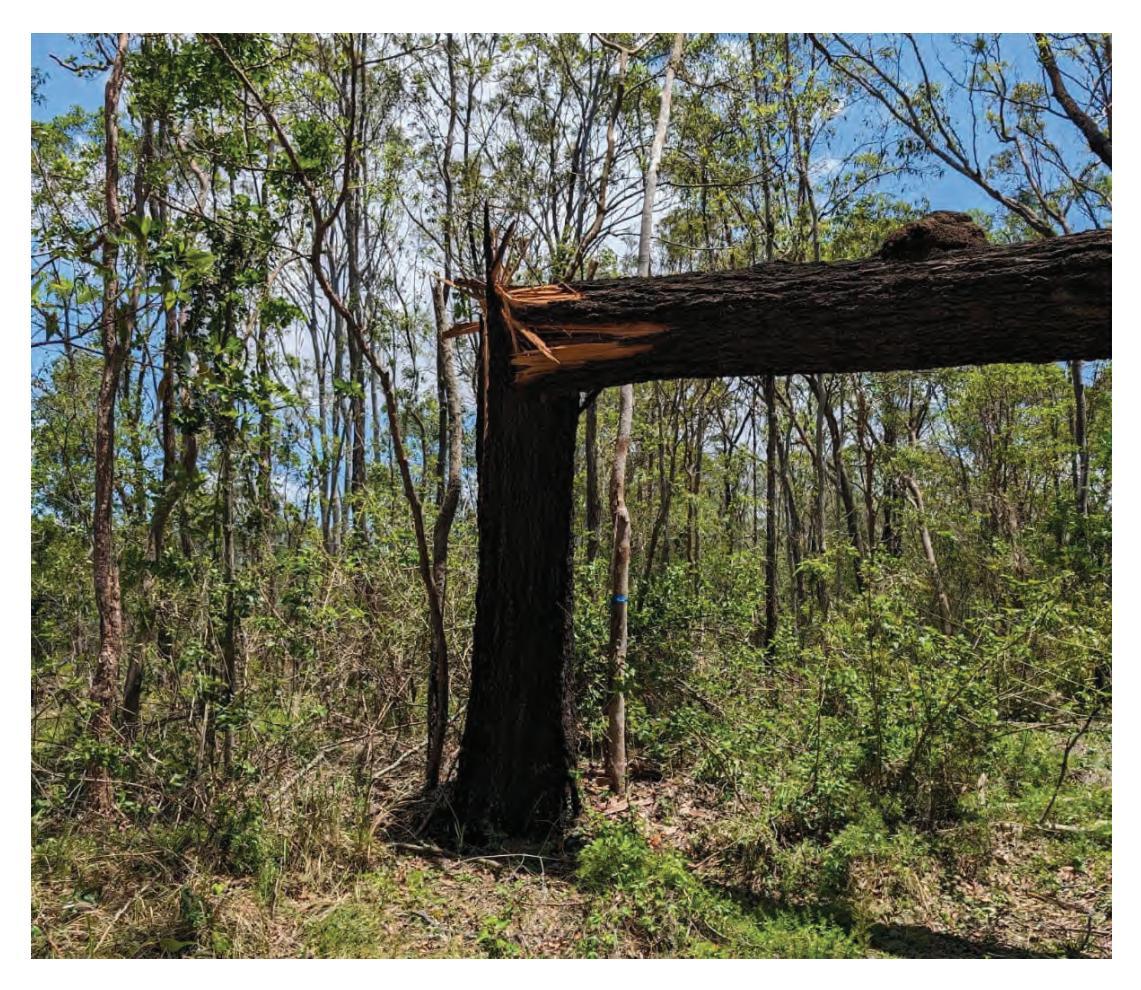
Figure 6: Post-storm vegetation damage on site, Ridgevale Drive north side

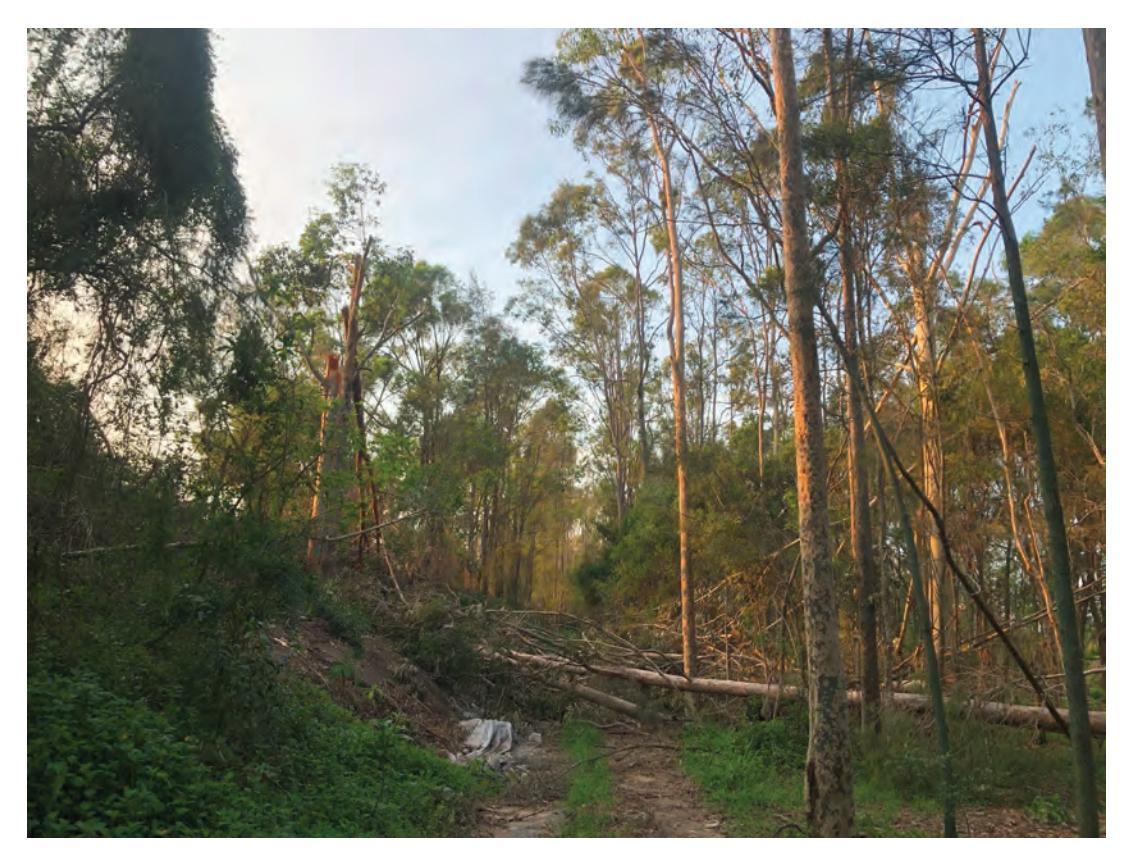
Figure 7: Post-storm vegetation damage on site, Ridgevale Drive south side

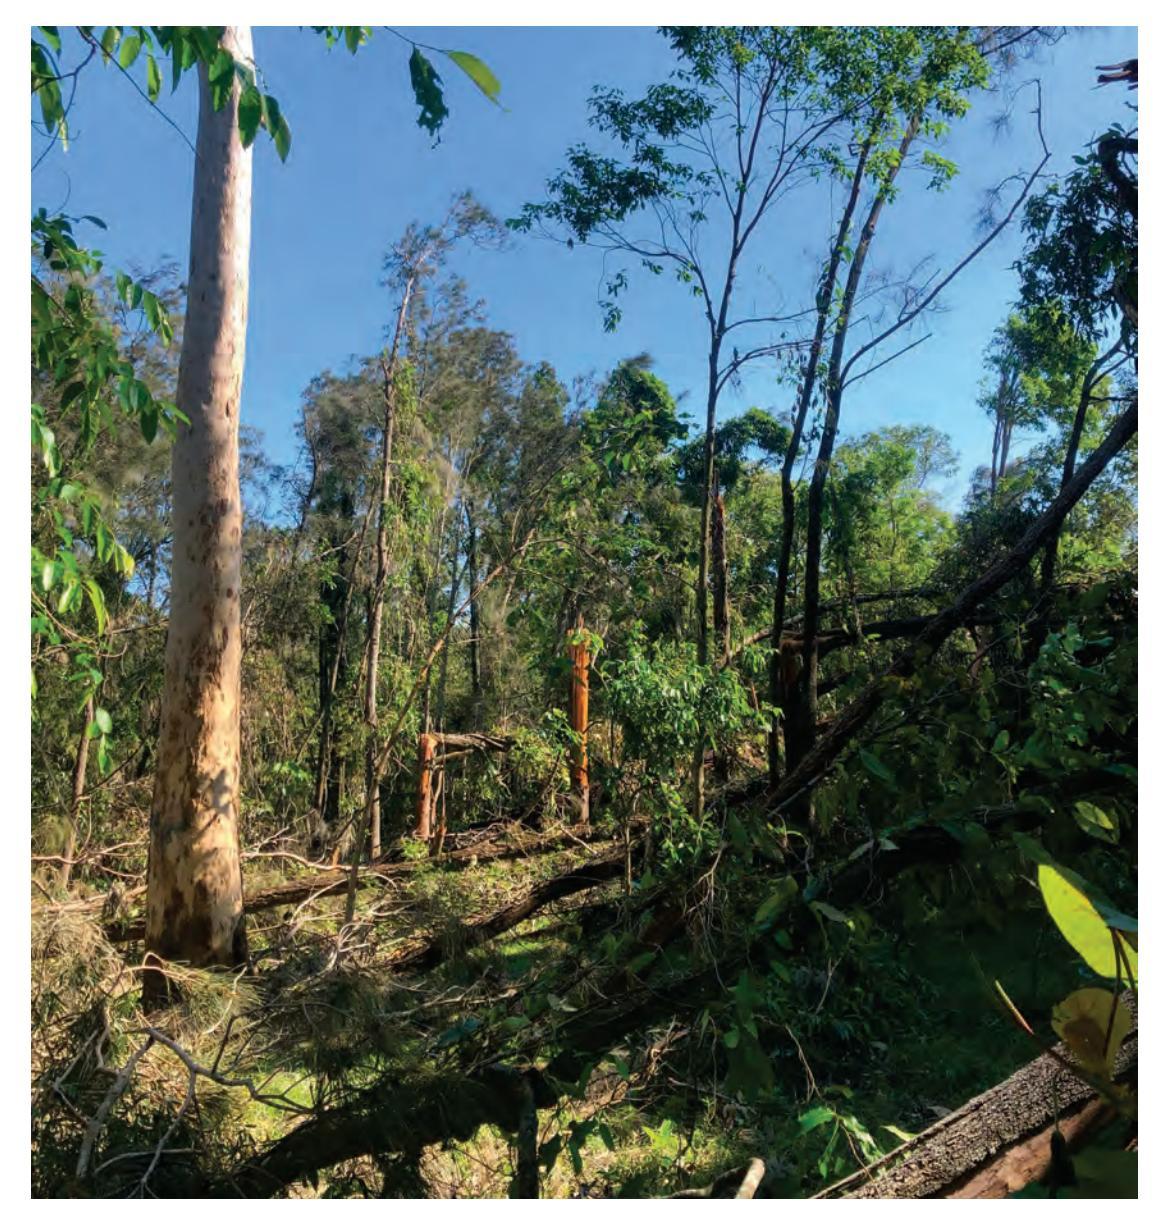
Figure 8: post-storm vegetation damage on site, Ridgevale Drive north side.

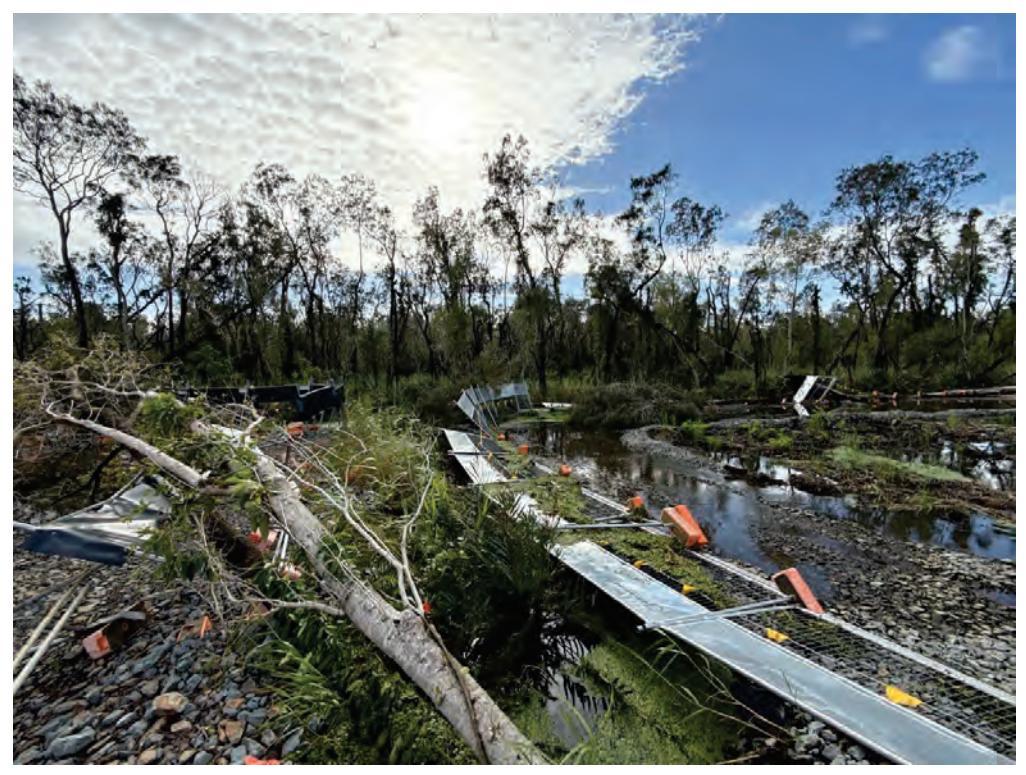
Figure 1: Post cyclone Alfred vegetation damage and temporary koala fencing damage near Helensvale Road.

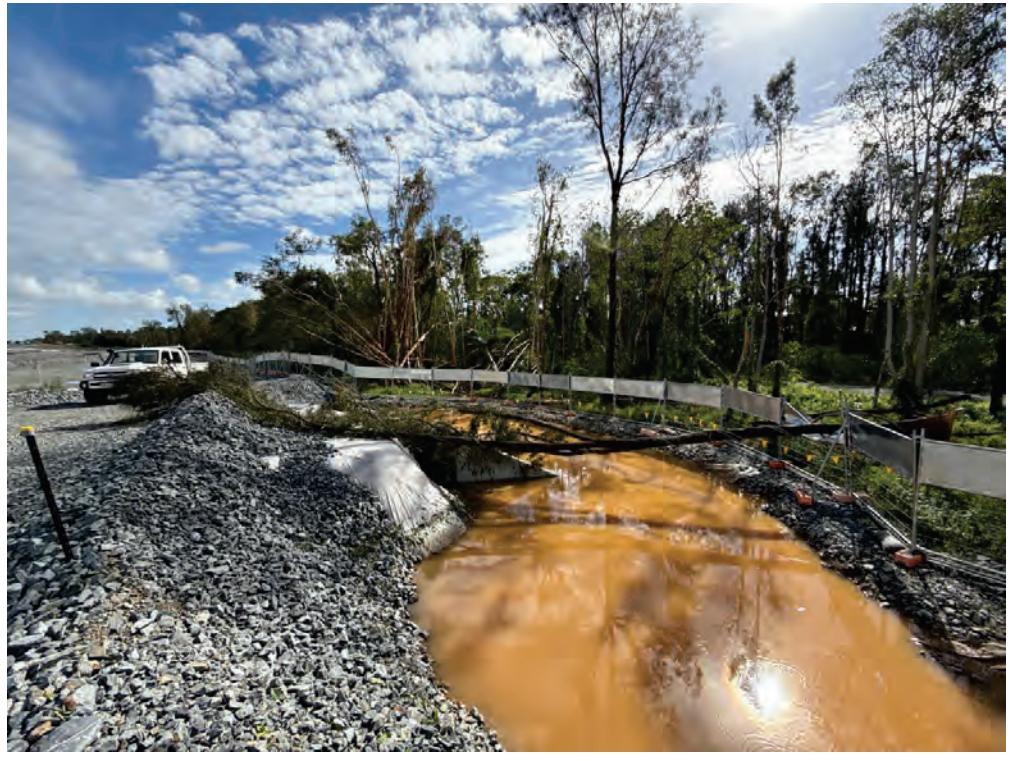
Figure 2; Post cyclone Alfred evidence of fallen vegetation near Ridgevale Drive. Compliance Report – Coomera Connector Stage 1 - EPBC 2020/8646, 18 March 2024 – 17 March 2025

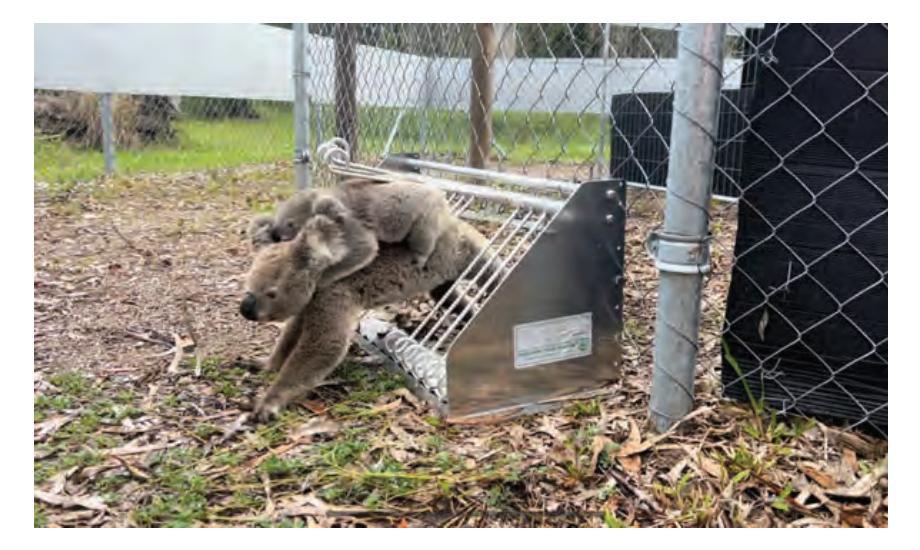
Figure 1. Female and back rider joey koalas demonstrating movement through the traditional fauna escape hatch (360mm x 1200mm)

Since 2021, comprehensive trials at Endeavour Veterinary Ecology's Toorbul facilities have evaluated the effectiveness of structures designed to facilitate safe koala movement across roadways. Three structures were trialled: the koala escape pole, Koala Valve and a push-under Fauna Escape Hatch (FEH). The Phase 1 findings released in mid-2024 revealed that while koalas showed no device preference, the Fauna Escape Hatch) had a 100% success rate use whenever encountered by koalas. Notably, these studies confirmed that the standard FEH successfully accommodate female koalas carrying back-riding joeys (Figure 1).

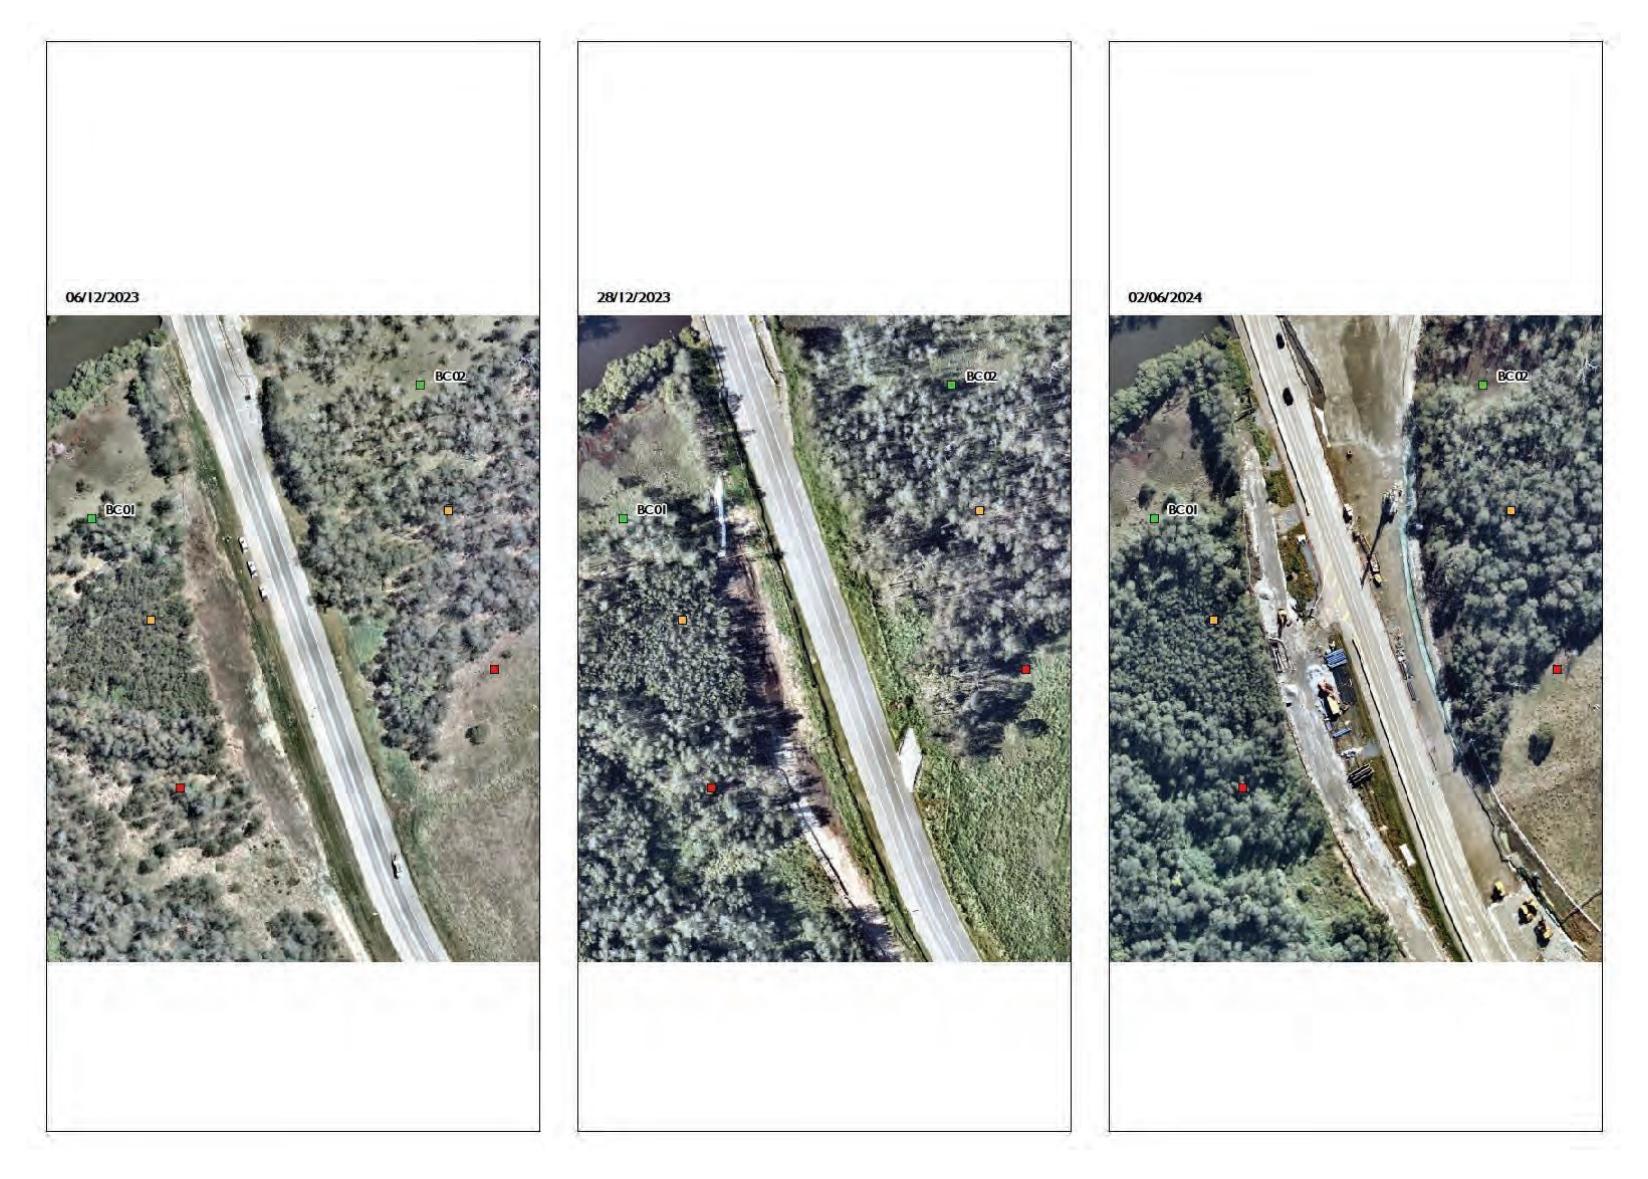
Figure 3-1 Timestamped aerial images of sites BC01 and BC02 before and after storms on Christmas Day 2023. Source: Nearmap.

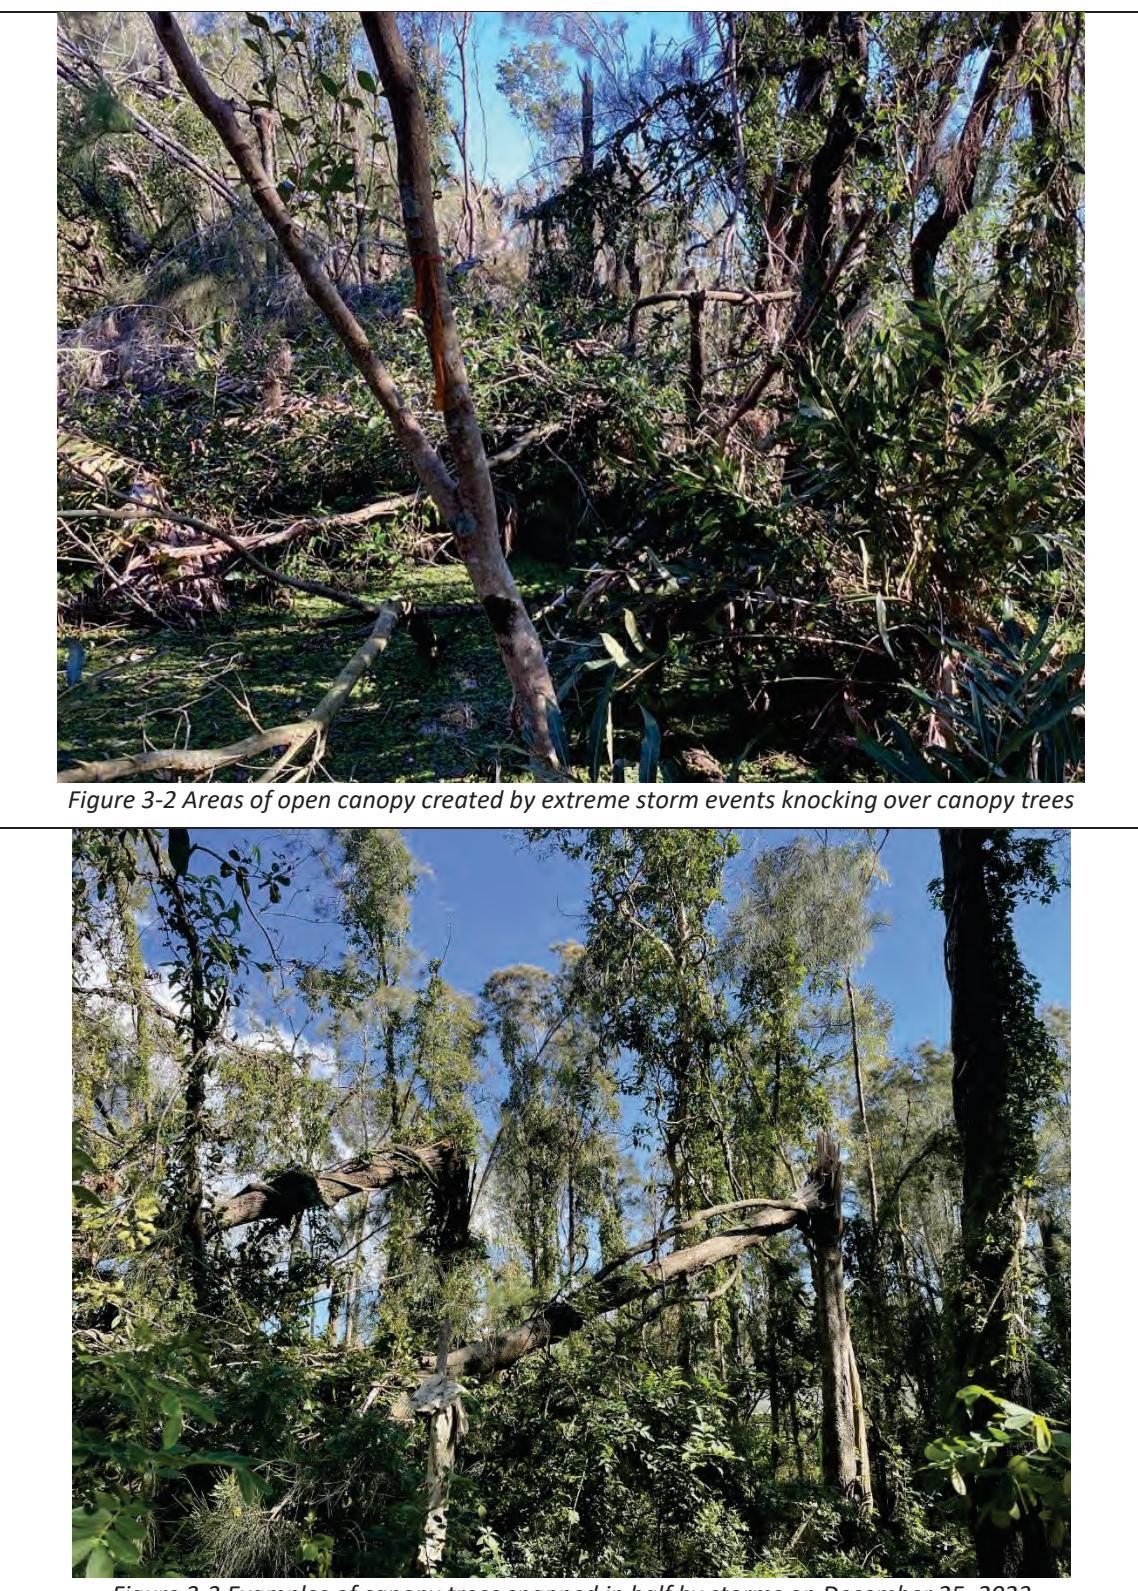
Figure 3-3 Examples of canopy trees snapped in half by storms on December 25, 2023

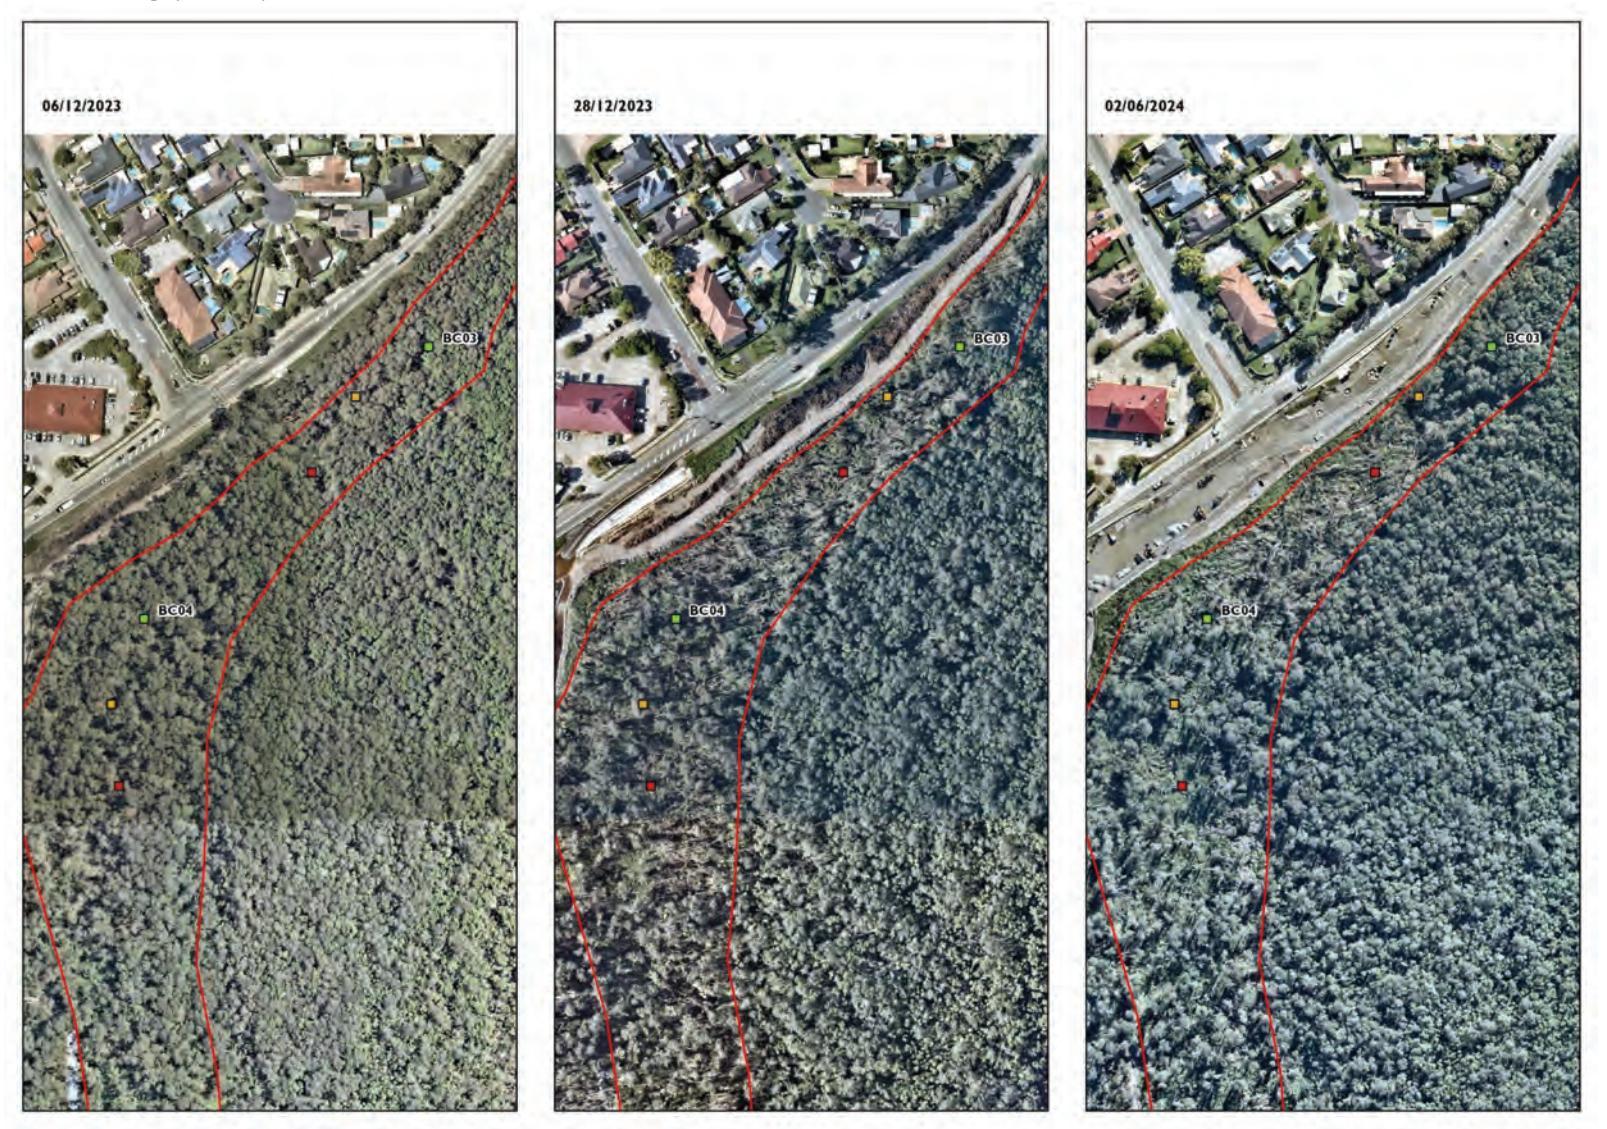
Figure 3-6 Timestamped aerial images of sites BC03 and BC04 before and after storms on Christmas Day 2023. Red boundary highlights mapped storm damage areas. Realigned transects can be seen in Appendix A. Source: Nearmap.

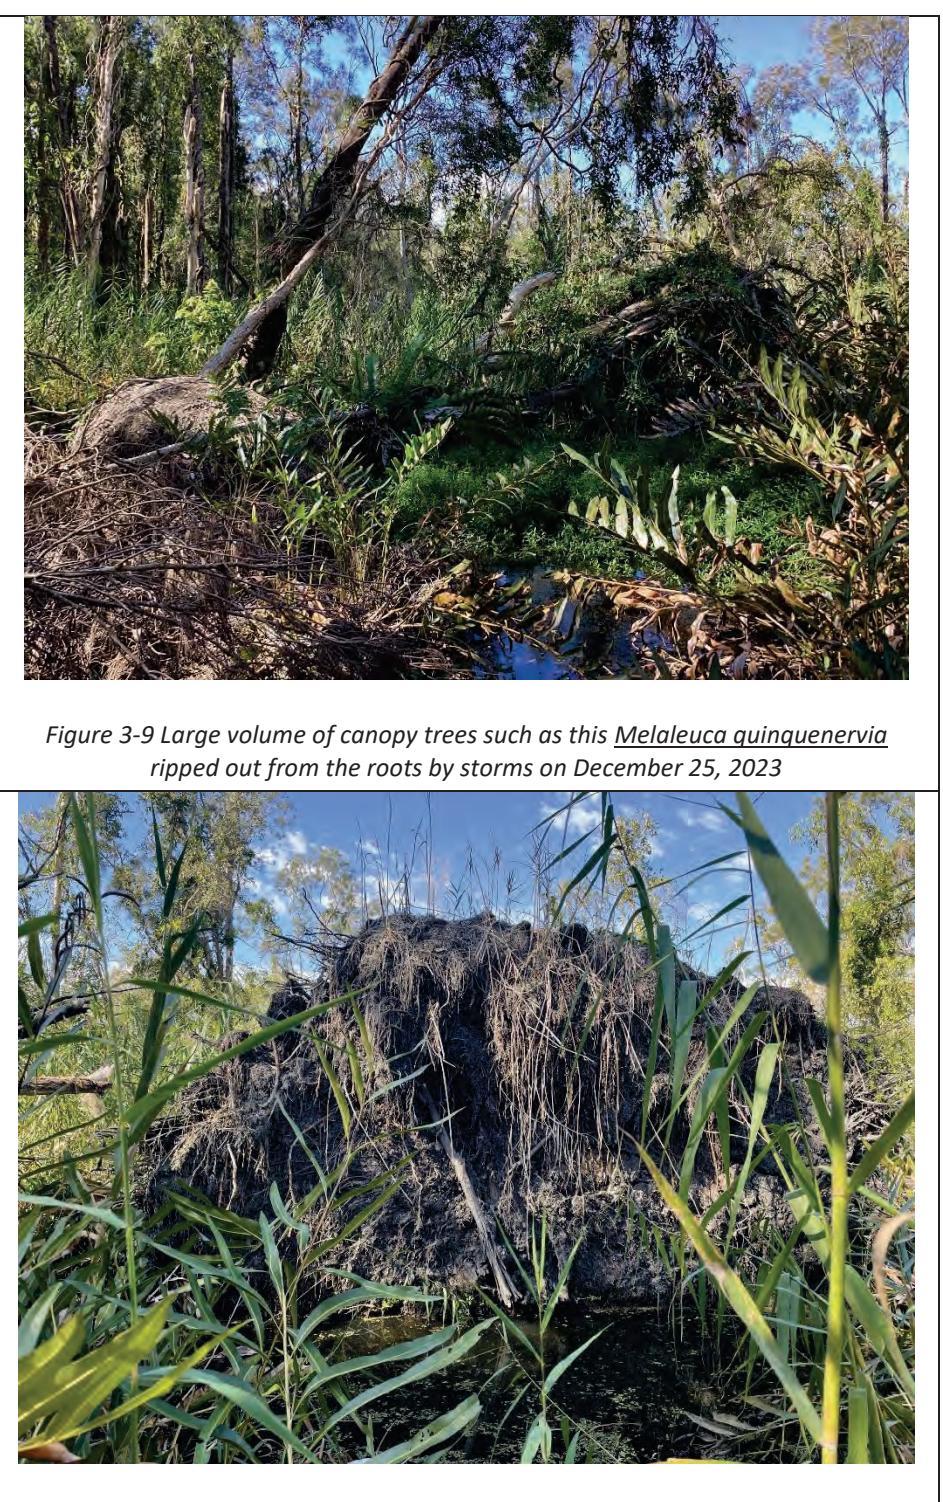
Figure 3-10 Entire root area ripped from the ground and leaving a large pool of water up to 1.5m deep. This tree would have qualified as a large non-eucalypt tree. These new pools are frequently colonised by the restricted weed <u>Salvinia molesta</u>

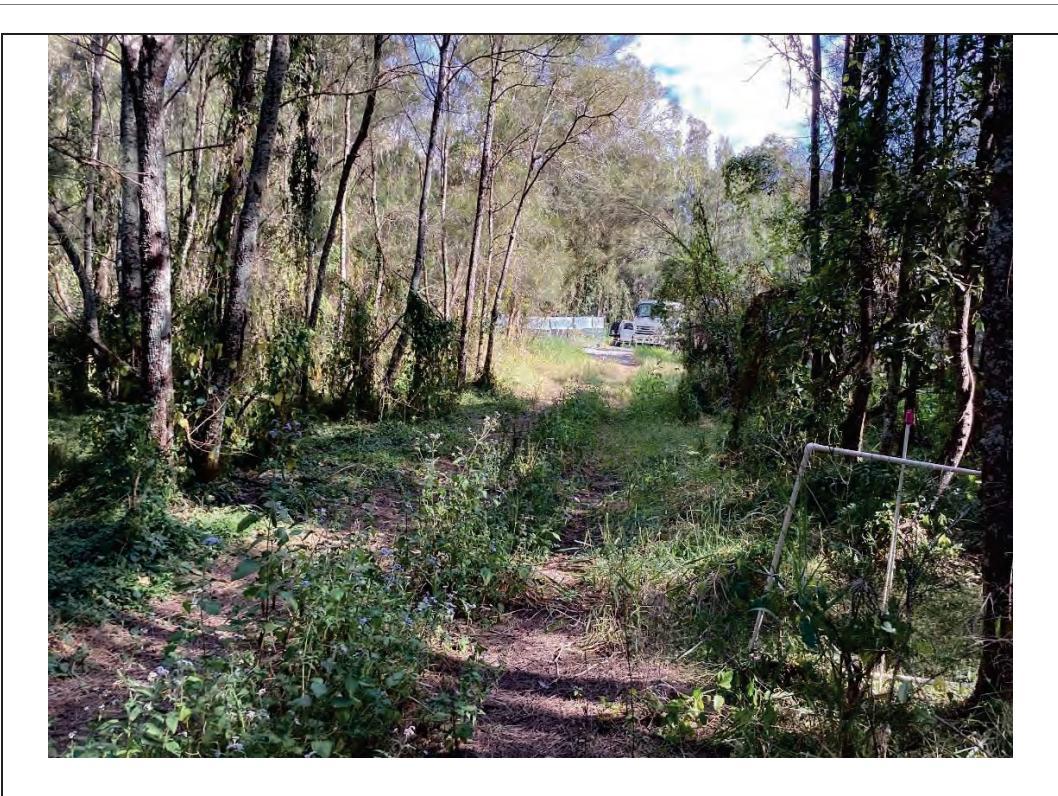
Figure 3-11 Access track running immediately behind the end of the transect with high volume of blue billy goat weed (<u>Ageratum houstonianum</u>)

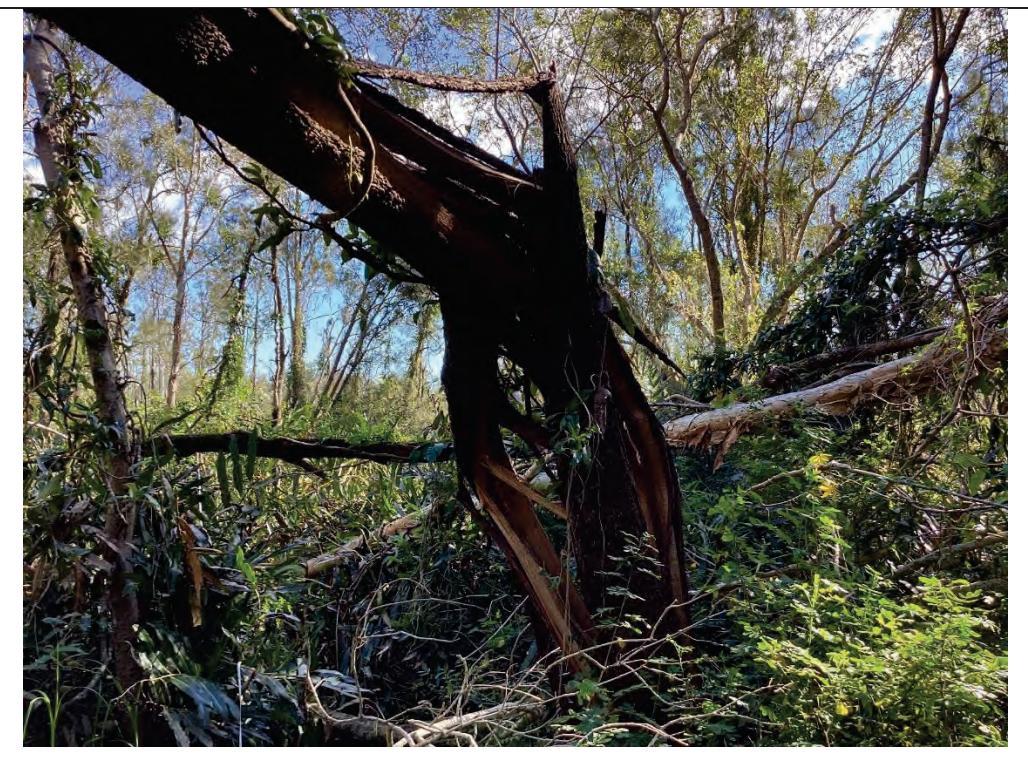
Figure 3-12 Evidence of potential large non-eucalypt trees snapped in half by storm damage on December 25, 2023

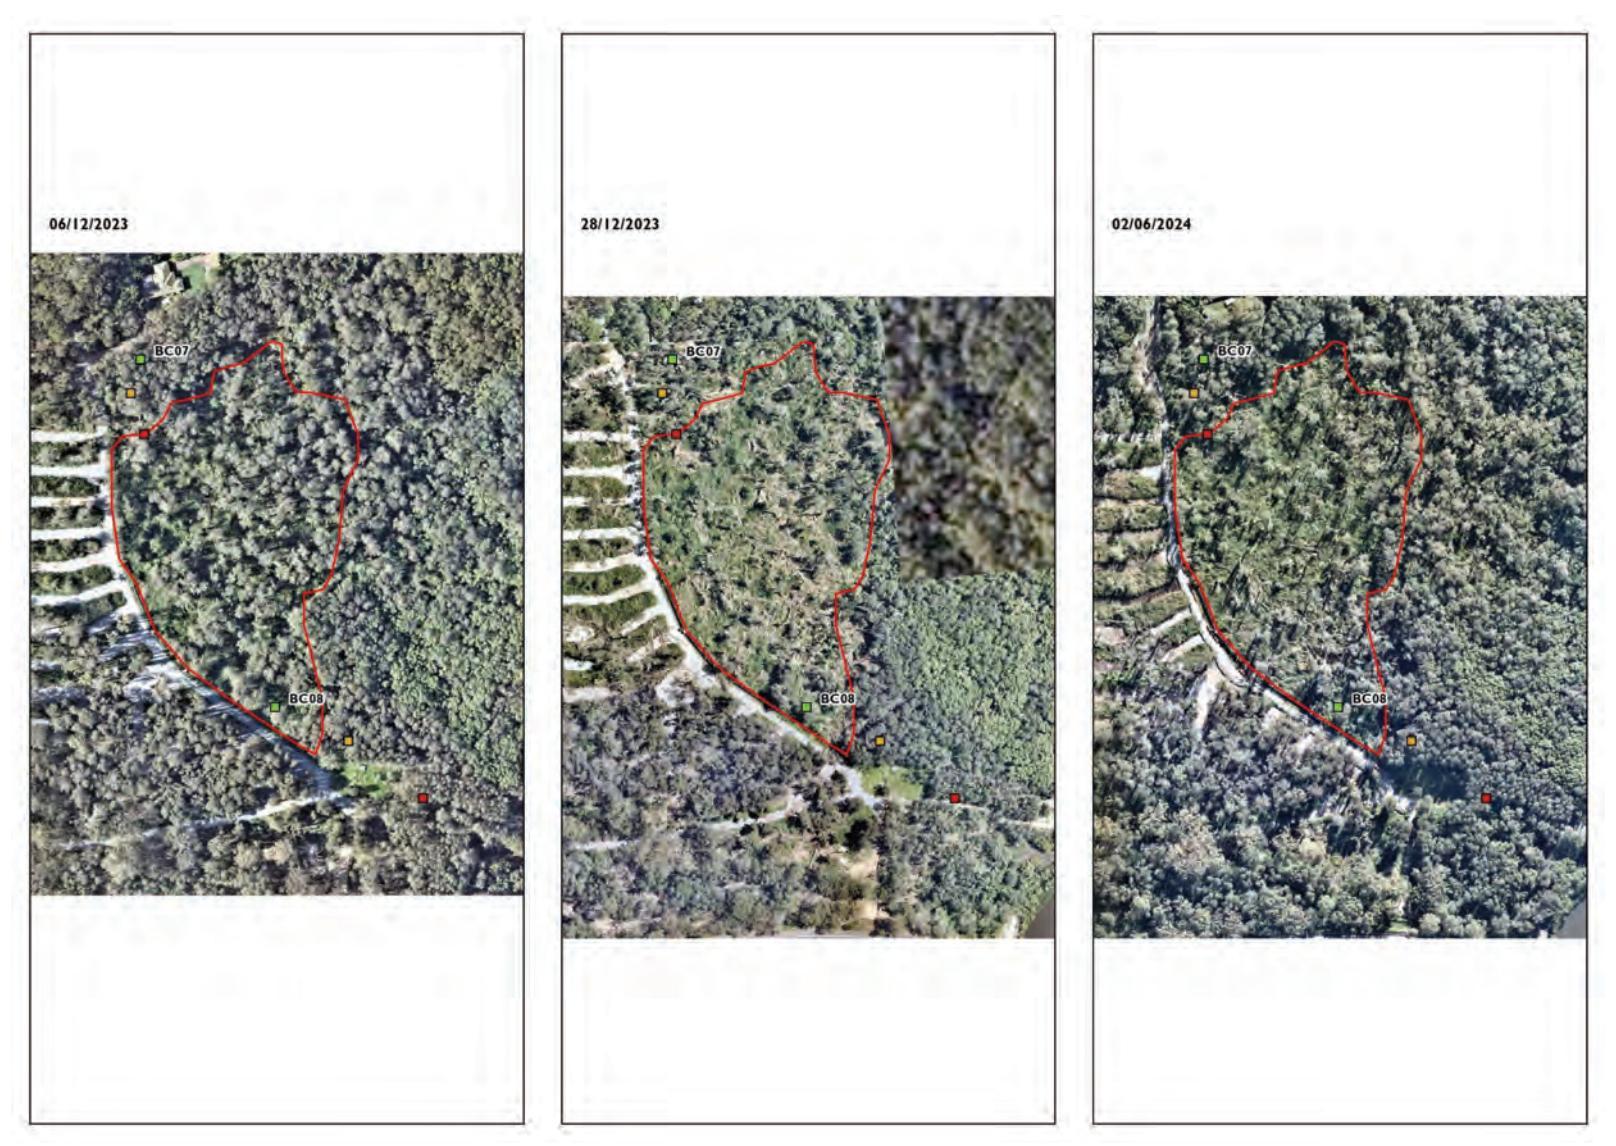
Figure 3-13 Timestamped aerial images of sites BC07 and BC08 before and after storms on Christmas Day 2023. Red boundary highlights mapped storm damage areas. Realigned transects can be seen in Appendix A. Source: Nearmap.

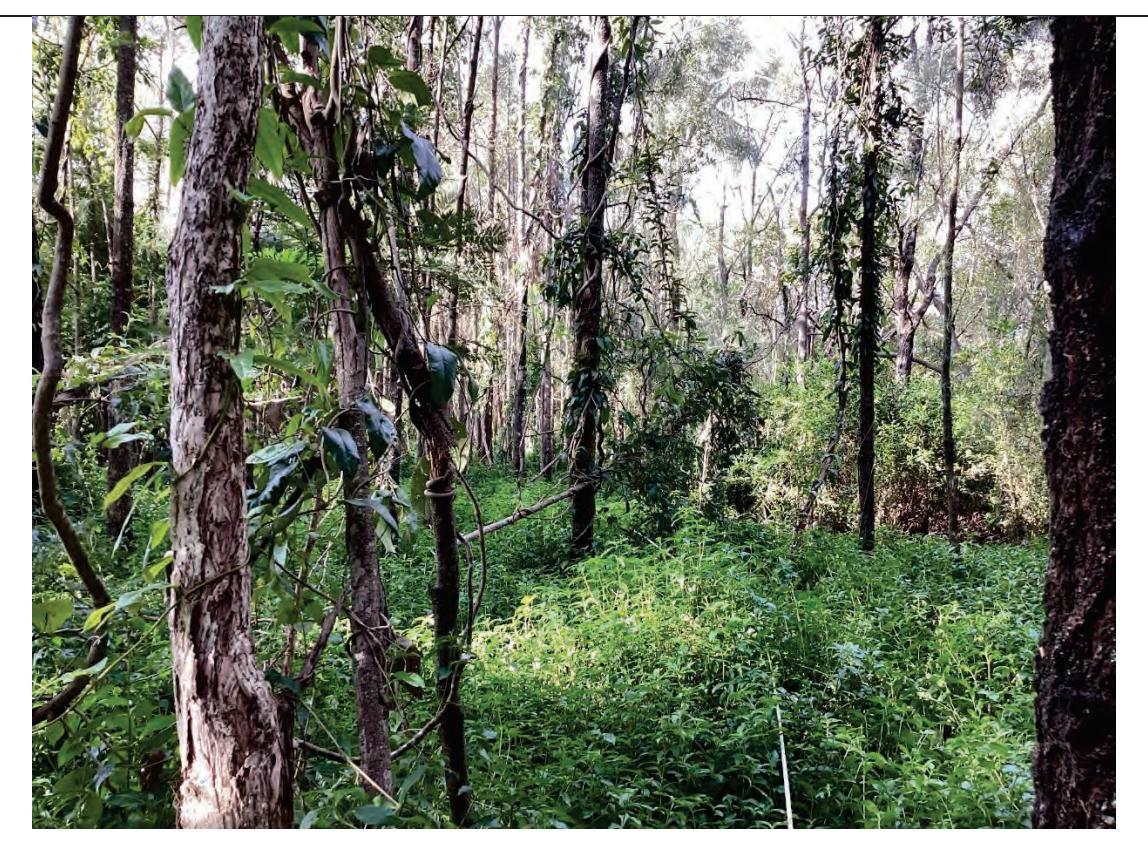
Figure 3-14 Extremely dense cover of Singapore daisy (Sphagneticola trilobata) at BC09.
