Targeted collection of inventory data for wetlands fish barriers in the Great Barrier Reef catchment

Final Report

DEPARTMENT OF PRIMARY INDUSTRIES AND FISHERIES • 2009

January 2009

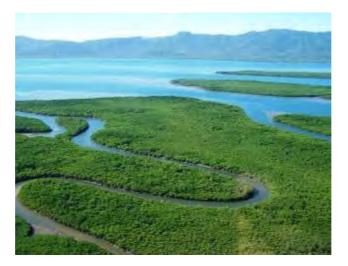
Figure 3. Hinchinbrook declared Fish Habitat Area.

The Hinchinbrook declared FHA (Fig. 3), draining the Herbert River catchment, is part of one of the largest and most complex estuarine systems in eastern Queensland and is the largest tropical estuary of the north-eastern coastal zone.

Covering 12 268 ha. The Hinchinbrook declared FHA includes extensive mangrove stands and seagrass meadows and is an important nursery ground for banana and offshore tiger prawn fisheries. Hinchinbrook fish habitats support a range of commercially caught species including mud crab, barramundi, threadfin and mackerel (CHRIS). The Hinchinbrook declared FHA supports a sea cage barramundi aquaculture farm and there are a number of aquaculture operations in the wider Hinchinbrook region.
