# Barrier fences in Queensland

Barrier fences in Queensland consist of the Darling Downs-Moreton Rabbit Board fence and the wild dog barrier fence.

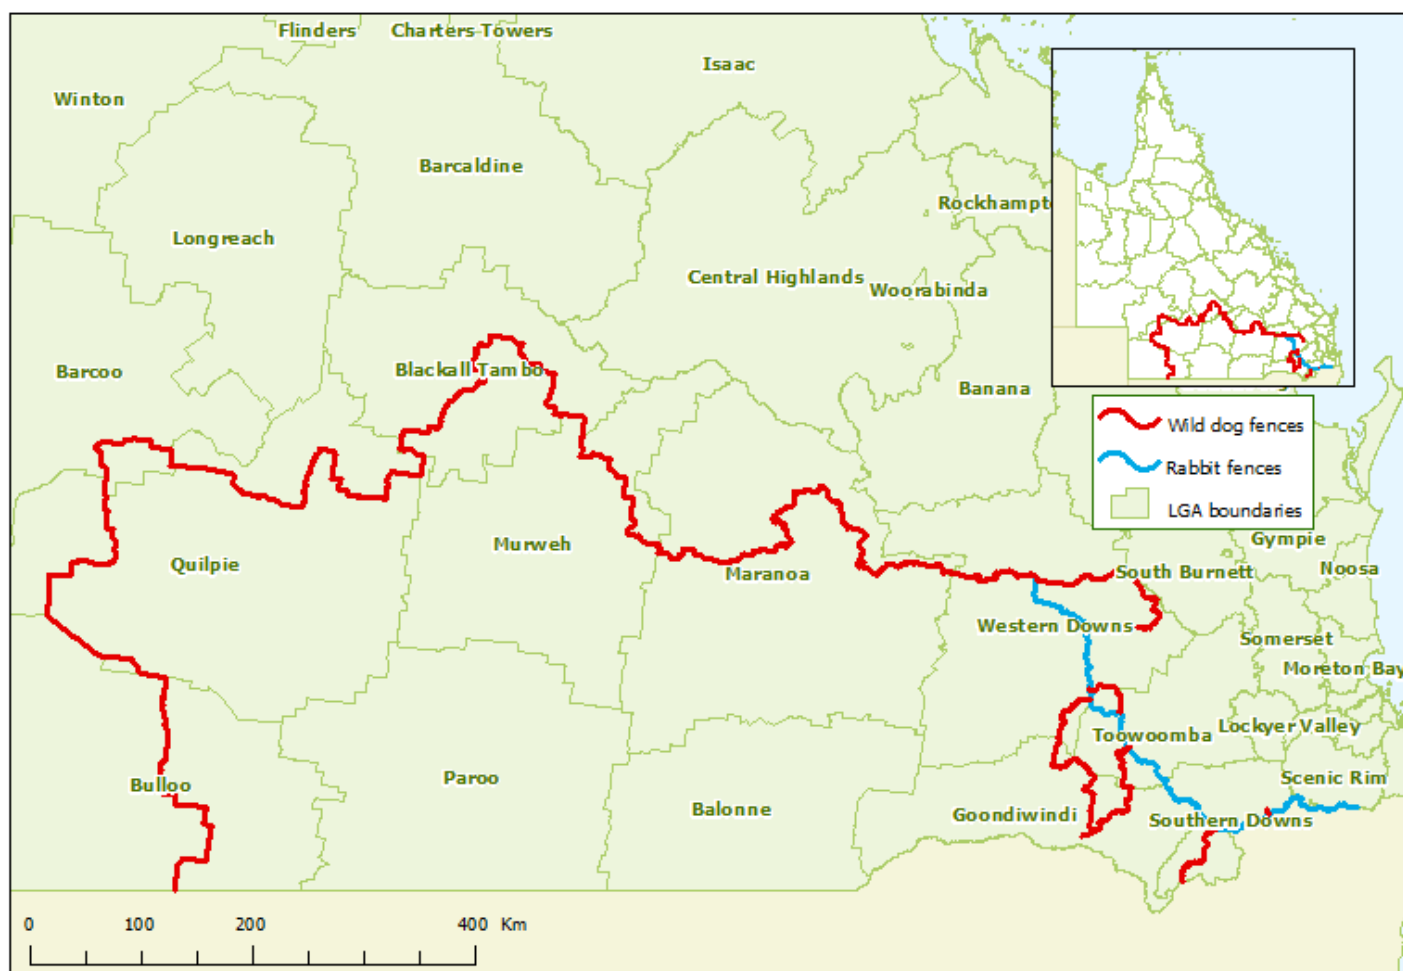
Map of the wild dog barrier fence (red line) and wild dog check fence (blue line)

The Department of Agriculture and Fisheries administers the wild dog barrier fence. It is approximately 2400 km long and has been totally reconstructed. The wild dog barrier fence protects 26.5 million ha of sheep and cattle grazing country.
